Subj: Command inspection of fire suppression and prevention services at Marine Corps Base, Camp Lejeune

REPORT OF FIRE DEPARTMENT INSPECTION  
AND FIRE PREVENTION PROGRAM REVIEW

MARINE CORPS BASE  
CAMP LEJEUNE, NORTH CAROLINA

28 NOVEMBER - 9 DECEMBER 1983

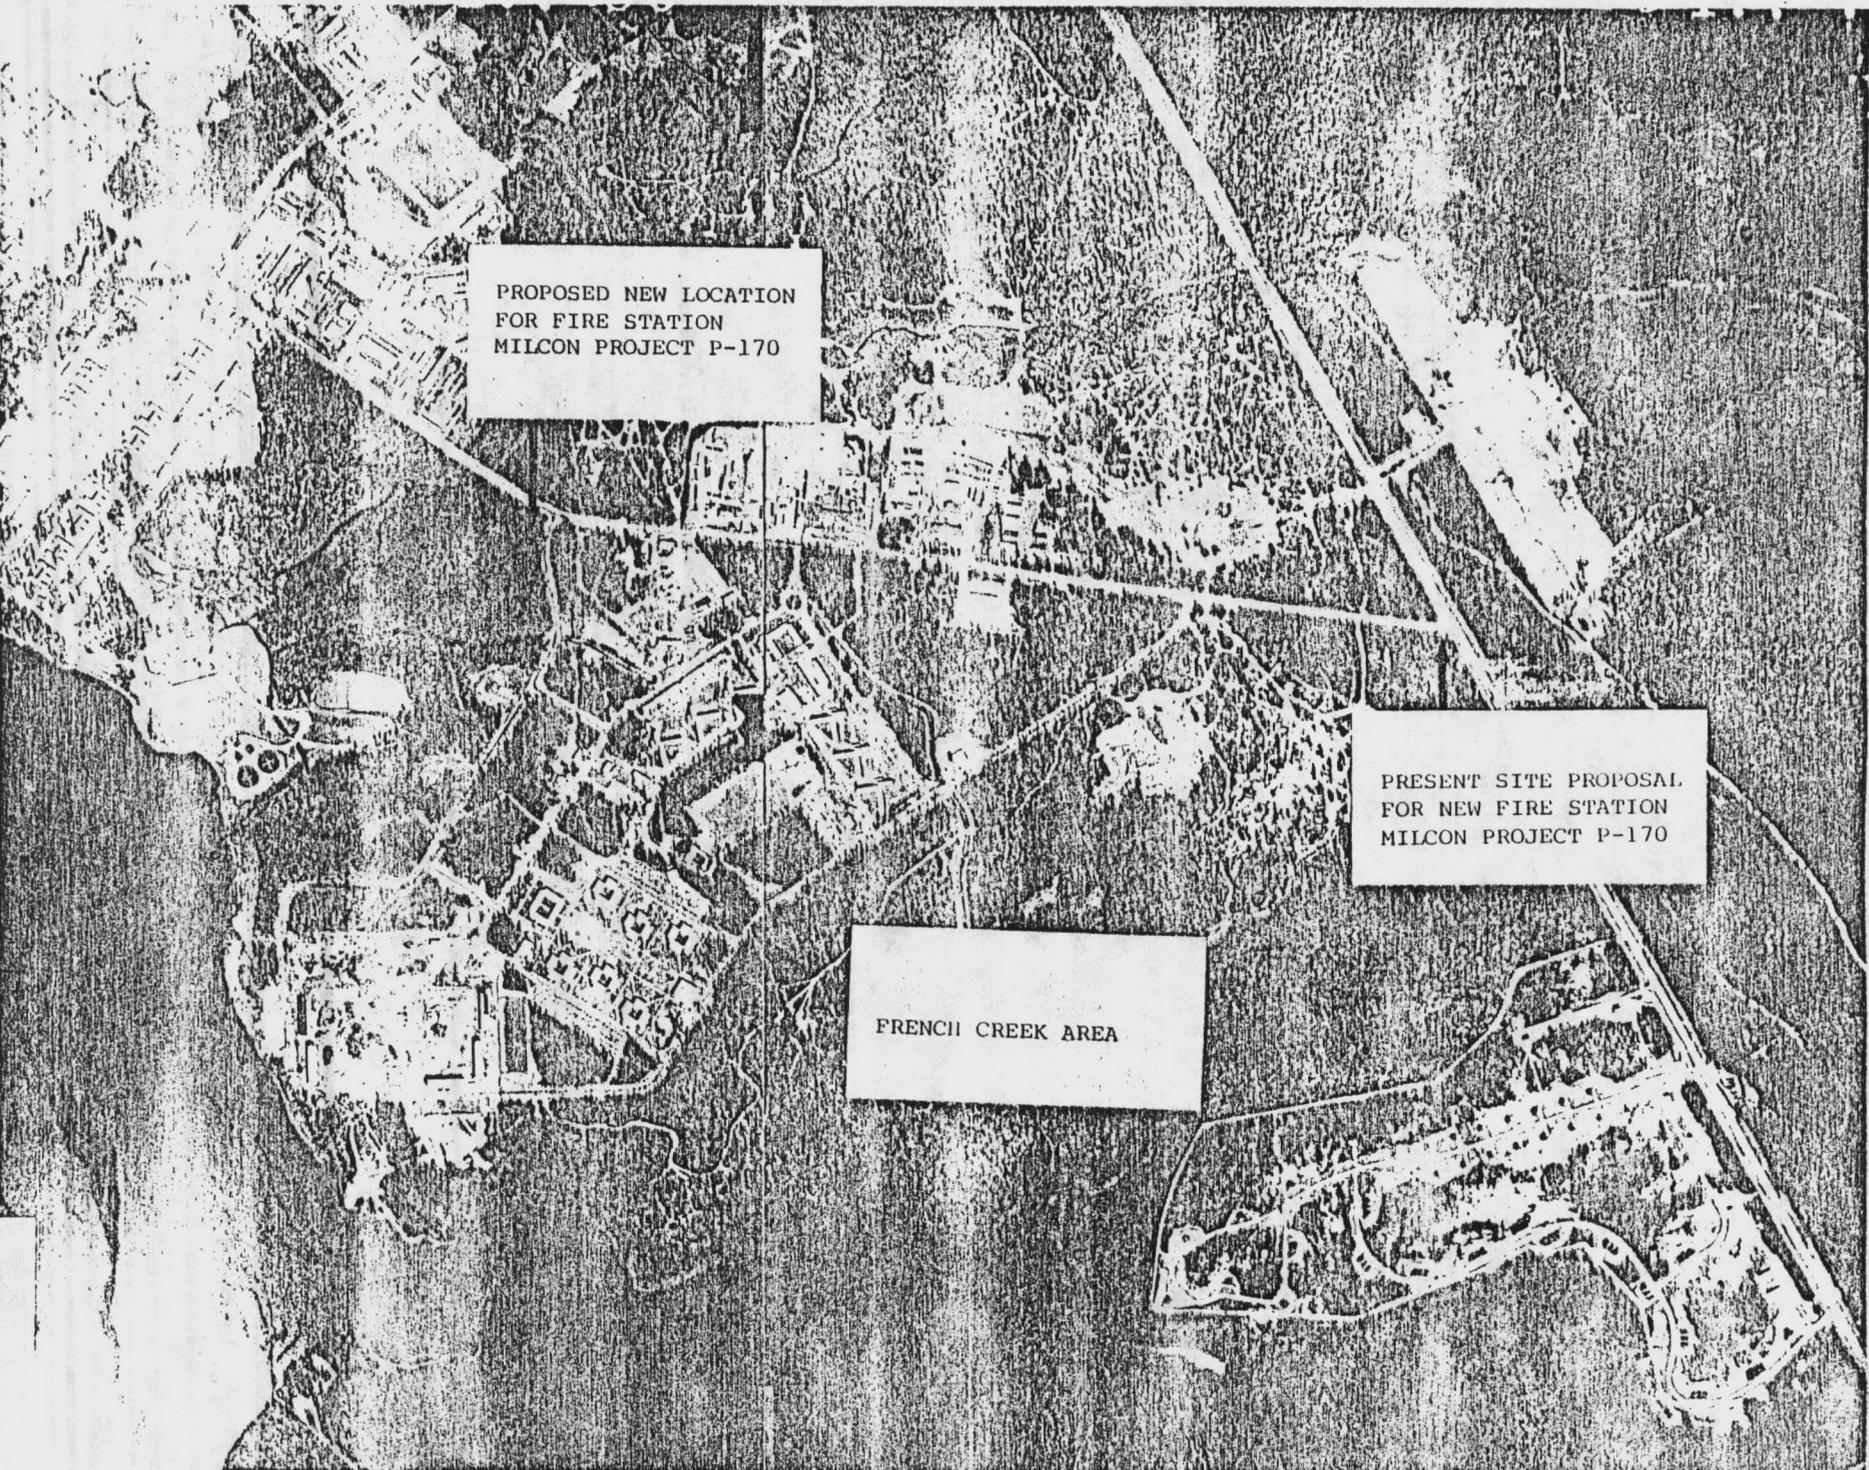
PROPOSED NEW LOCATION  
FOR FIRE STATION  
MILCON PROJECT P-170

Fire Station No. 5, located in the industrial area, needs to be relocated in order to meet time and distance criteria to the French Creek area. This area is experiencing a vast increase in construction up through FY-89. Replacement of Fire Station No. 5 is presently in an unprogrammed year (Mil Con P-170).
