SUBJECT: Metallographic Report

Attached is our laboratory report of the metallographic examination of a failed tube from the No. 1 Power Recovery Boiler. This failure was detected on June 3 at a point near the mud drum in the bottom row of tubes entering the drum on the side away from the furnace (the cooler side). The actual failure was in the shape of a "V" approximately 3/16" diameter on the inside surface of the tube culminating in the pinhole on the outside surface. Just adjacent to this V-shaped hole was a heavy layer of what appeared to be pure copper approximately 3/8" diameter and 0.025" in thickness. The top and the bottom of the tube were not indicated, but there was a slightly acid attacked channel area which we assumed to be the bottom of this nearly horizontal swaged tube. The copper plated area and the pinhole failure are located in approximately the 7 o'clock position relative to this acid damaged area. Further, it should be noted that the pinhole failure is in the transition zone of the swaged tube.

SUBJECT: Failed Boiler Tube
Lab #D7592

TO E. K. Lederach
FROM F. H. Seels
SUBJECT Procter & Gamble, Ivorydale Plant
No. 4 Boiler, Crossover Tube Corrosion

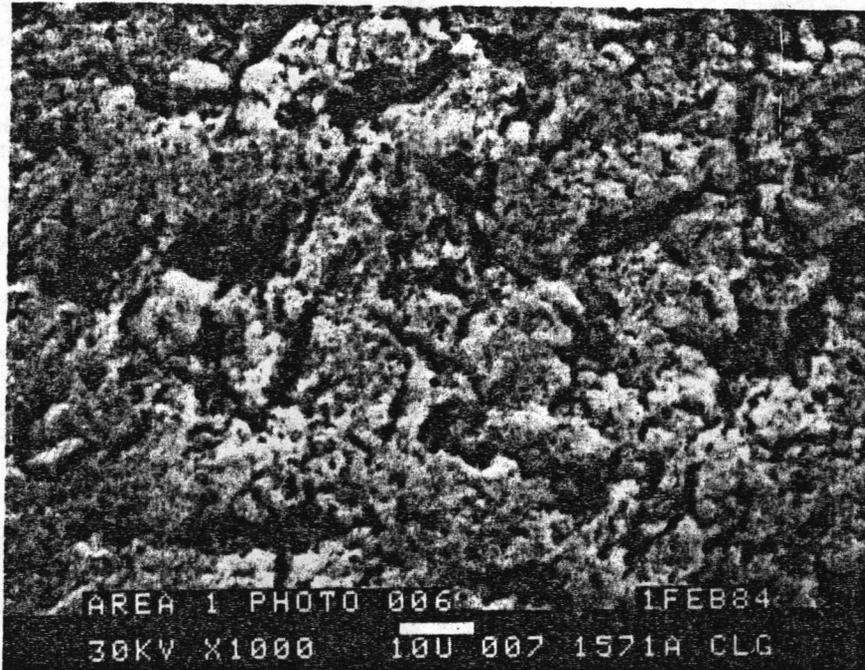
PHOTO 8 Closeup Of Area 1 In Photo 7
Note Fissures In Oxide Layer

Photos 8 and 9 are close-up views of metal oxide characteristics in the freshly corroded areas shown in Photo 7. They show variations in fissure formation and localized deposition. The localized deposition in Photo 9 is likely the redeposition of by-products of the upstream erosion-corrosion process.

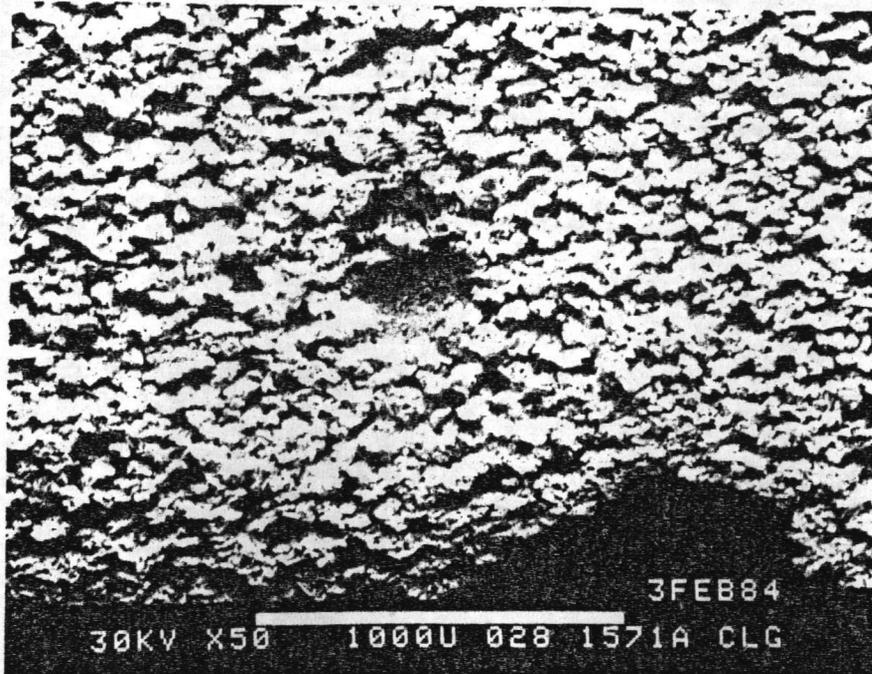
PHOTO 16 Closeup Of Cavitation Damage To Surface Deposit, Area Shown In Photo 6 Below And Left of Center

Photos 16 and 17 provide another view of deposit damage adjacent to an area of metal loss. The pocked area shown in Photo 16 is barely evident in Photo 6 (lower left of center, in axial alignment with pillar). As with deposit damage in Photo 4 and 6, it is clear that a substantial thickness of deposit must be removed before metal damage can begin.

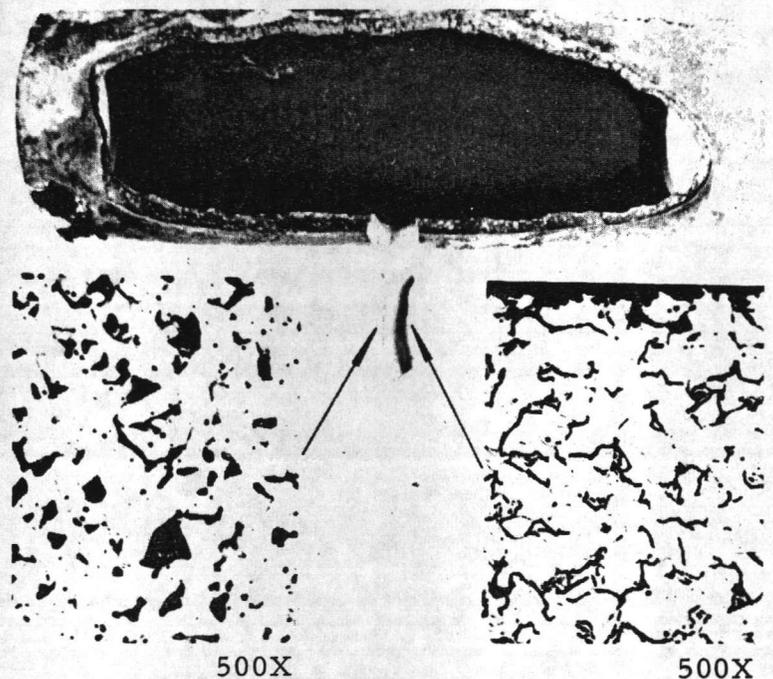
Figure 10 shows pretty much of the whole story in one illustration. The failed tube with a window section blown out is at the top. Notice the thick-edged break. A little macroetched section is shown just below the tube. The dark area of the etched section is typical of H_2 damage. The two micrographs, one from near the inner surface and the other from near the outer surface, are at the bottom and show damage to the normal structure.

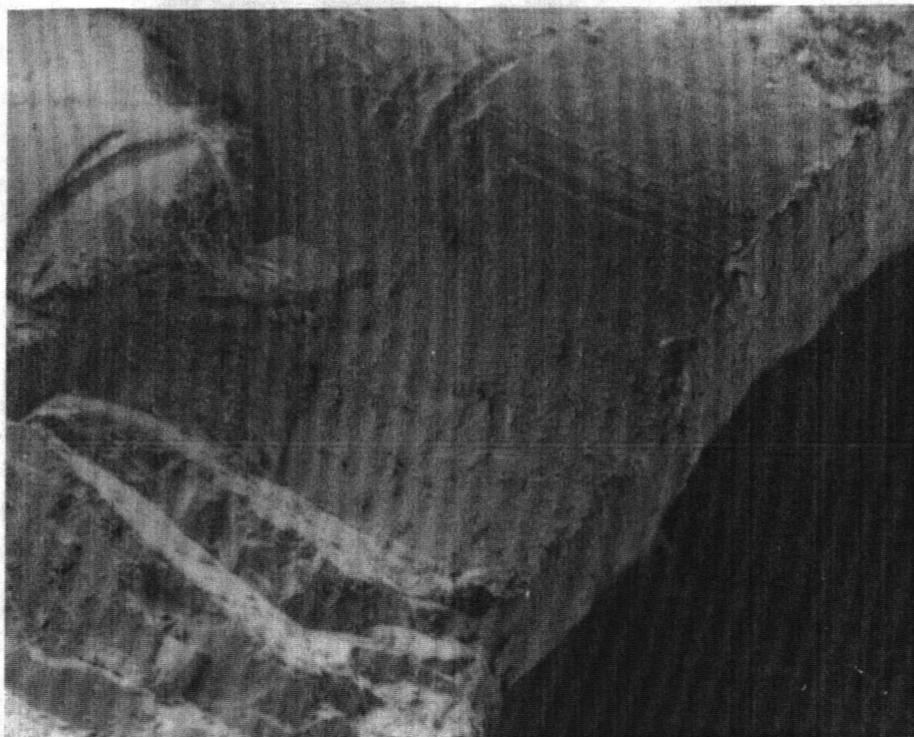
PHOTO 1
Circumferential Corrosion Cell with
Corrosion Products in Place (17x)

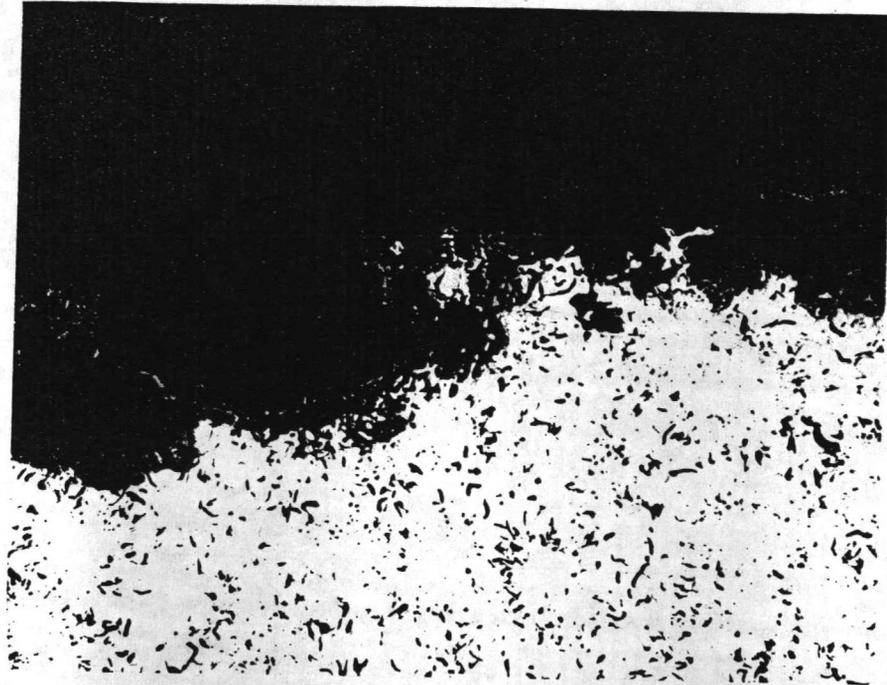
FIGURE 3, 50X
Unetched microstructure adjacent to the velocity face on the damaged liner

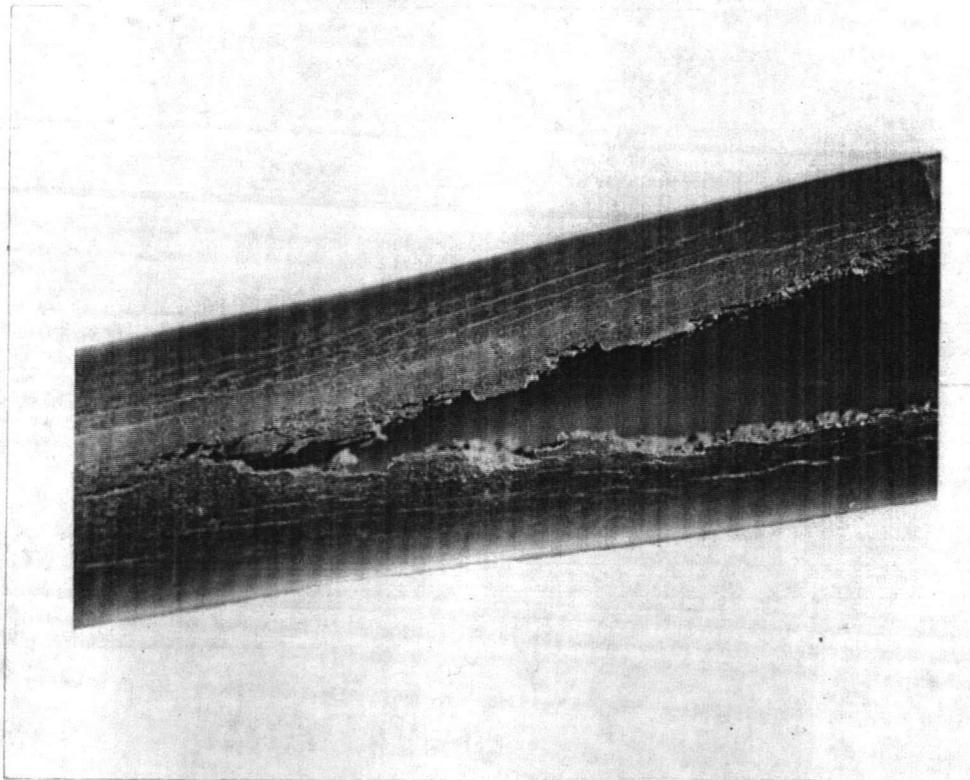
Figure 1

Based on the above observations, it is evident that the tube is not T-11 steel but is a 0.5% molybdenum steel. The tube was apparently overheated as is indicated by the spheroidized structure and the decarburization. Final parting of the tube is attributable to stress rupture. The tube weakened by surface crevices, decarburization, and its operation above a useful temperature range succumbed to the applied internal pressure of 2475 psi, which constitutes a stress in excess of 8000 psi on the reduced wall.

Fractured Superheater Tube - 2" Diameter X 0.320" Wall

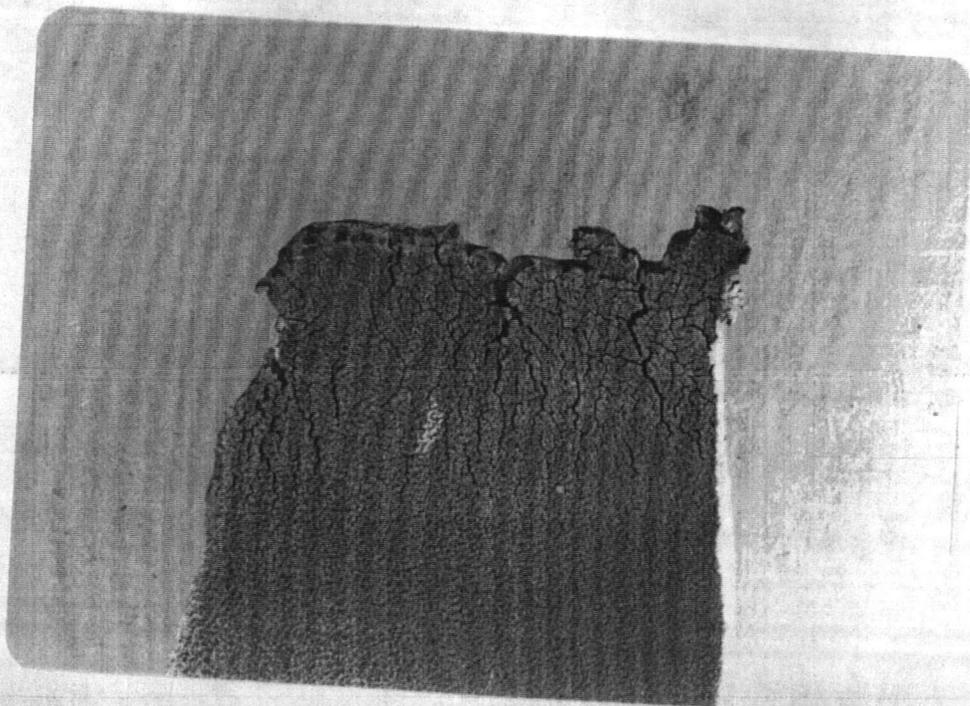
Fig. #2

Failed Edge

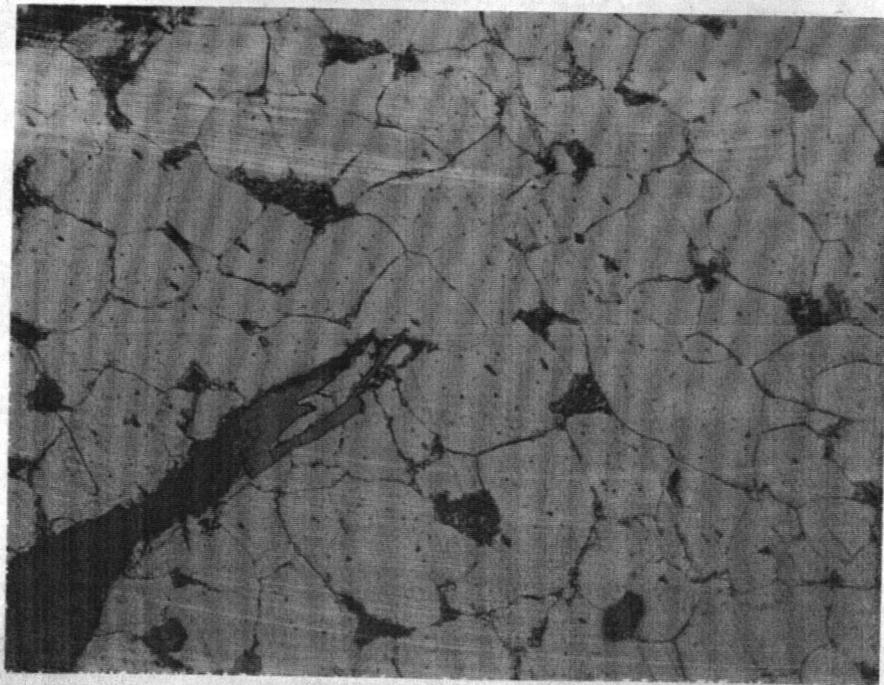
The grain structure adjacent to the edge of the failure did not show evidence of plastic deformation (grain elongation). (Figs. #3 & #4)

Fig. #4 Grain structure near the edge of failure midway between internal & external wall surface. 360X
