This letter is to report a 24 September 1986 bypass in the Camp Johnson (Montford Point) Wastewater Treatment System, Marine Corps Base, Camp Lejeune, North Carolina. Telephonic notification was made to your office on 24 September 1986. Approximately 3,000 gallons of wastewater were leaked into Northeast Creek when a crack developed in the terra cotta line feeding lift station M-241. The crack developed sometime after 10:00 pm (2200) on 23 September 1986 when the lift station was checked and before 9:45 am on 24 September 1986 when the leak was discovered. The bypass was stopped by 10:00 on 24 September 1986. The line was repaired and the ditch treated with 100 pounds of HTH the same day.

SUBJ: NPDES PERMIT VIOLATION, M-241 LIFT STATION

SUBJ: SEWER SPILLAGE

SUBJ: NPDES PERMIT VIOLATION, S-47A LIFT STATION

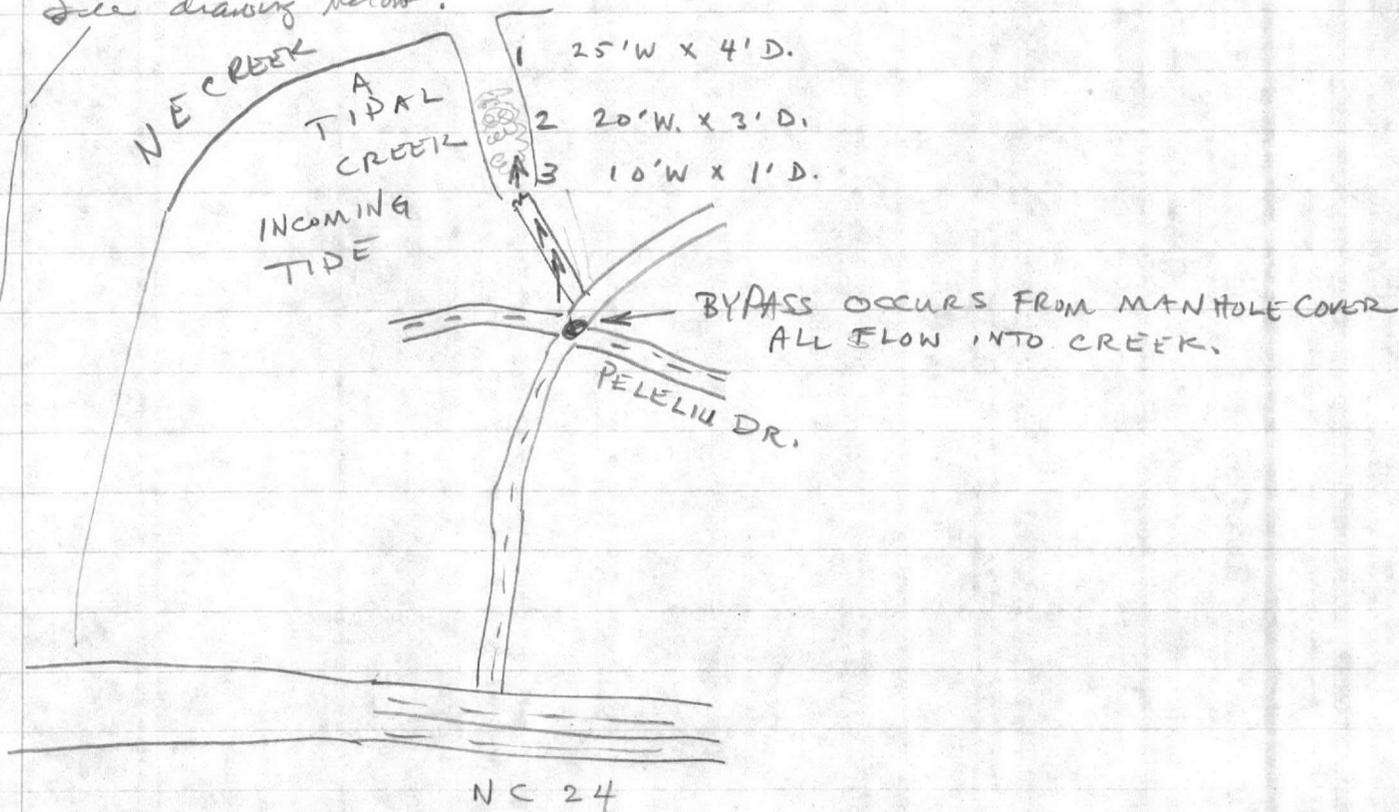
Sewage Bypass @ TT (Storm Drain # 28)

Sewage Bypass reported to Lab at 1010 from D. Sharpe.
from manhole in road/street at intersection of Tarawa Blvd and Peleliu Dr.

When I arrived at 1030, ^{both} utilities personnel and base maintenance personnel were on the scene. Using a high pressure water line and a "gouge" they removed the large grease deposit (household type) that was occluding the flow of sewage in the main.

Quantity of spill estimated 9,000 gallons - 10,000 gal.
100# HTH was added into the small creek. (which happens to be our storm drain #28.)

Ms. Betty, Supervising Chemist called STEVE LONG to report the bypass. He directed 3 samples be taken from 3 locations in the zone of mixing for D.O., B.O.D, and fecal coliforms. I took these samples @ 1315 - 1345.

SAMPLE POINT	# 1	# 2	# 3
pH	7.5	7.4	8.7
D.O.	5.4	5.7	11.0
BOD	5.4	3.5	5.1
Fecal Coliform	1000	0	30
DO ₅	0	2.2	5.9

At 1120 the street had been worked, manhole cover replaced, and all personnel were gone.
