**GENERAL DYNAMICS**

TO: R. G. Hill  
XC: J. Brummans, T. Offer, J. Ruma  
SUBJECT: Water Ingestion - Mississippi National Guard  
REFERENCE: RGH/86-356 Correspondence Dated 01 July 1986  
ENCLOSURES: (1) Trip Report  
(2) Engineering Work Directive

GENERAL DYNAMICS  
LAND SYSTEMS DIVISION  
TRIP REPORT

PURPOSE OF TRIP: Investigate Air Induction Water Ingestion

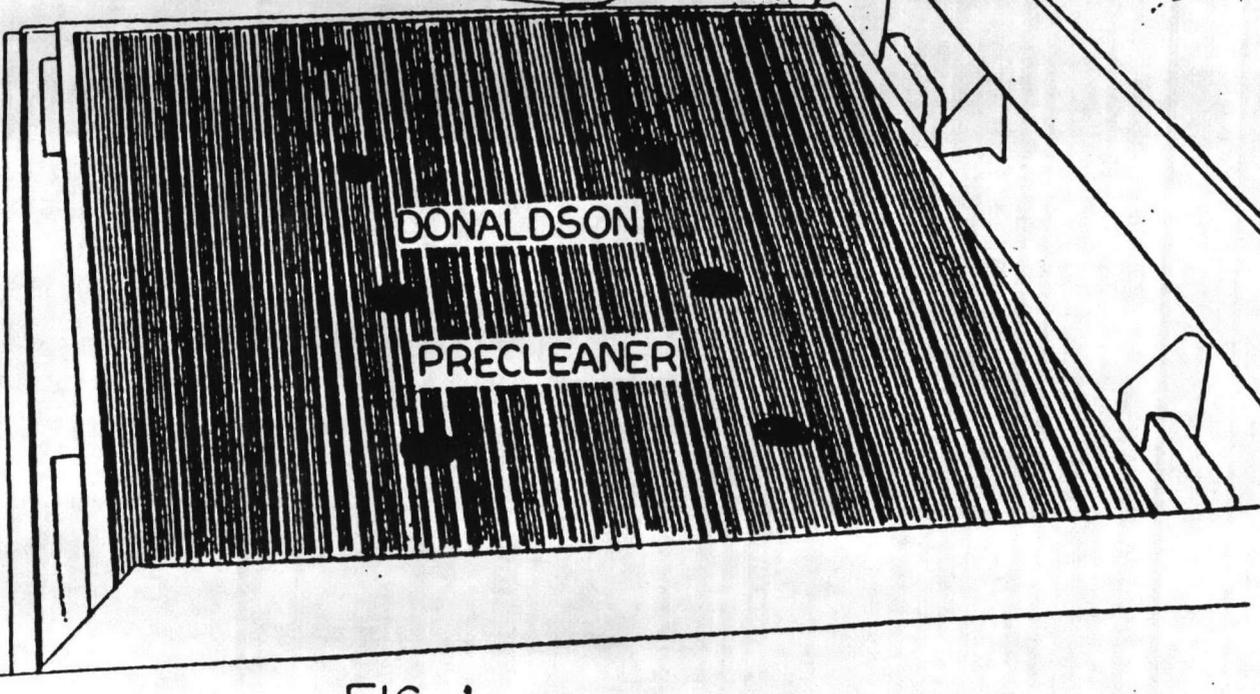
FIG 1

- a. The Donaldson precleaner (Fig. 1) may not have as much water falling on to it as the PLM precleaners do (Fig. 2), due to its higher top surface relative to the air scoop outlet.
- b. The Donaldson precleaner may be able to extract greater amounts of water due to different vortex tube design.
- c. The Donaldson precleaner assembly has a screen, that PLM precleaner does not. This may cause the water to splatter, allowing increased water extraction.

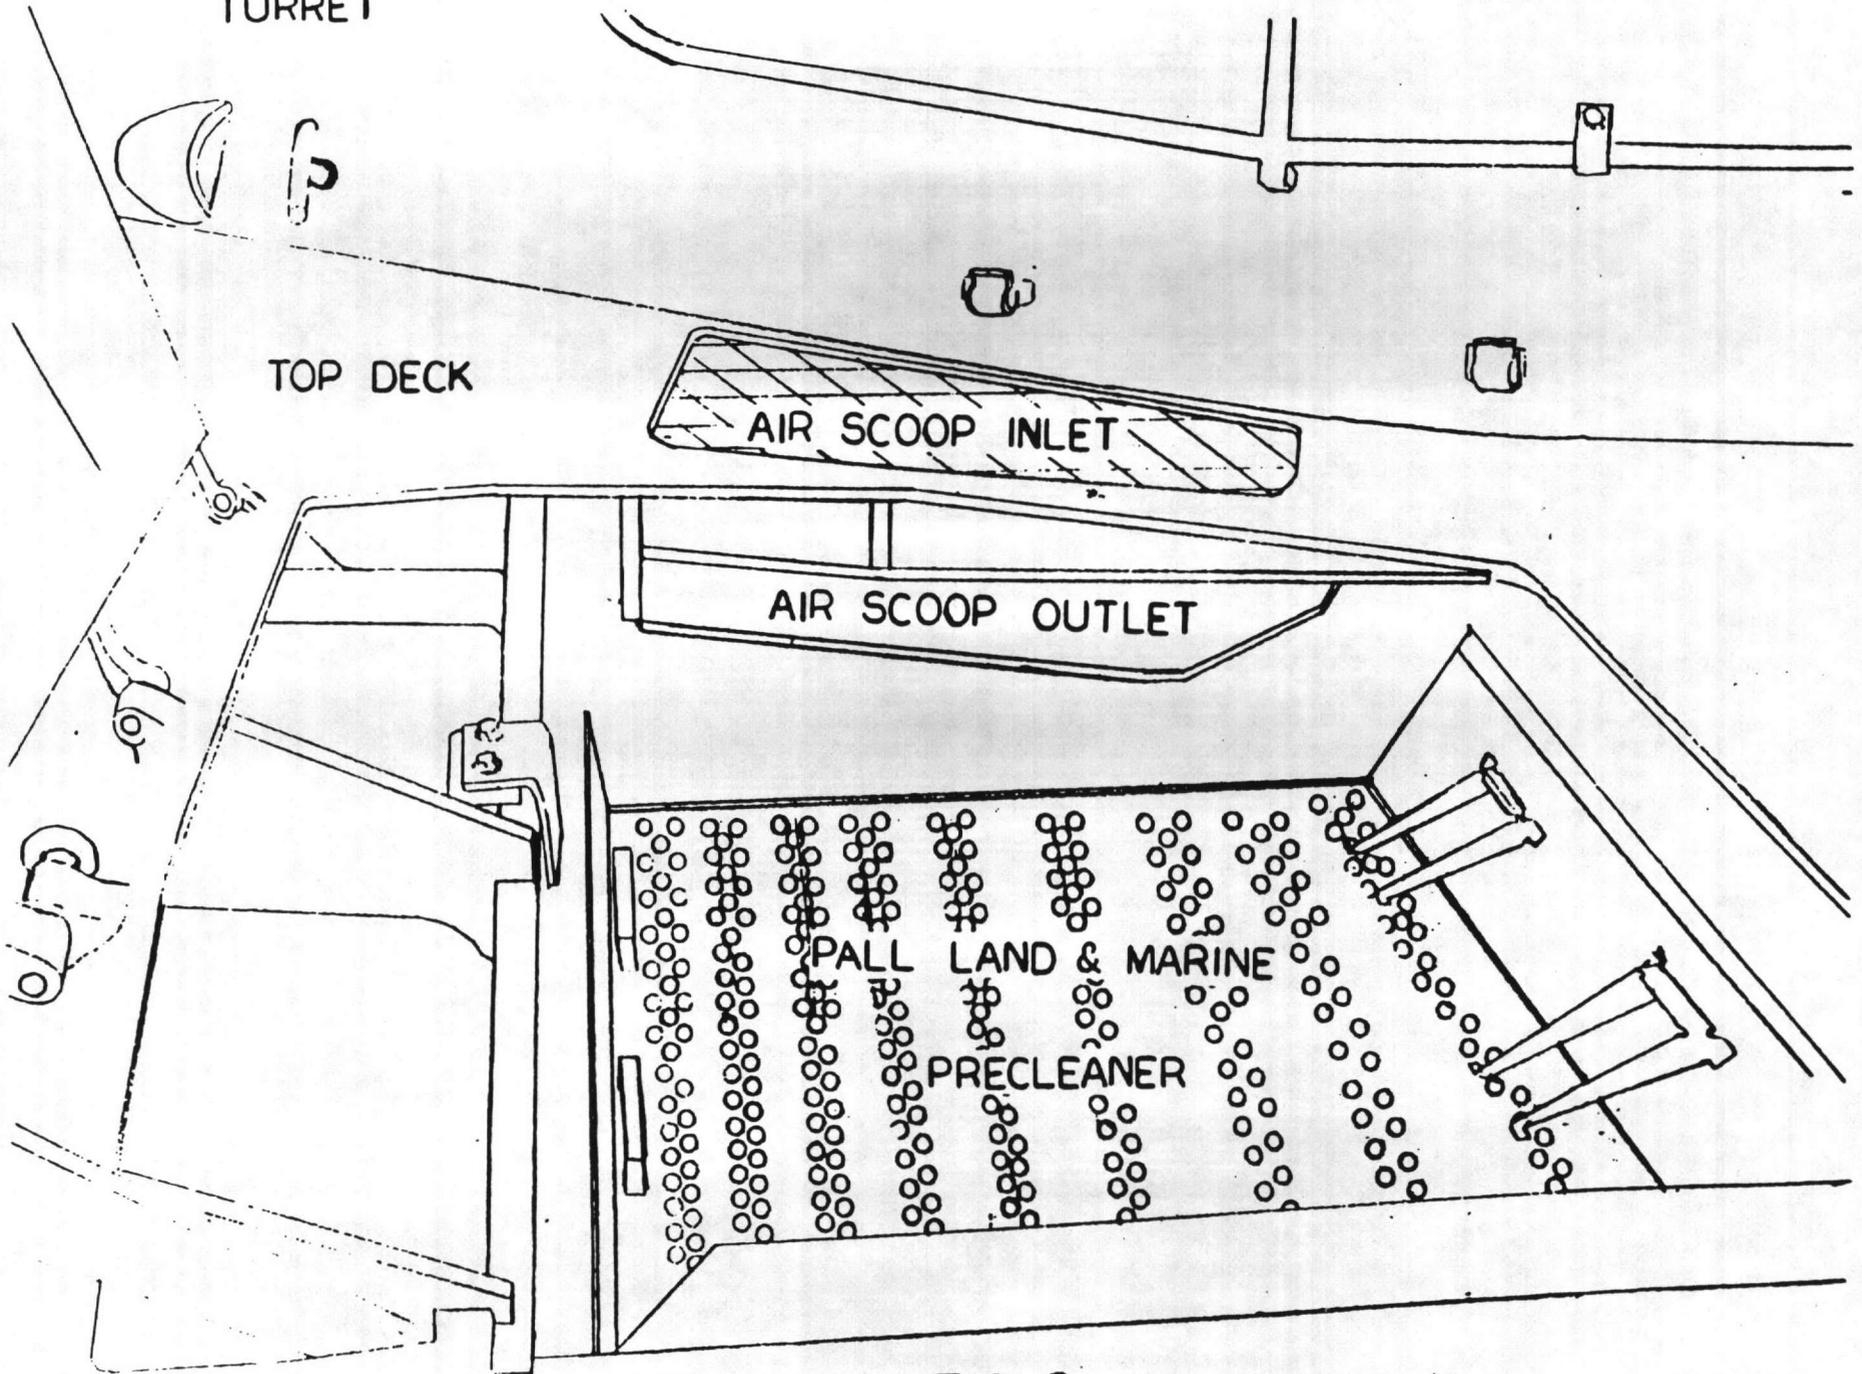
FIG. 2

The modified PLM precleaner would have a strip of material added to match the Donaldson precleaner height at the air scoop outlet.

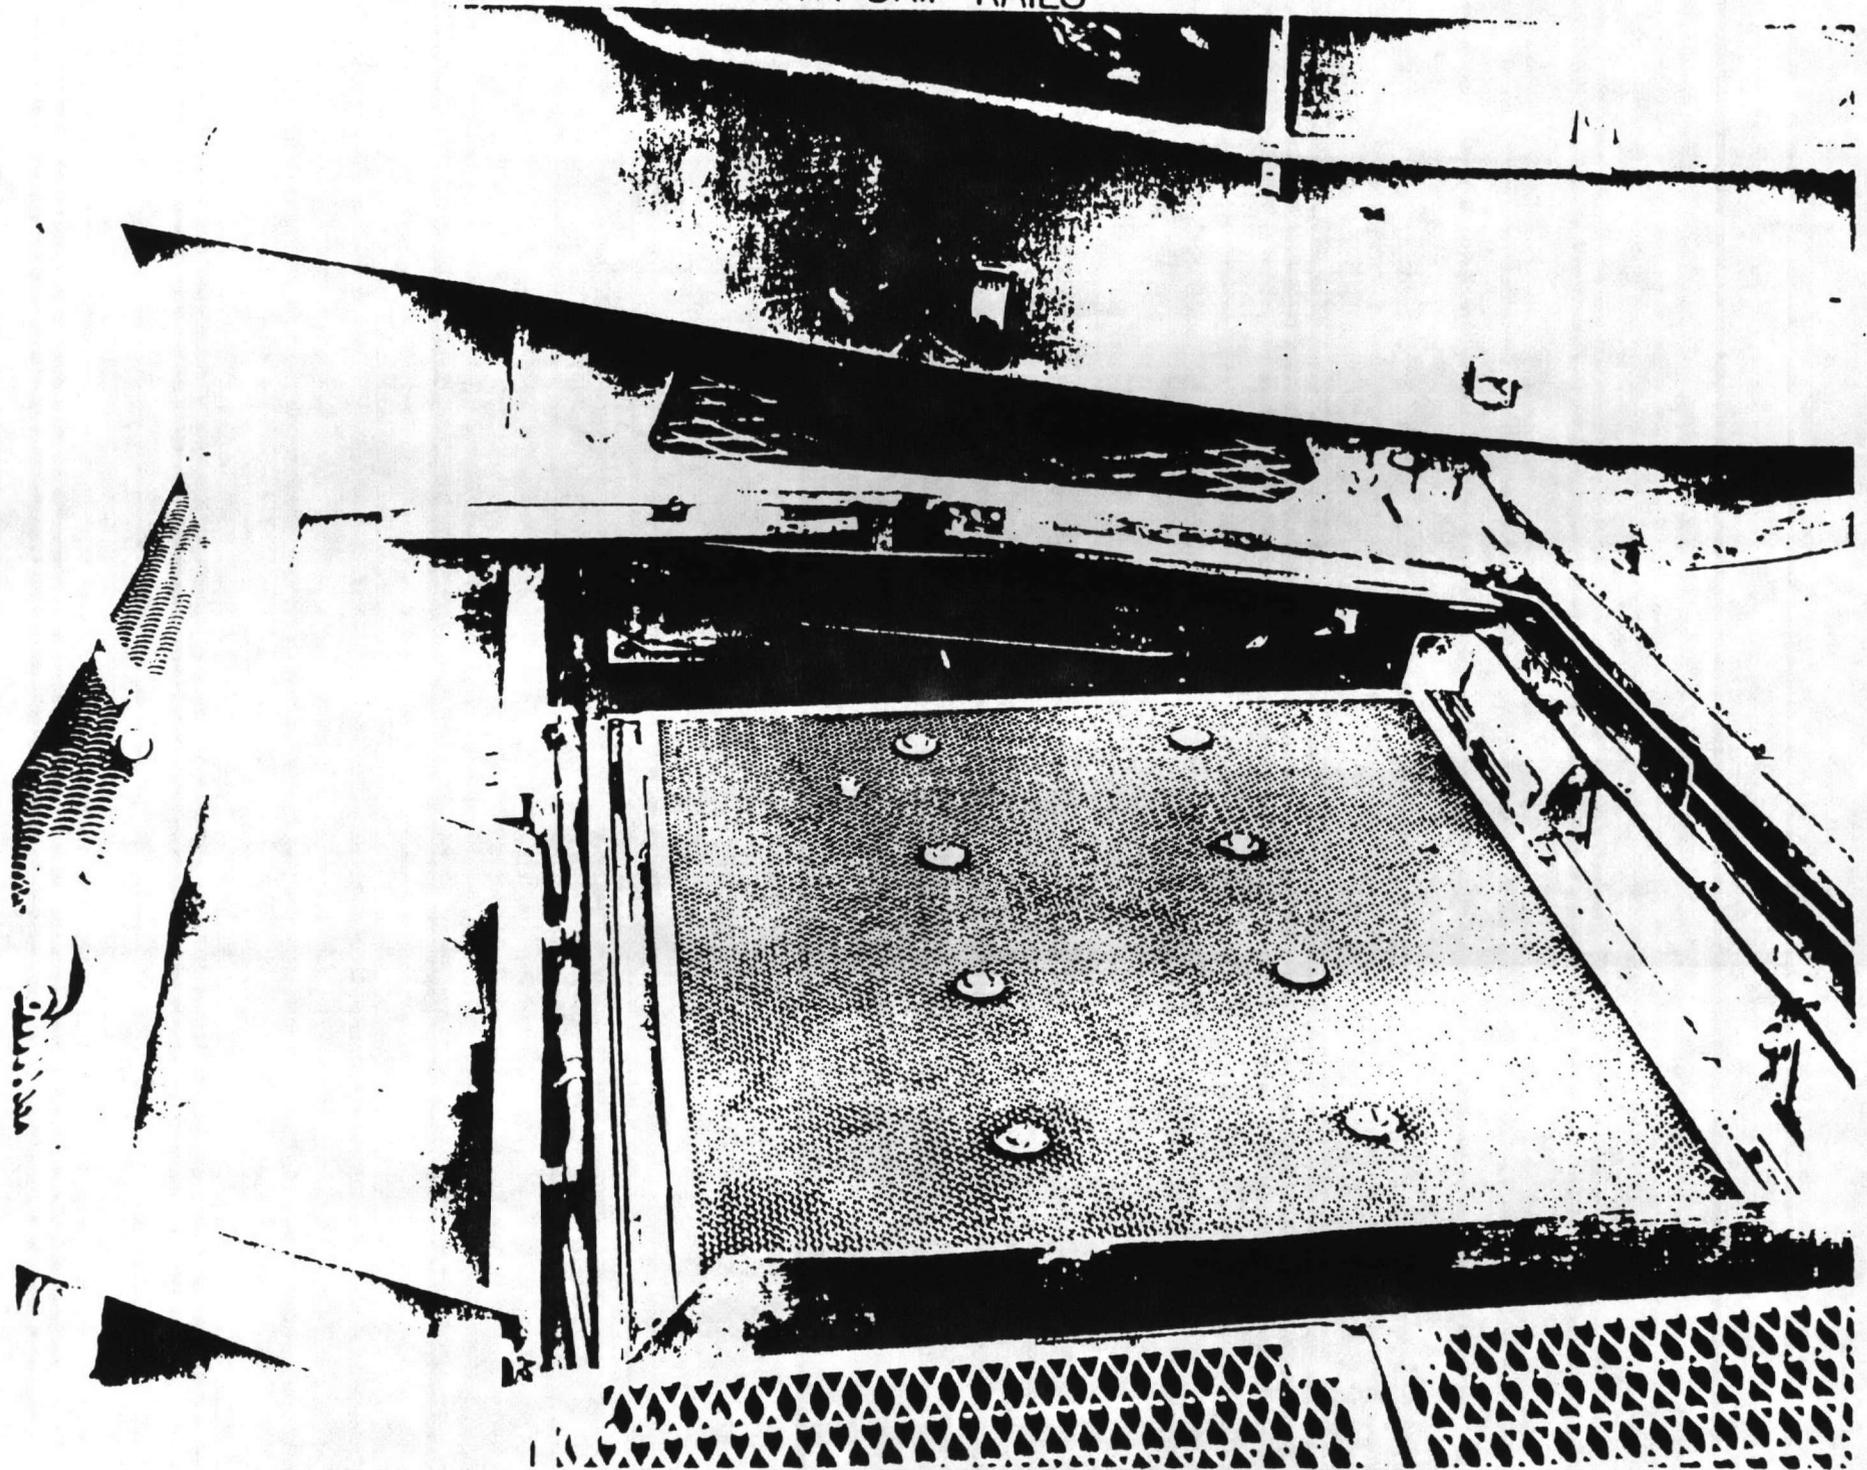
FIG 3

ECP GDLL 3626 has released a change to incorporate drip rails to alleviate air induction water ingestion. Reported incidents of water ingestion from Fort Hood, Fort Puke, APG and Europe were the reason for the drip rail ECP. A vehicle at GDLS engineering facility was modded with drip rails and successfully tested in the prototype shop with both Donaldson and PLM precleaners. A modded vehicle underwent a salt fog and field test at Eglin Air Force Base in Florida with a Donaldson precleaner. None of the Camp Shelby vehicles has been modded with the drip rails. When site personnel were shown photographs of the drip rails installed on a vehicle, all indicated that the rails would reduce water ingestion, but some were uncertain that the mod would be sufficient to eliminate it.
