Subject: M1E1 CEU Potential Safety Hazard

Subject : Subcontract DEM 805001 (0178)
120mm Gun FSED
M1/IM1E1 CEU Interchangeability

Subject: Interchangeability of M1 and M1E1 CEUs.

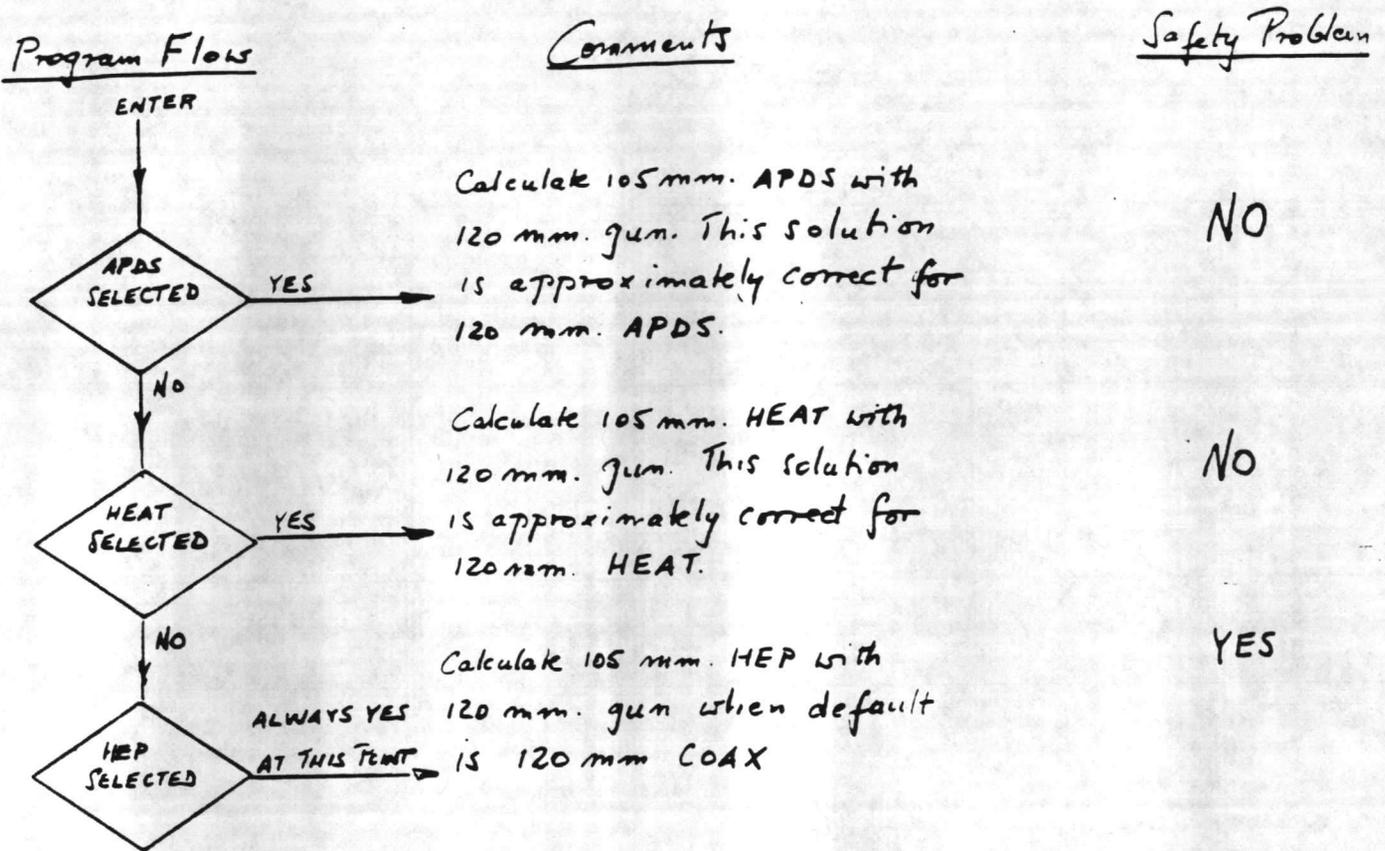
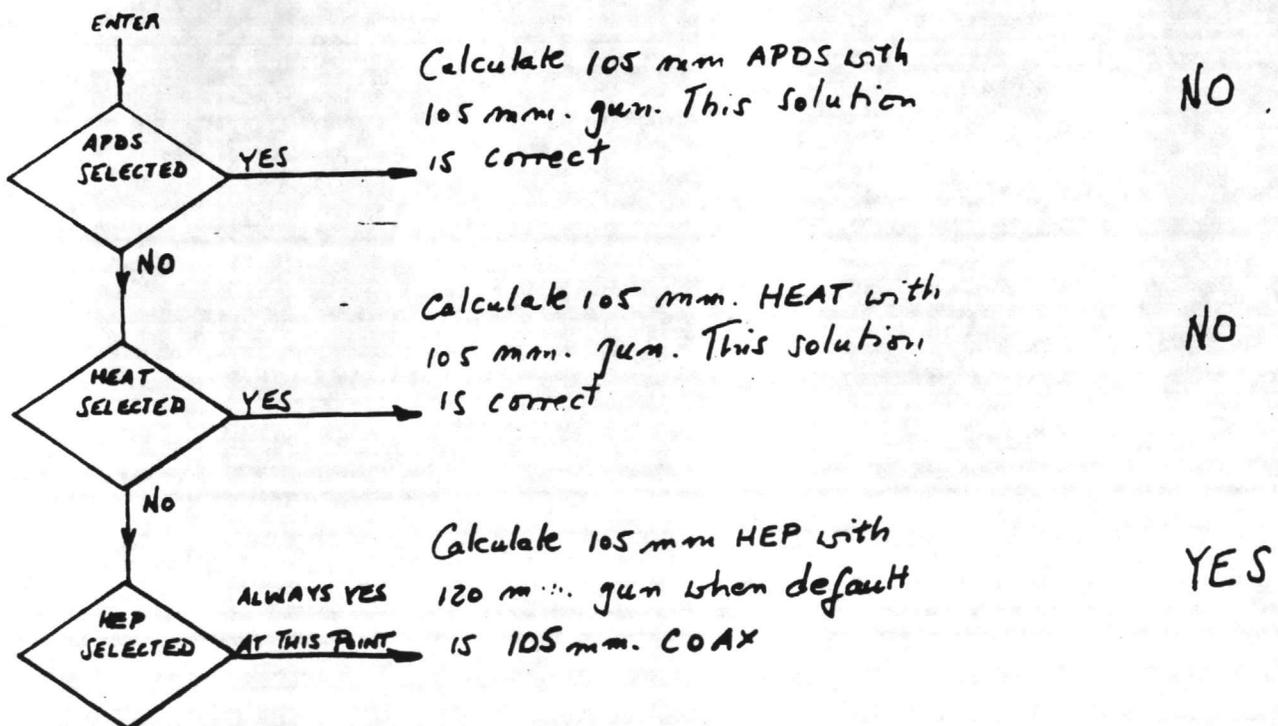
FIG.1

With an MI CEU installed in an IMIEI tank, no hardware safety problems would exist (by applying voltages to the outputs of IMIEI sensors), however software problems would as shown in Fig. 1. Please provide comments to the above suggestions.

IMIEI Tank with MI CEU Installed

1. 120 mm Gun Installed

2. 105 mm. Gun Installed
