Update on Water Ingestion Problem on M1 Tank.

SUBJECT: Water Ingestion in the M1

Title of Kit: AIR BOX Drip Rail AND Baffle KIT FOR WATER ELIMINATION	Date 12 OCT 84	RFC Number -B
---	-------------------	------------------

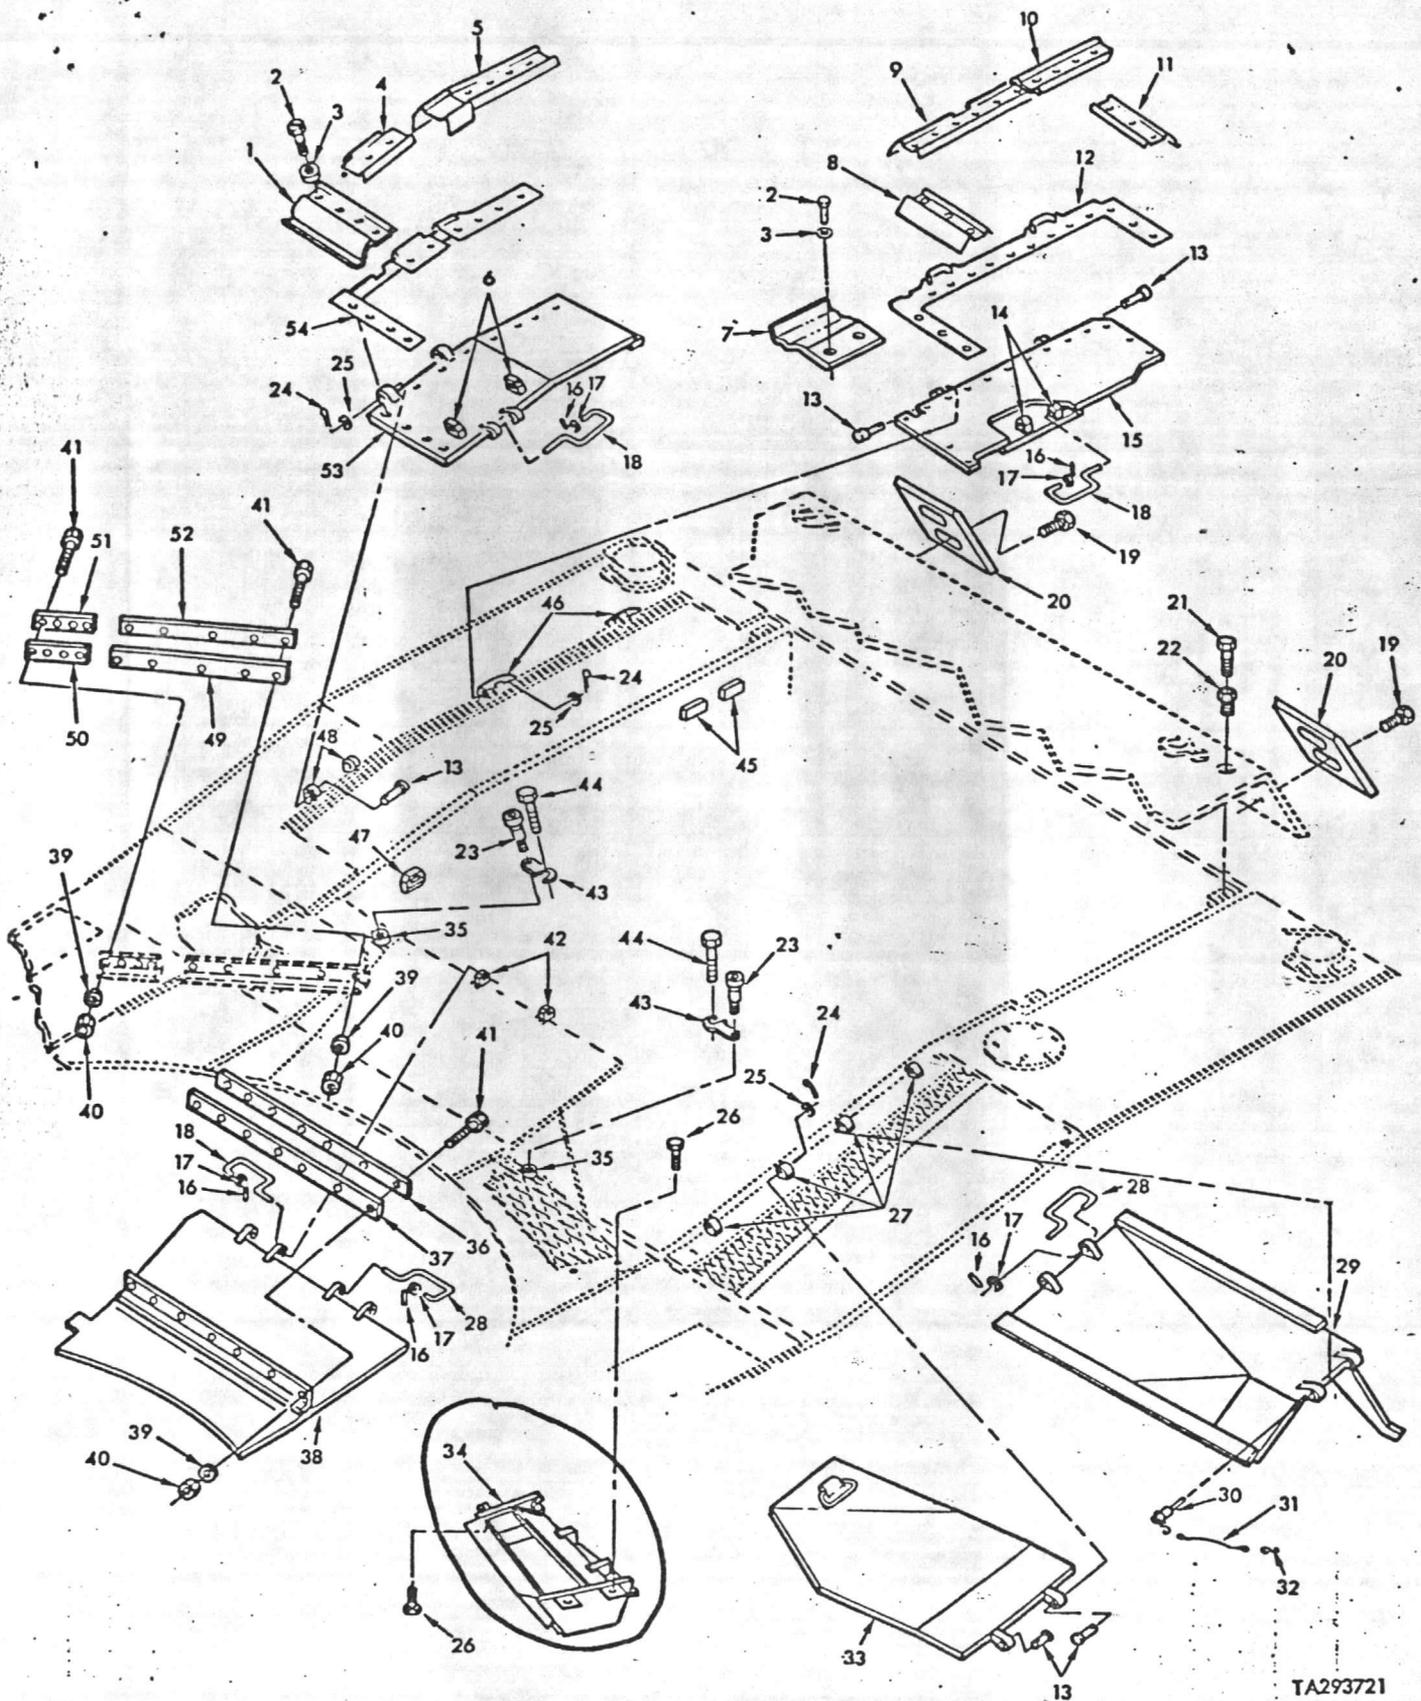
FIGURE 188. TOP DECK COVERS, AIR BOX, AND RELATED PARTS.

2. In both cases of 2/8 and 1/7, I strongly feel that water was ingested, primarily, through the air inlet grill located above the air box and forward of the precleaner doors (item 34, Encl 1). Extensive checks by both 2/8 and 1/7 indicate this is the case. To further substantiate this, ECP L3626-B (Encl 7) has been designed for the M1A1 (I am not sure if it is approved or not). This ECP adds a "drip rail" to channel water away from the precleaner as it comes in through the air inlet grill.

(3) The major contributor to water ingestion is water flowing into the precleaner through the air inlet grill located above the air box and forward of the precleaner doors.

(4) ECP L3626-B adds a "drip rail" which directs water from the precleaner.

(2) Make ECP 3626-B effective ASAP and get it into the hands of fielded units (Ft Hood and Germany).
