Range Control  
Marine Corps Base  
Camp Lejeune, North Carolina 28542

5100  
RCTL  
18 Dec 84

Subj: SAFETY DEFICIENCIES: BASE RIFLE RANGE

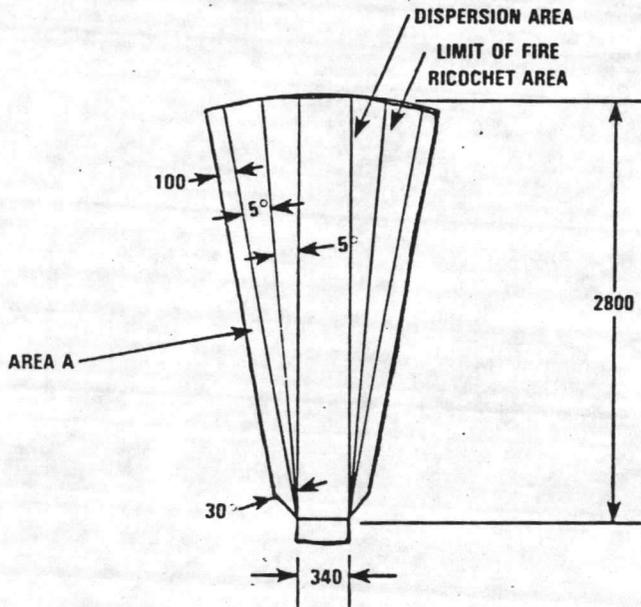
Figure B-3 Record firing range - M16

b. A quick fix completed this week by Range Maintenance has been the emplacement of two range warning flag poles at grids vic 764305 and 759321. The Rifle Range must raise and lower red warning streamers from these poles to coincide with actual firing times. To fly streamers continuously, 24 hours a day would be contrary to the requirements of references (a) and (b). Enclosure (1) depicts the SDZ.
