FLUID ENGINEERING SERVICES

AIR AND WATER BALANCING

SUBJECT: Exh. Fan 101. Rooms S155 & S144

New Naval Hospital

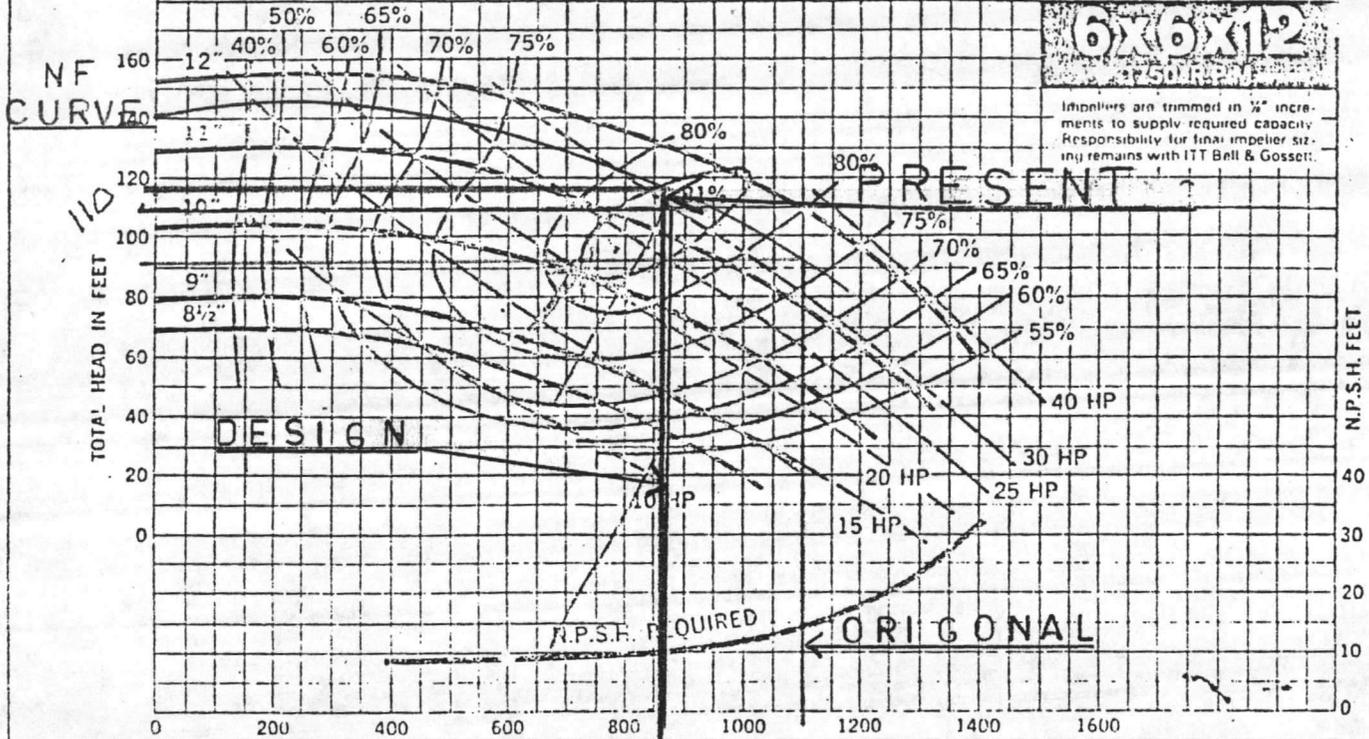
P 116

In regard to chiller pump balance reports, note the specific pump curves denoting the "design" characteristics as compared to the pre-balance "original." Note also that the respective pumps (P116, P117, & P118) have been balanced according to design as denoted by "present". This balance has been verified through EMCS reporting of these flow characteristics.
