Ref: JP-5 Fuel Recovery Project
MCAS, New River
Rapid Refueling Area

INTERIM REPORT

CONFIRMATION STUDY TO DETERMINE
EXISTENCE AND POSSIBLE MIGRATION
OF SPECIFIC CHEMICALS IN SITU

SOILS INVESTIGATION
MCAS NEW RIVER
RAPID REFUELING AREA

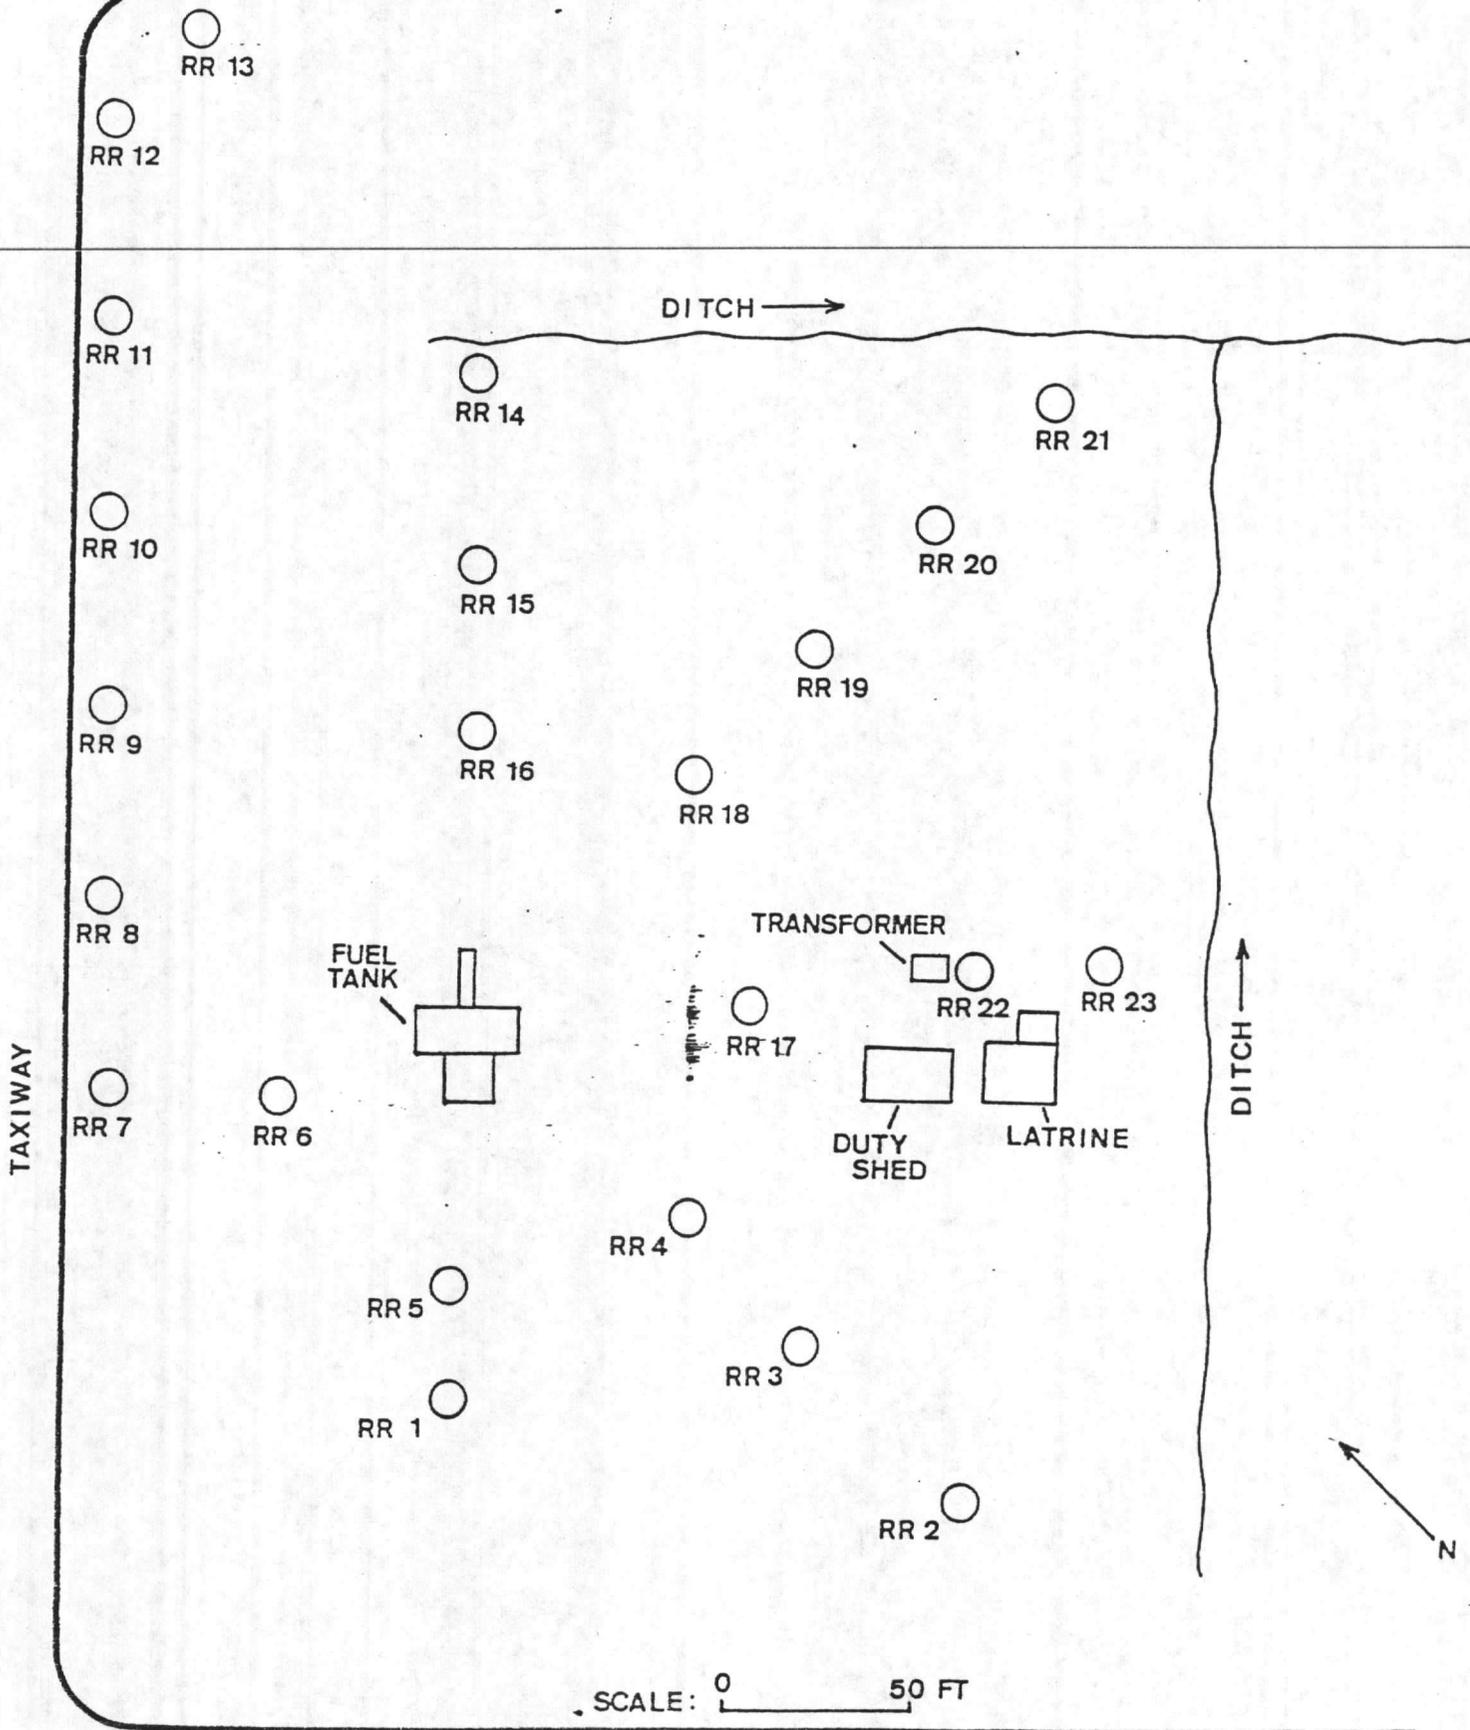
Figure 2-1. Locations of Soil Borings at Rapid Refueling Area, MCAS New River

Twenty-three soil borings were distributed in the area suspected of contamination by fuel (Fig. 2-1). Each boring was completed using 6-inch outside diameter (OD) hollow stem augers. Continuous soil samples, obtained by standard penetration tests (SPT) with a split-barrel sampler, were collected from each boring. These samples were visually described according to the Unified Soil Classification System (USCS). Boring logs for these borings are presented in Appendix A of this report.

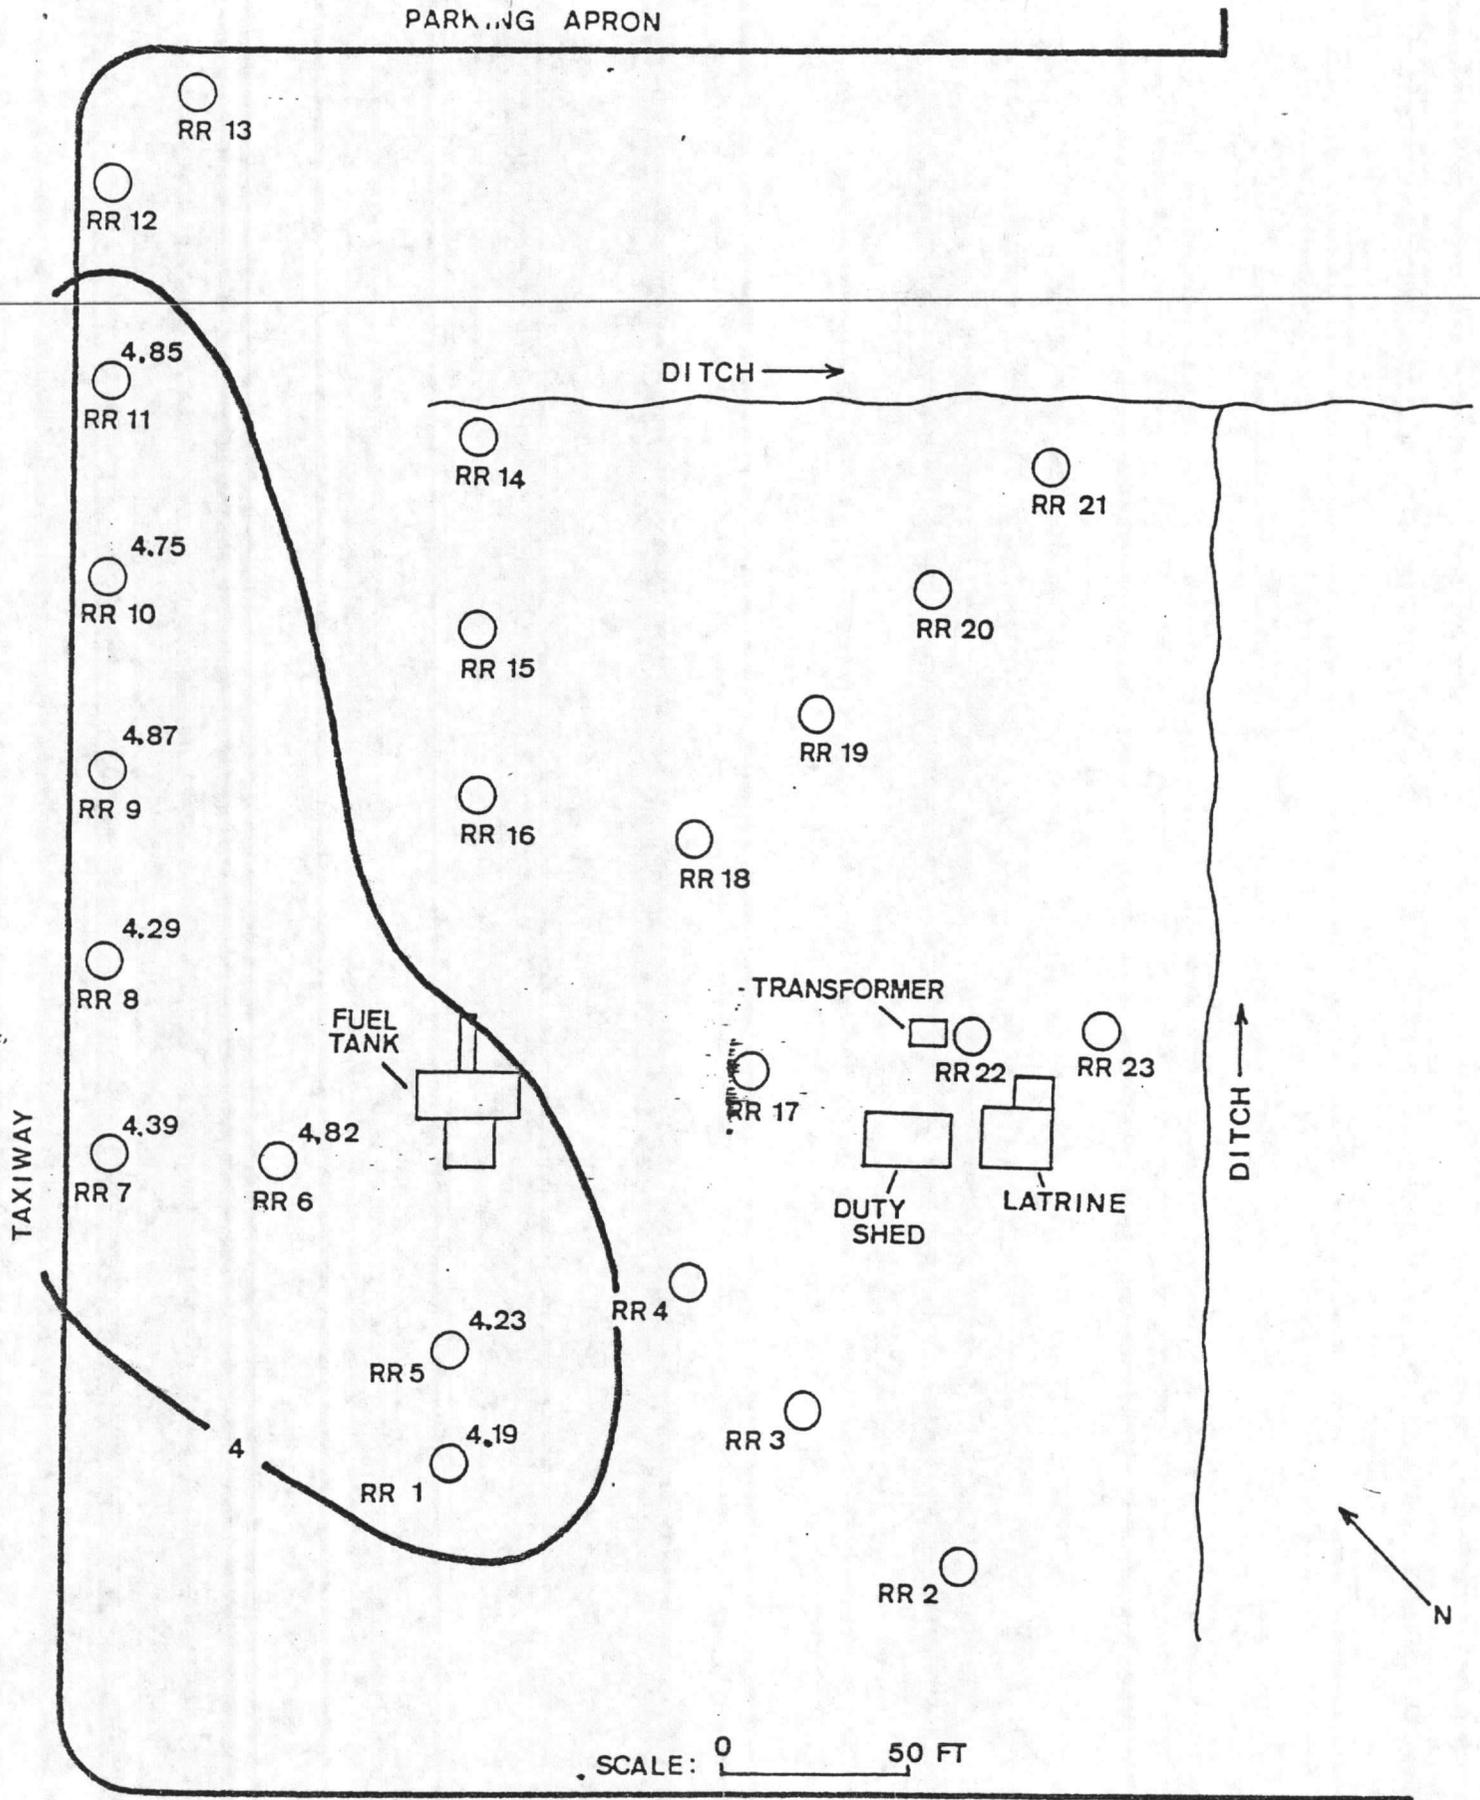
Figure 2-2. Measured Fuel Thickness (ft) at Rapid Refueling Area, MCAS New River

The distribution of measurable fuel thickness is shown in Fig. 2-2. A lens of fuel, approximately 4-5 ft thick, appears to be located to the north of the fuel tank, and may extend under the taxiway which forms the northern limit of the grassed tank area.

Fuel has been observed in both of the drainage ditches shown in Fig. 2-2. The lens of fuel floating on the shallow ground water detected in the current study may discharge into the northern ditch under the action of percolating rainfall. The presence of fuel in the eastern ditch does not appear to be supported by the relative location of the fuel lens. However, fuel was detected along a fuel line to the southwest of the current study area by a similar soils investigation conducted by Soil & Material Engineers, Inc. in 1983. A separate fuel lens or lenses in this area may discharge into the upstream end of the eastern ditch.

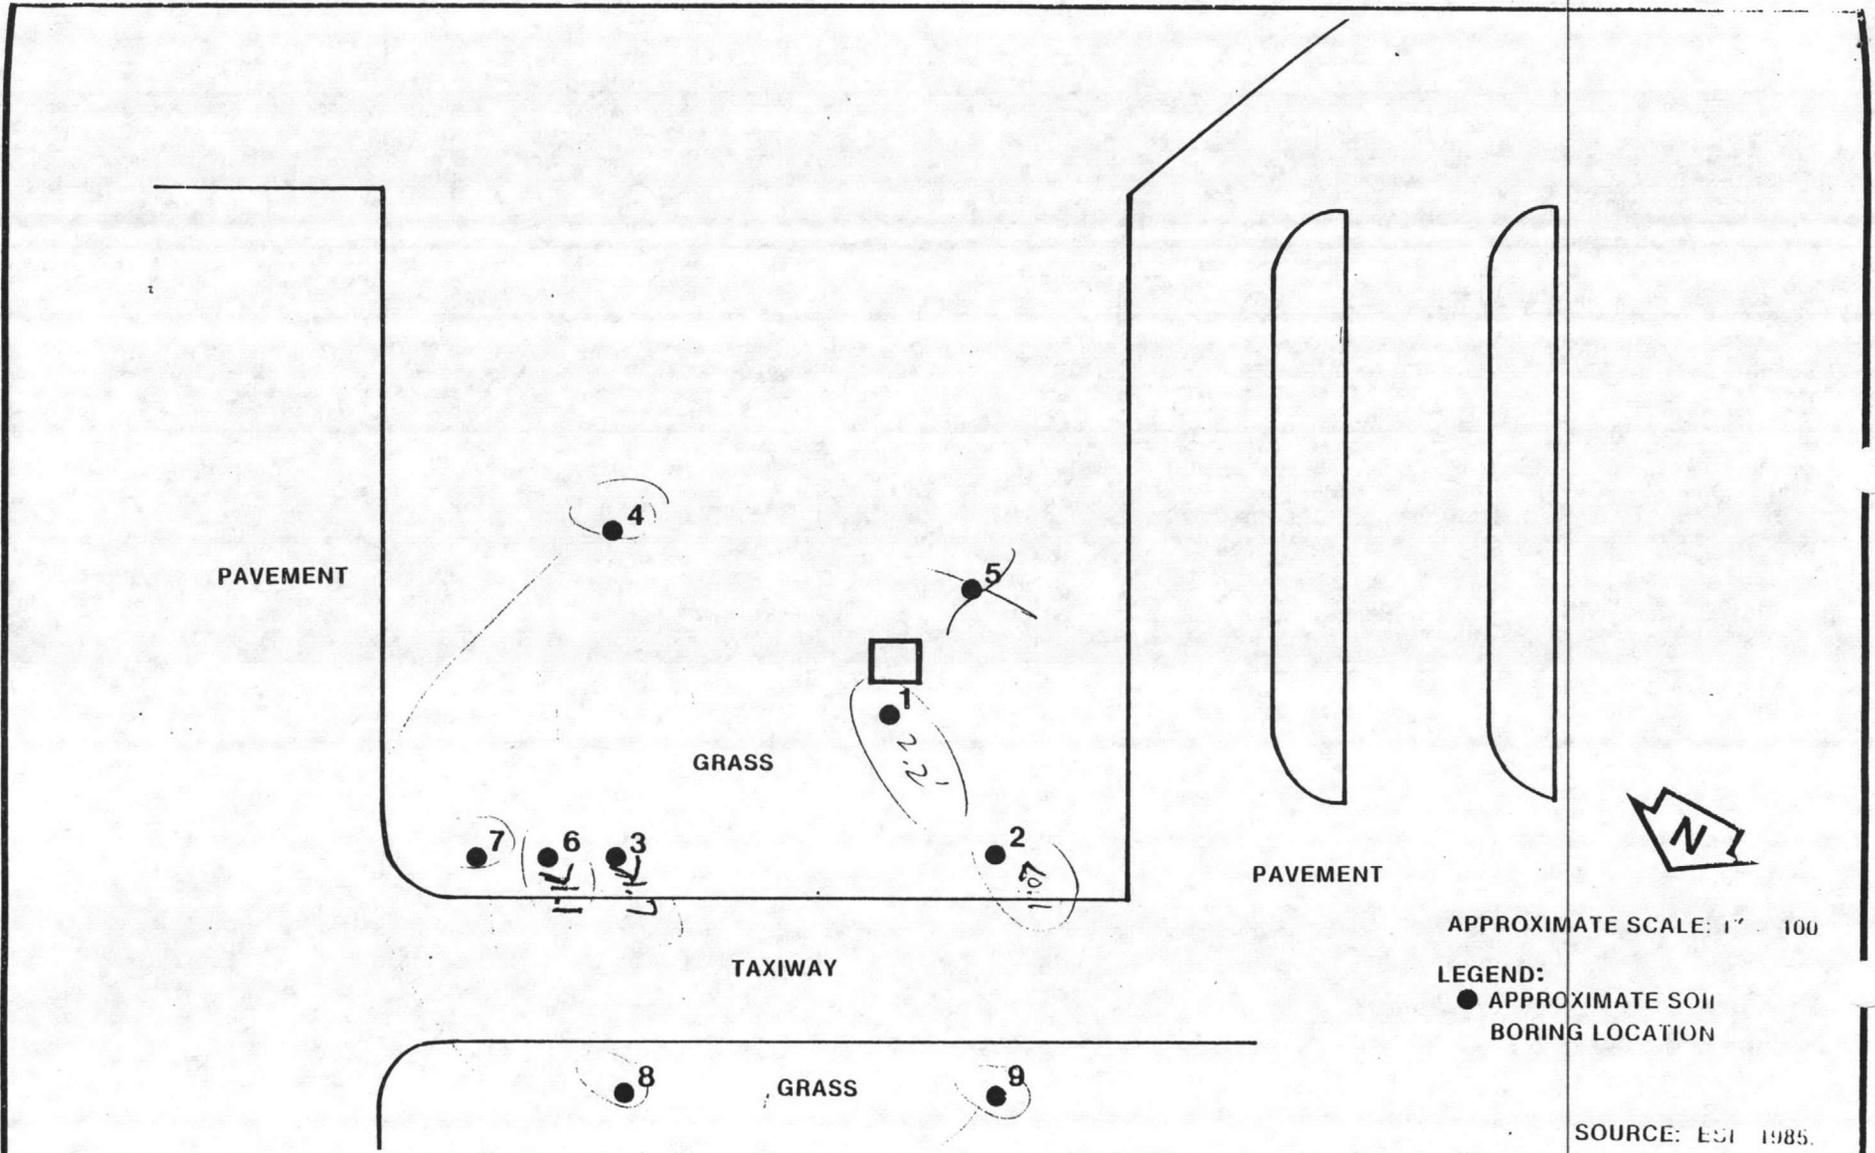
Figure 2-2
 MCAS AIR FIELD RAPID REFUELING
 AREA SOIL BORING LOCATIONS

The purpose of the soil boring investigation at the MCAS Air Field Rapid Refueling Area was to determine if the extent of underground fuel contamination had increased. The extent of fuel contamination is documented in the report "Leaked Fuel Inventory Direct Fueling Pipeline Marine Corps Naval Air Station Camp Lejeune, North Carolina," Soil & Material Engineers, Inc., December 1983. The approximate locations of the nine soil borings performed in this investigation are shown in Figure 2-2, and the results of the investigation are presented in Table 2-25. The data presented in Table 2-25 indicate that the underground fuel contamination has not spread and remains in the area identified in the previous investigation conducted by Soil & Material Engineers, Inc.

Due to the lack of significant topographic relief in the Rapid Refueling Area, ground water gradients under normal conditions are extremely low, and rapid horizontal migration of the fuel floating above the shallow ground water is not expected. This is corroborated by the relative immobility of the existing underground contamination indicated by the soil boring investigation.

No further verification monitoring is recommended. Serious consideration should be given to installing a recovery well(s) in this area to recover the large volume of fuel currently floating above the shallow ground water.
