GROUNDWATER INFILTRATION STUDY  
FOR  
AS 4000 AREA

PREPARED BY  
HOBBS, UPCHURCH & ASSOCIATES, P. A.  
CONSULTING ENGINEERS  
290 S. W. BROAD STREET  
POST OFFICE BOX 1735  
SOUTHERN PINES, NORTH CAROLINA

AUGUST 1, 1986

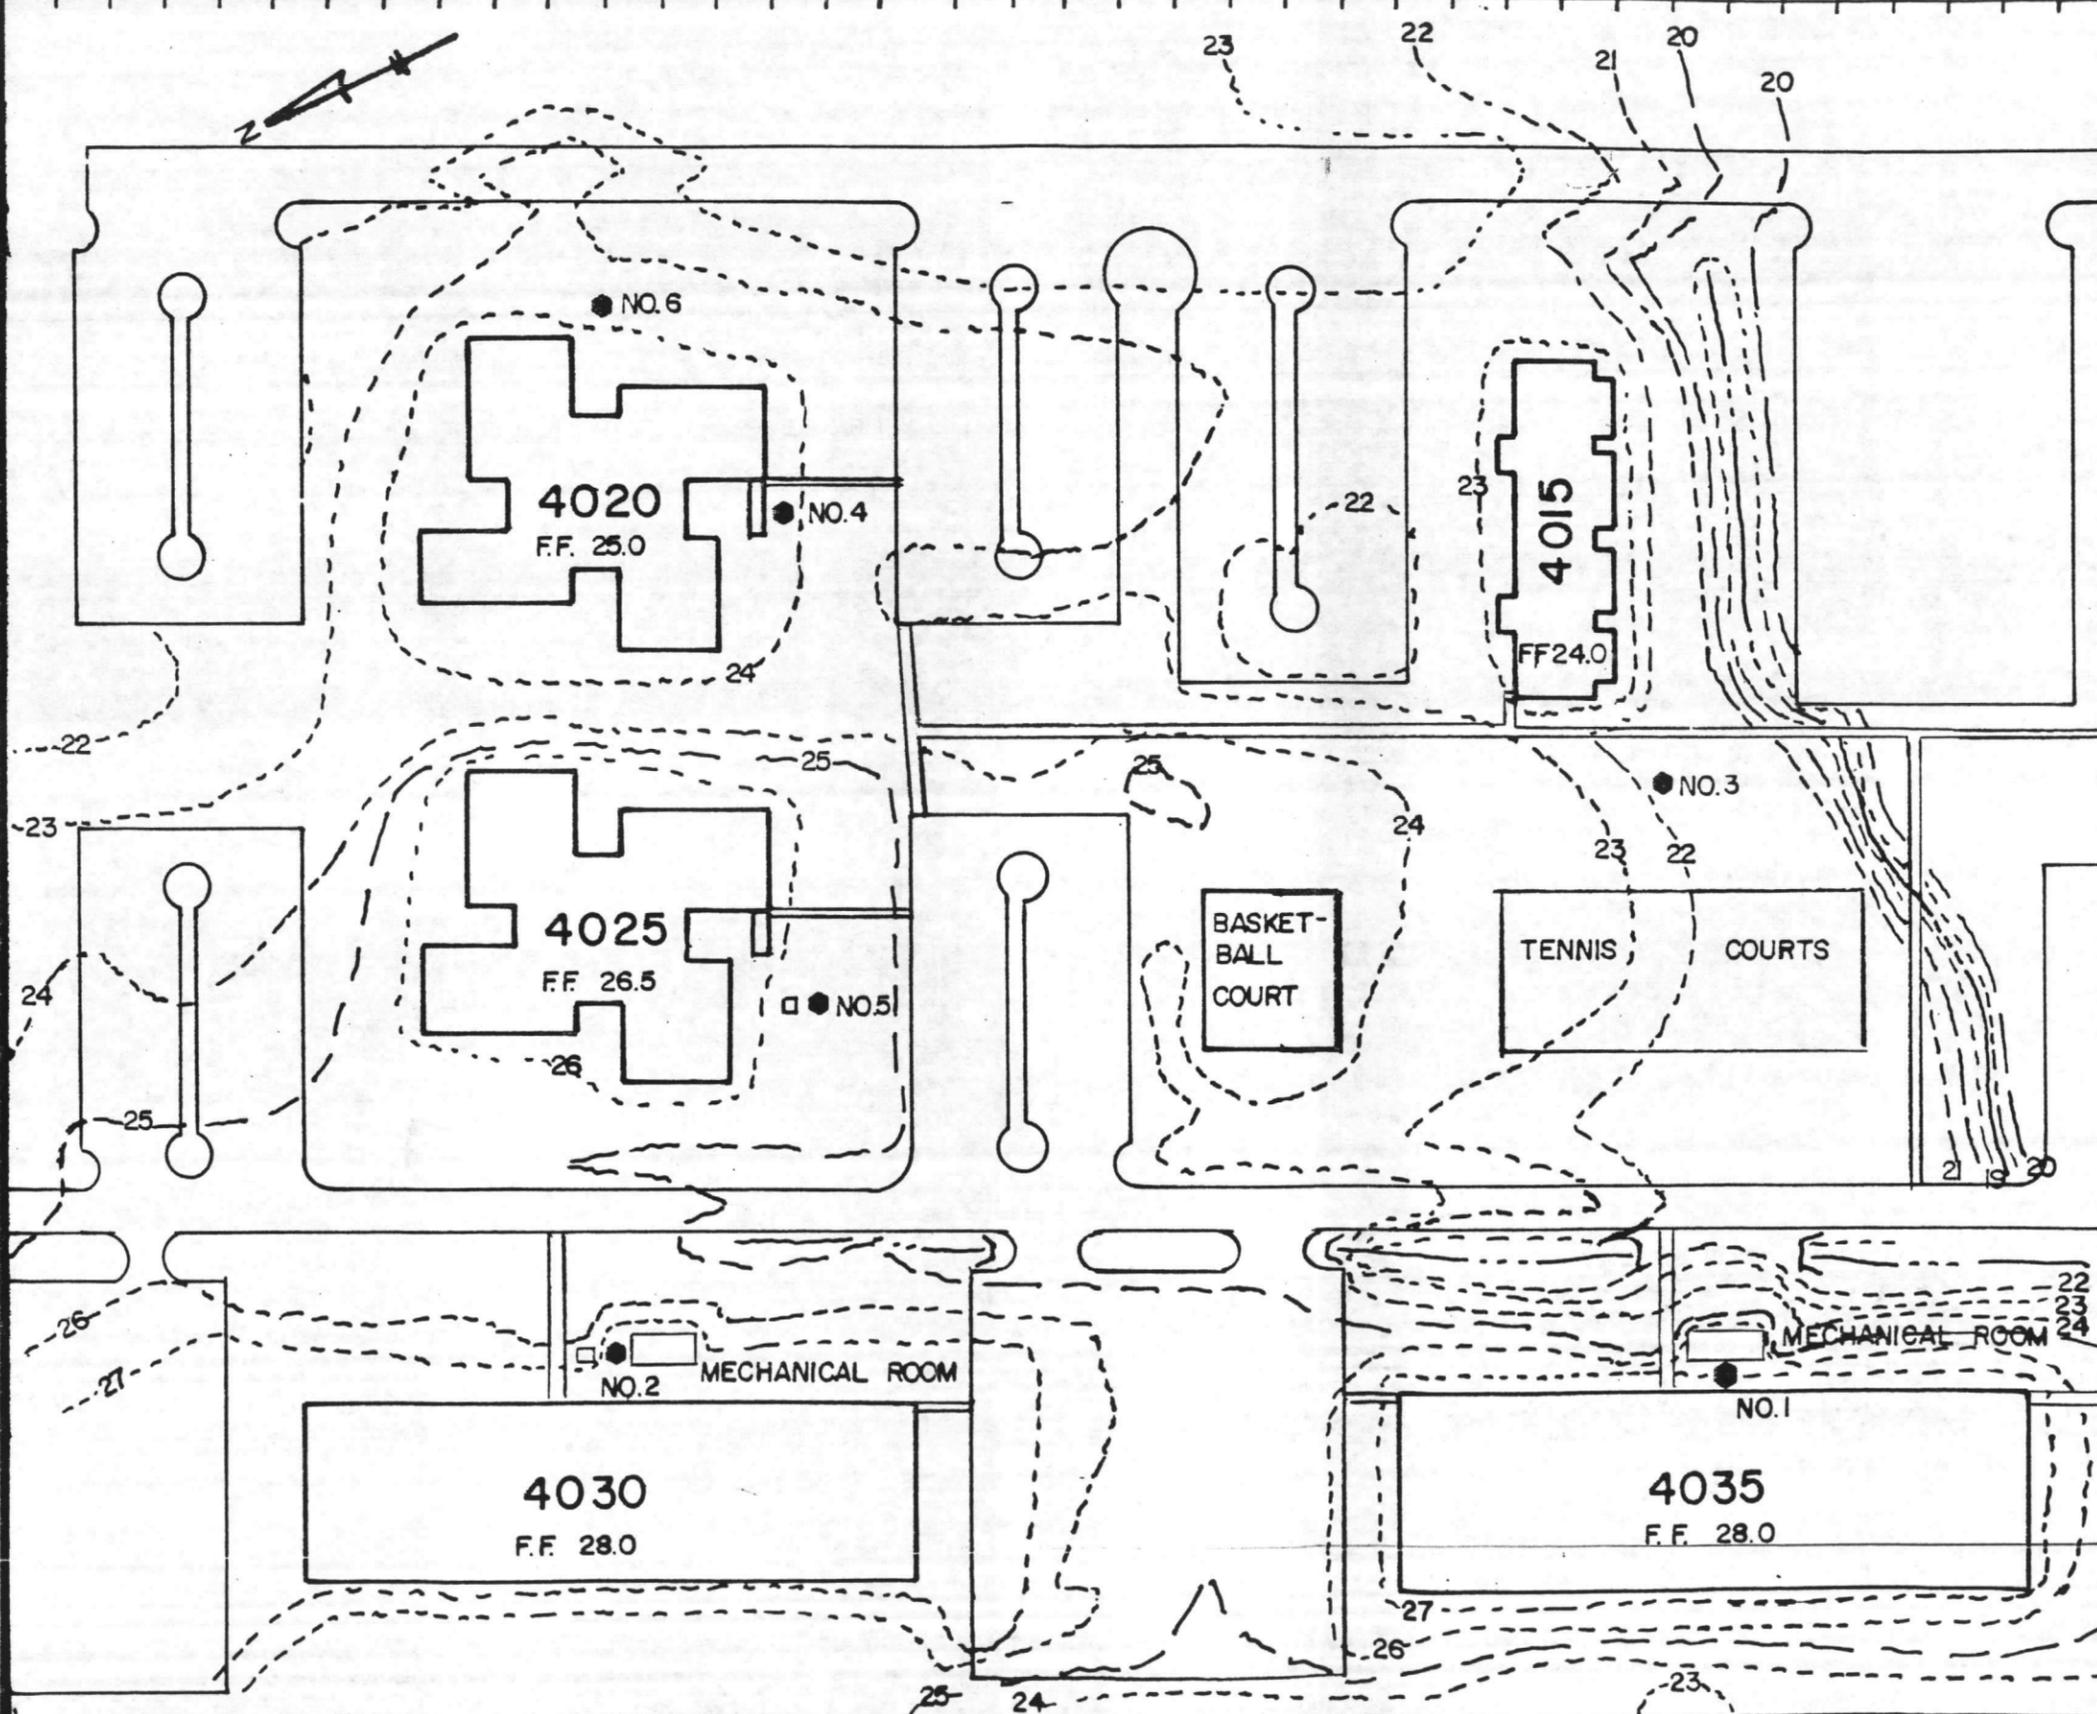
MONITORING WELL LOCATIONS

To determine the extent that ground water was contributing to this problem, six monitoring wells were installed at various locations around the site. These are shown on Drawing No. 1 which also indicates the general topography of the site and location of the structures, parking areas and roads. The data from the groundwater level monitoring wells is probably not indicative of average conditions because of the sustained drought occurring at this time. There has been only 8.5 inches of recorded rainfall for the entire year at this date. The normal rainfall for this time of year is 28 inches. The elevations for the ground water and wells is presented in Table 1.

Elevations are approximations from topographic maps developed during the design of the buildings. With the exception of Well No. 2, the water levels are approximately the same. Well No. 2 is notably different, with the water level only two feet below grade. The water line was checked and no leak was found. Steam lines are constantly monitored for pressure and no leak has been detected in the line running next to the site. The condensate drip leg from the steam pit discharges into a dry well located 10 feet from the monitoring well. The water elevation in the dry well is the same as the monitoring well. Because of the soil structure, the water cannot flow away as fast as it is being supplied, causing the high ground water level.
