11. REQUIREMENTS:

INVESTIGATION OF
ASH COLLECTION AND DISPOSAL SYSTEM,
HIGH DUST LOADING IN BREECHING,
AND BYPASS STACK CAPS
AT THE
CENTRAL HEATING PLANT, BUILDING 1700
MARINE CORPS BASE, CAMP LEJEUNE, NORTH CAROLINA

DECEMBER 1982

DESIGN DIVISION
ATLANTIC DIVISION
NAVAL FACILITIES ENGINEERING COMMAND
NORFOLK, VIRGINIA 23511

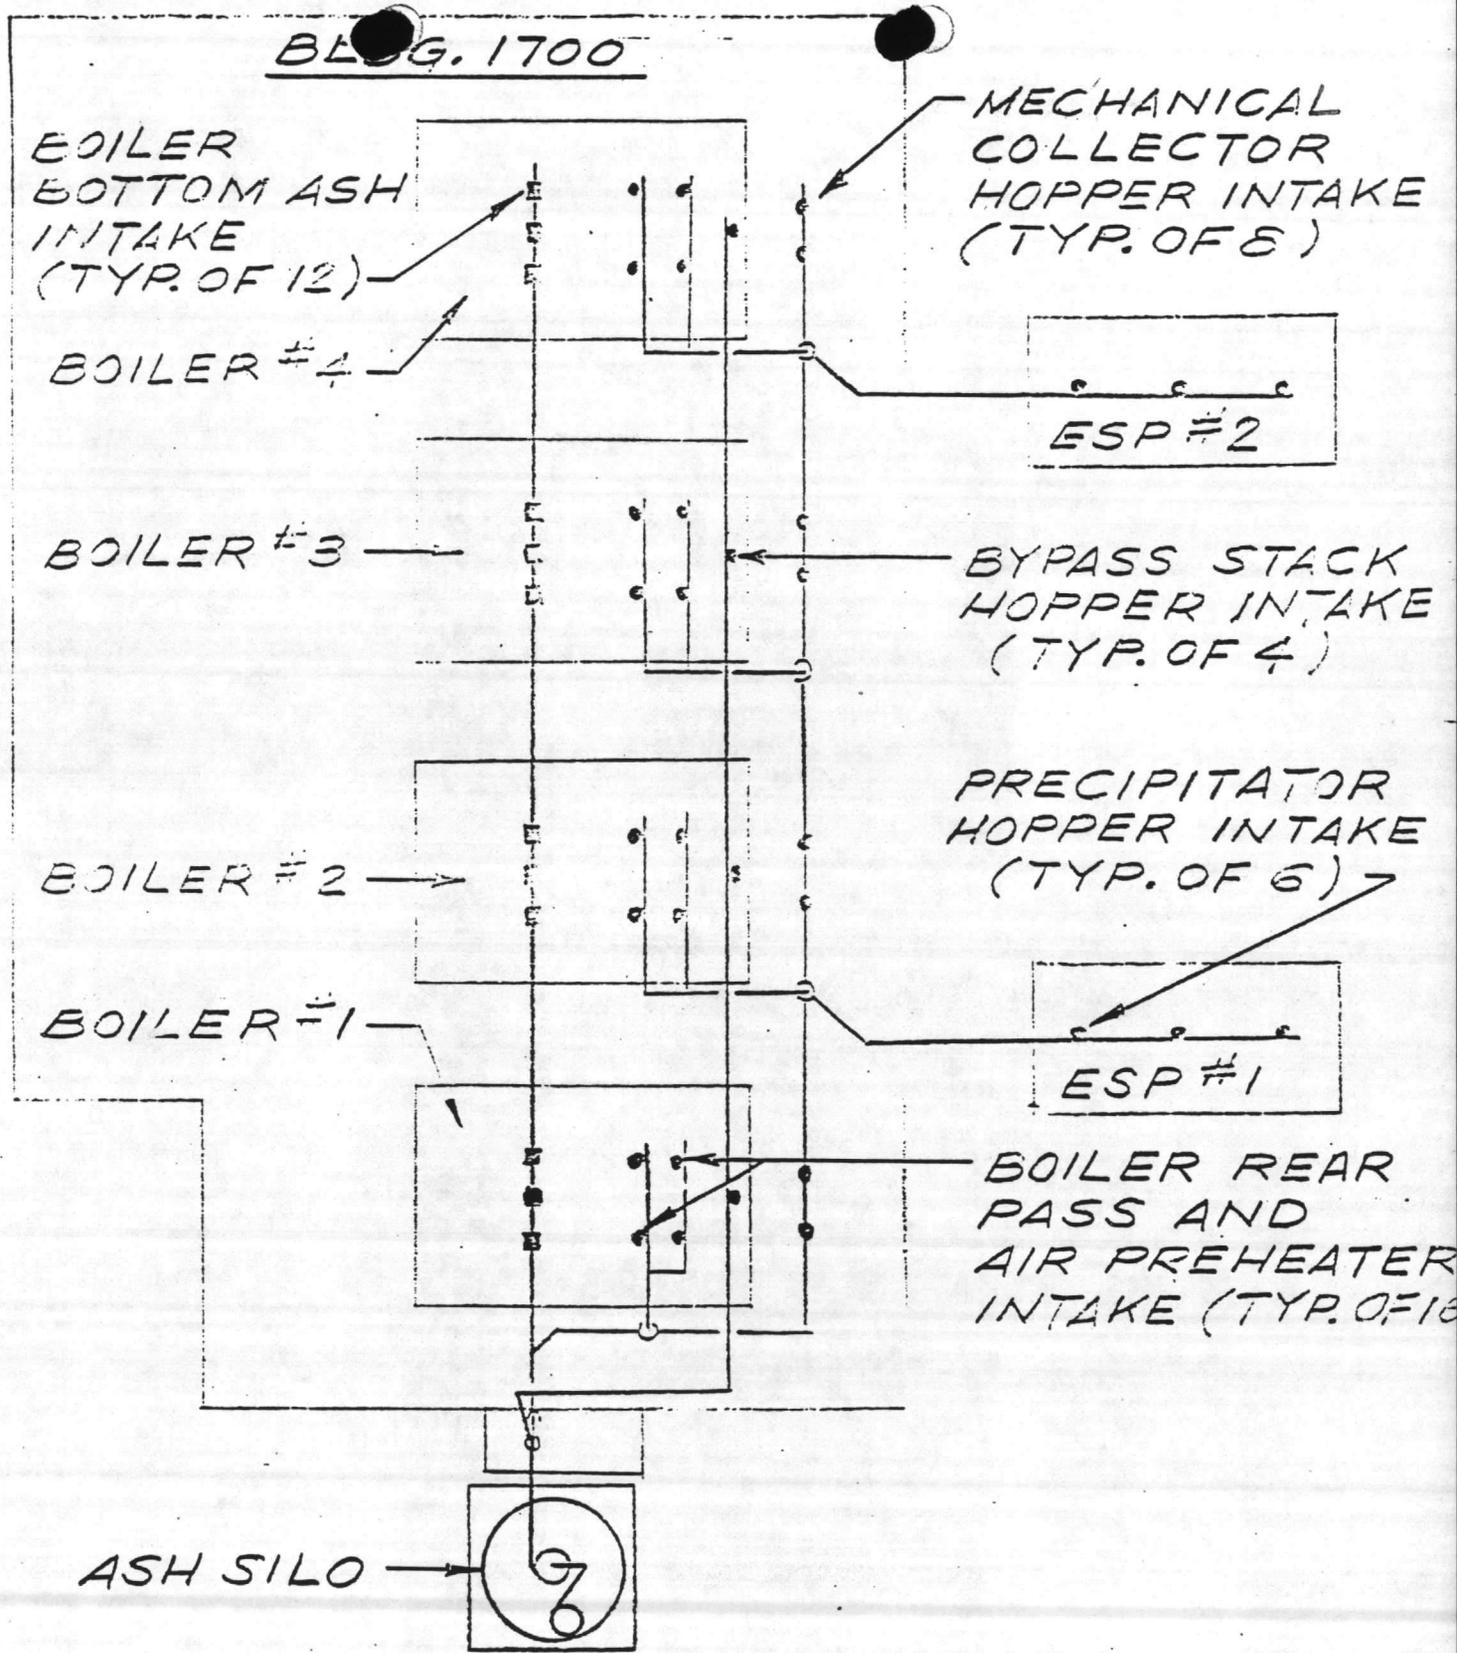
FIGURE 1

The ash collection and disposal system at the central heating plant was installed as a part of the original plant construction in the early 1940's. The system is of the dry pneumatic vacuum conveying type with a vertical storage silo and was manufactured by United Conveyor Corporation. A two stage steam ejector produces vacuum on the conveying system. Ash from the silo is loaded into open bed dump trucks by means of a rotary feeder and horizontal screw conveyor with water conditioning.

ASH COLLECTION SYSTEM

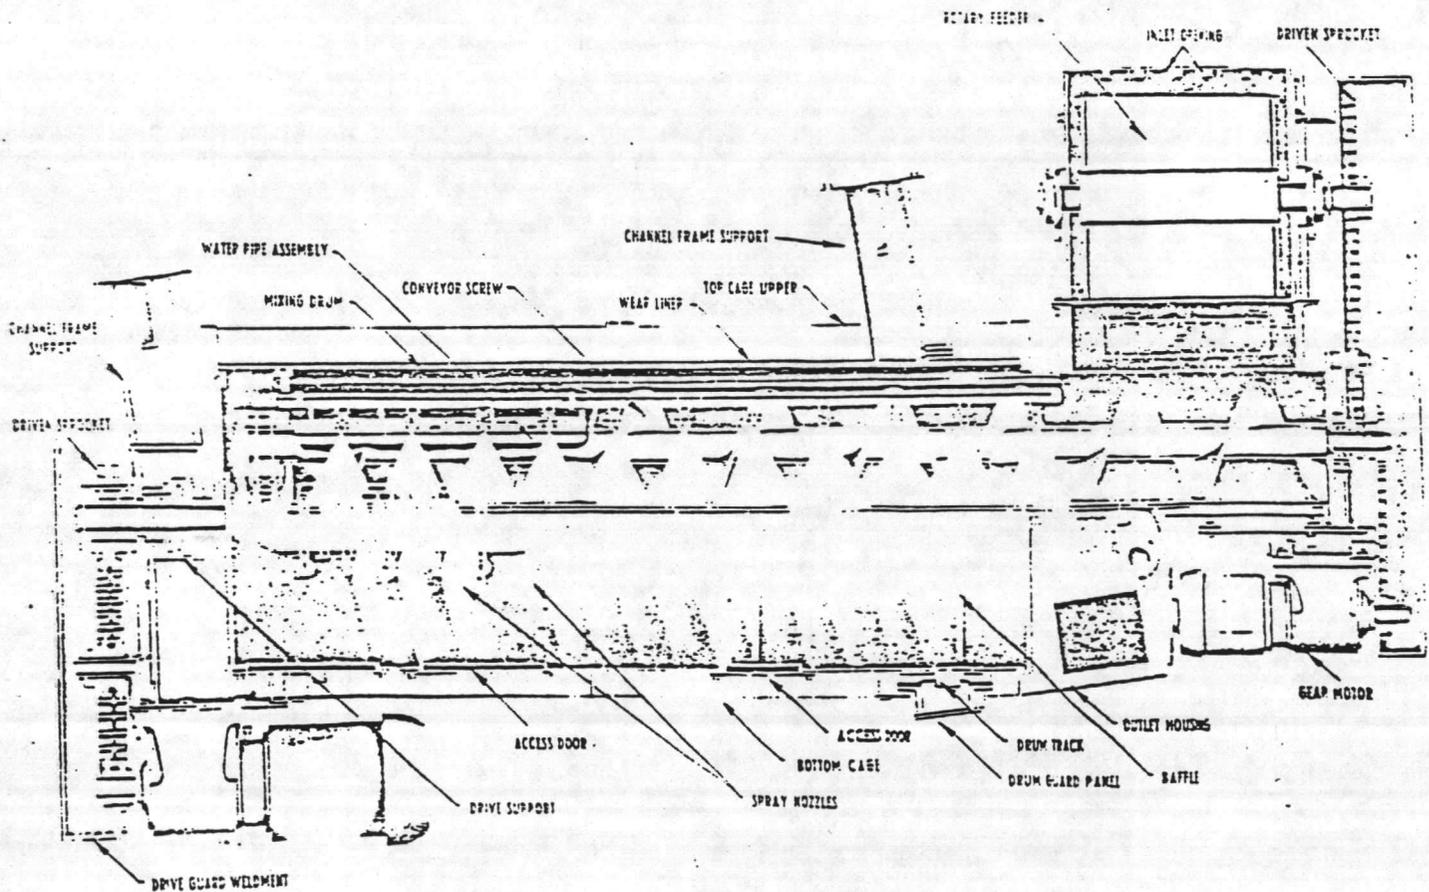
FIGURE 2

A rotary unloader such as the Model D-40 manufactured by Allen, Sherman, Hoff (see figure 2) would probably provide better mixing and wetting of fine particles but the variations in flow may continue to cause some minor problems. Initial cost of the unloader would be approximately \$40,000.00.

ASH ROTARY UNLOADER

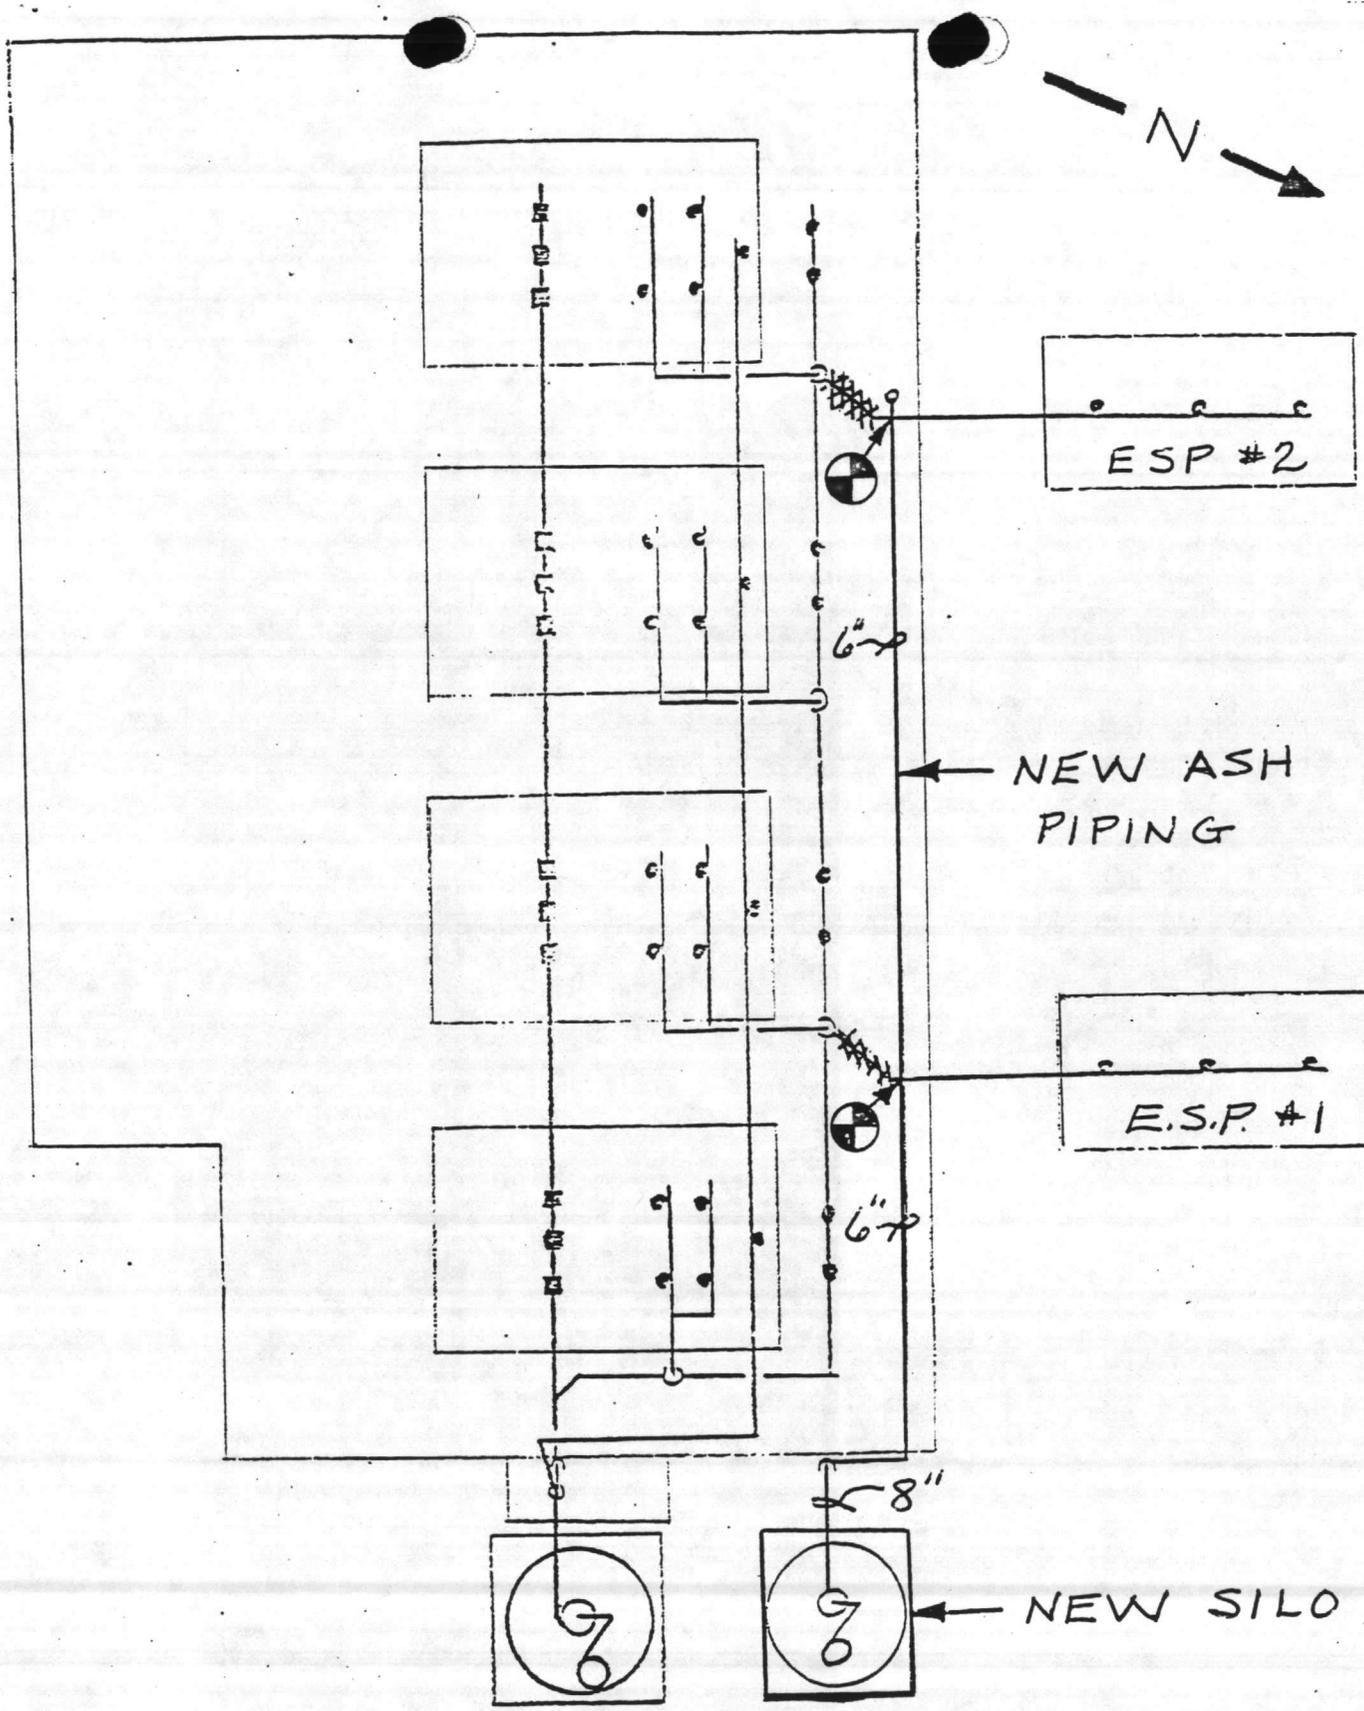
FIGURE 3

A separate silo and unloader to handle fine ash from the precipitators separately should resolve the major problems currently being experienced. (See figures 3 and 4) By separating the fine ash from the larger particles, each system would be handling ash of similar size and consistency. Variations in flow due to particle size should be minimized. The rotary feeder and unloader could be selected to handle fine material and could be set up to properly condition fine material only. The major drawback to this solution is initial cost. A separate system would cost approximately \$350,000.00.

NEW ASH SILO

The only solution investigated that will probably solve all of the current problems would be to install a separate ash system, silo and unloader for the precipitators. The separate system would also allow sale of the flyash if desired. The major drawback to this solution is the initial cost of \$350,000.00.

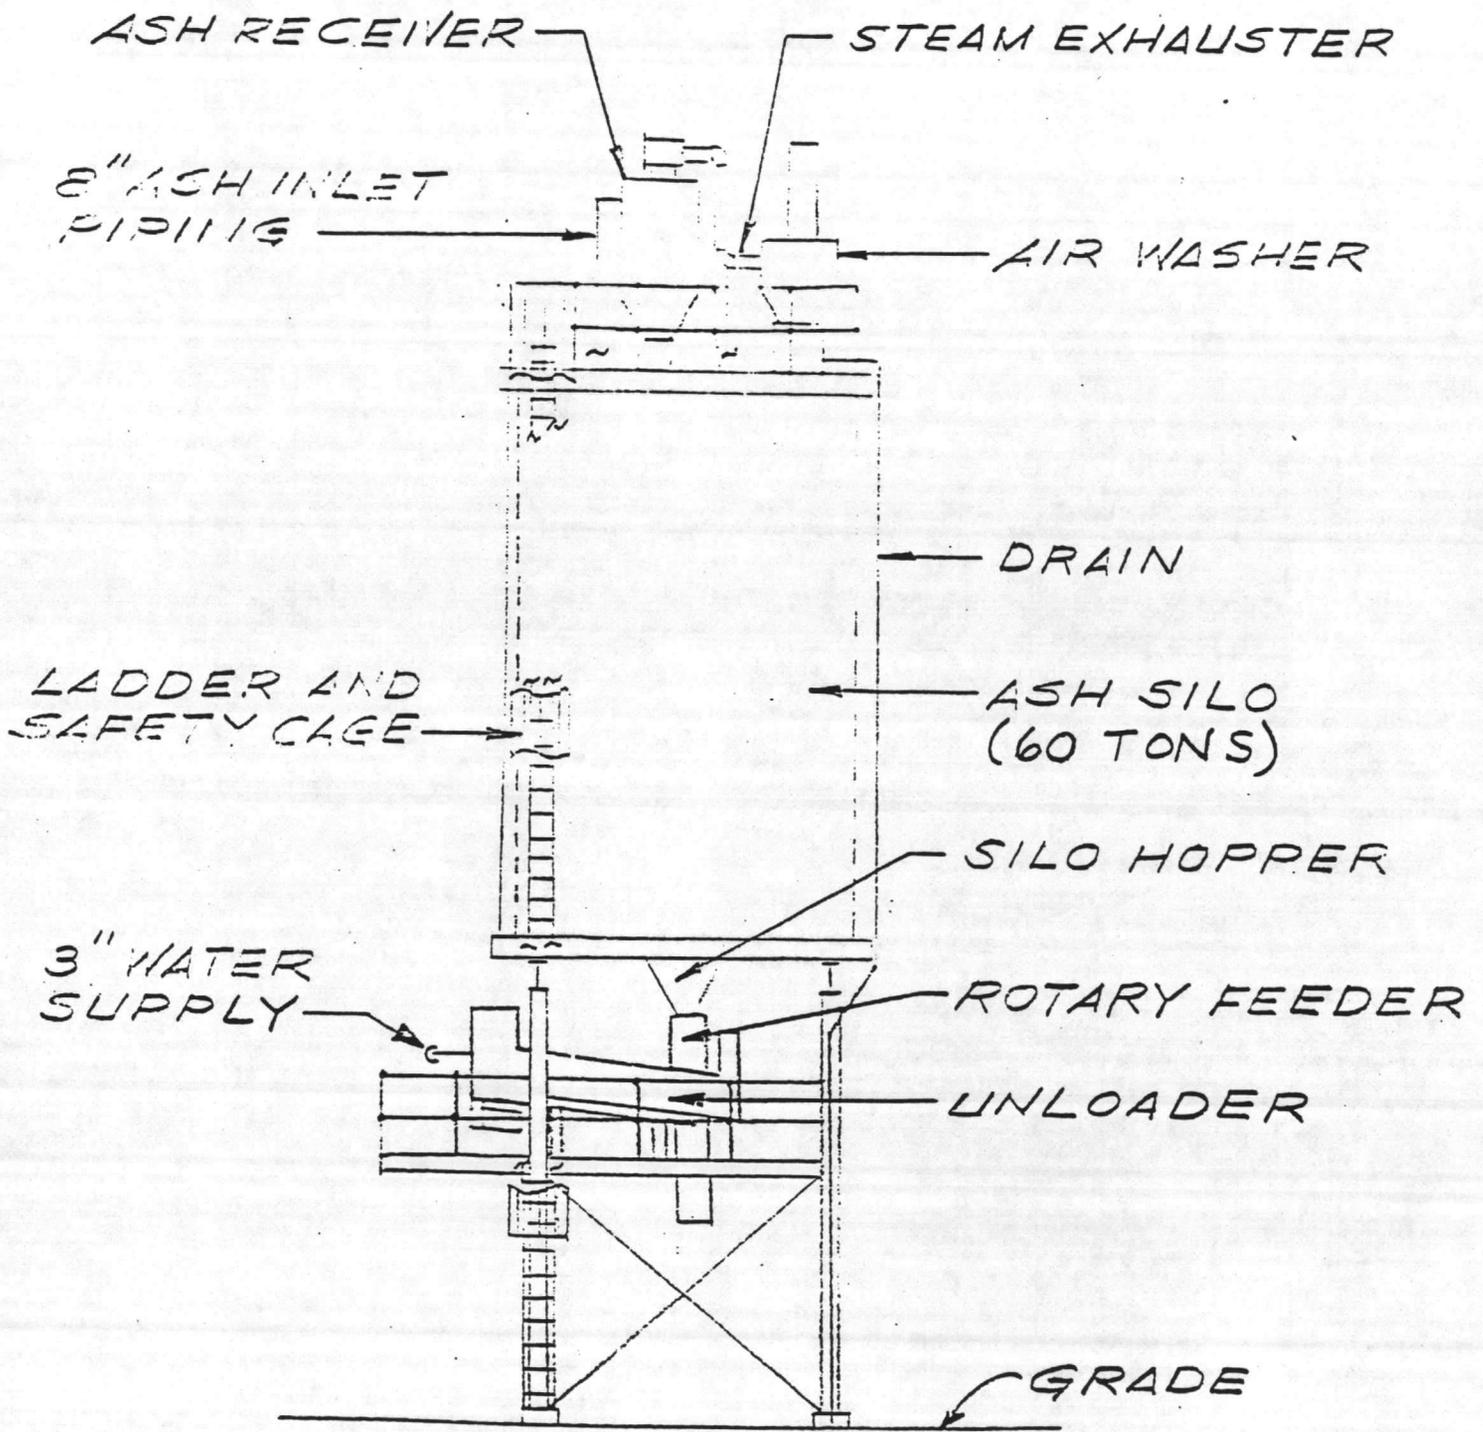
FIGURE 4

NEW ASH SILO

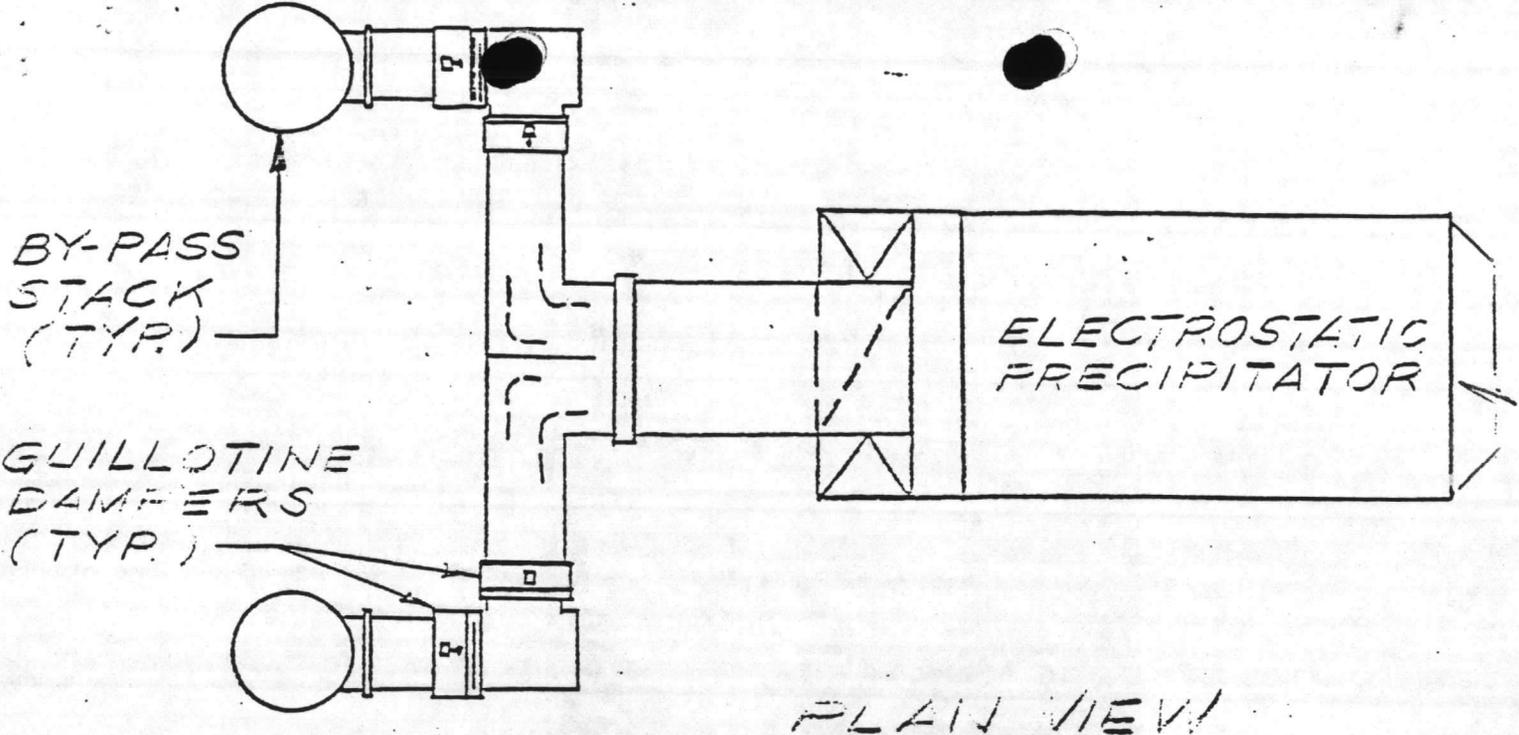
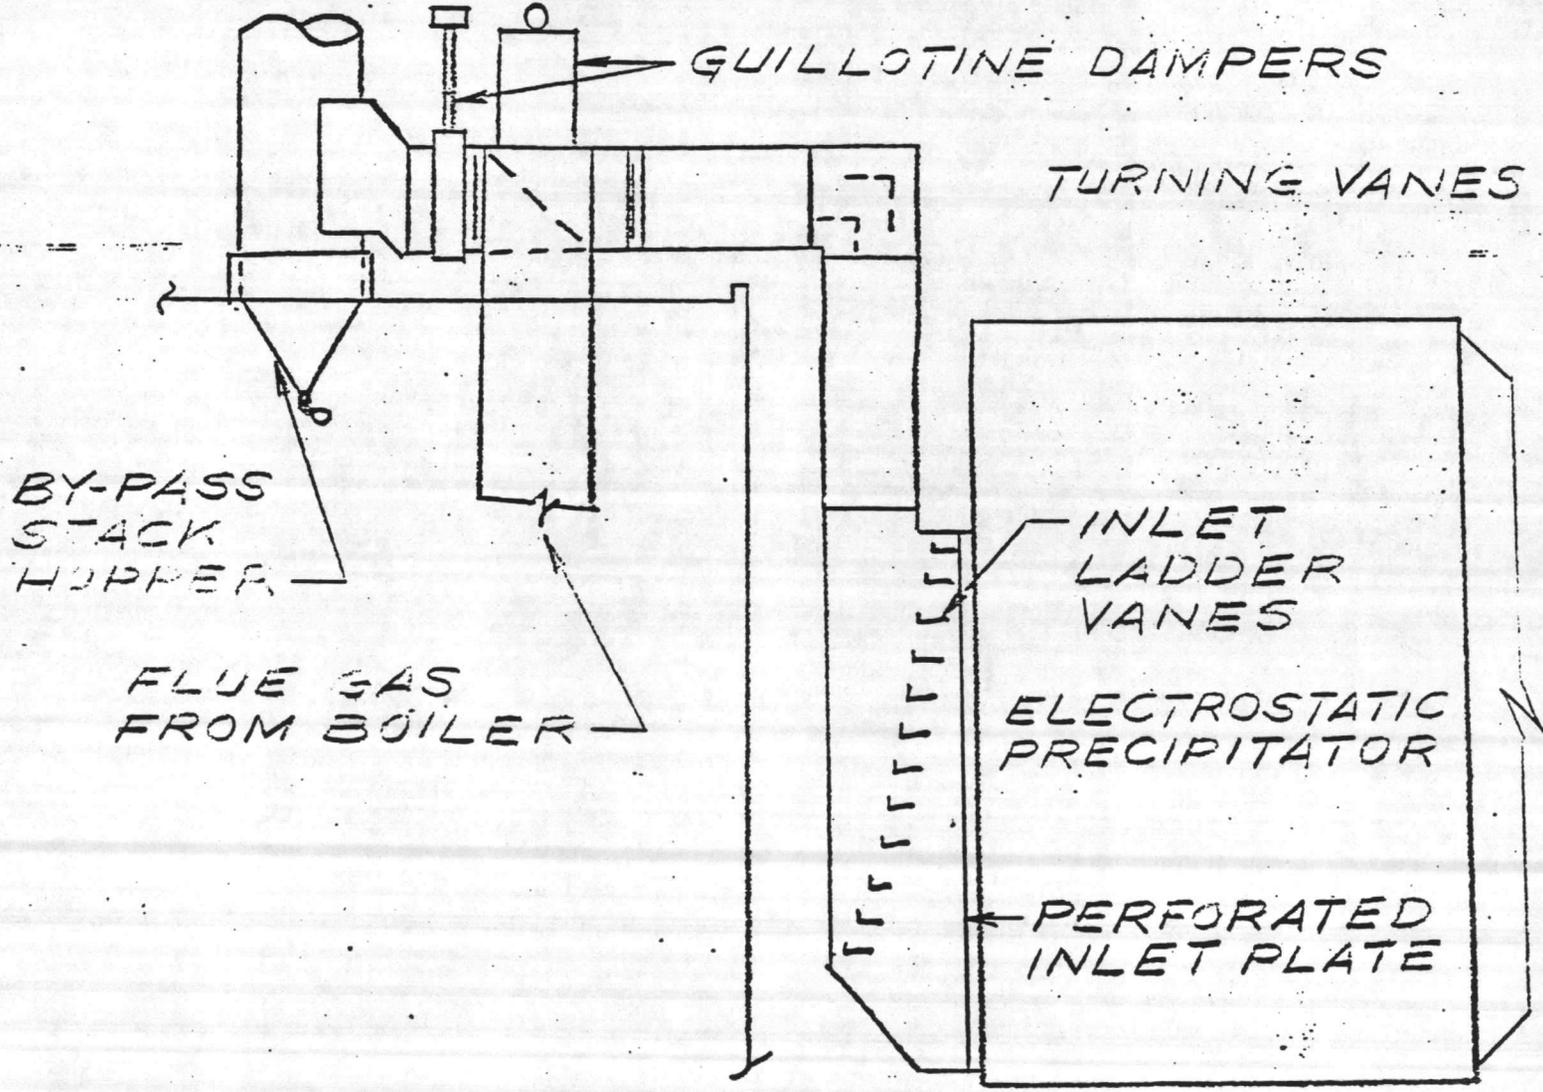
FIGURE 5

Each of the two new precipitators is connected to two existing coal fired boilers. The arrangement of the new breeching is shown in figure 5. The common breeching was designed for a velocity of 30 feet per second assuming two boilers operating at full load. The transition into the precipitator was designed to provide a maximum velocity of 5 feet per second assuming two boilers at full load. Turning vanes and ladder vanes in the transitions and a perforated plate at the precipitator inlet were installed to provide equal air distribution into the precipitator.

During normal operation, flue gas to the precipitator varies from one fourth to maximum design velocity. When the velocity reduces, ash falls out in the duct and on the ladder vanes. Some vanes near the top and bottom fill to where the opening becomes almost totally blocked. In addition, ash falls out and accumulates at the base of the inlet transition to the precipitator along the walkways. These ash buildups cause unequal velocity distribution through the precipitator as well as emissions when the velocity suddenly increases. The accumulated ash on the walkway also causes problems when entry into the precipitator is required for maintenance.

A team from the Navy Energy and Environmental Support Activity was requested to investigate the ash build up problems and to determine the velocity distribution through the precipitator. Site investigations were made in August 1980 and September 1981. Recommendations contained in the final report of February 1982 include removal of an 8 inch section at the bottom of the inlet perforated plate and the addition of a sonic sootblower to keep the inlet vanes free. Removal of the 8 inch section of the plate and installation of the sonic sootblowers are recommended and should alleviate the ash buildup problems at the precipitator inlet. Ash buildup in the inlet duct is not considered a major problem and should have no serious adverse effects on the system operation.

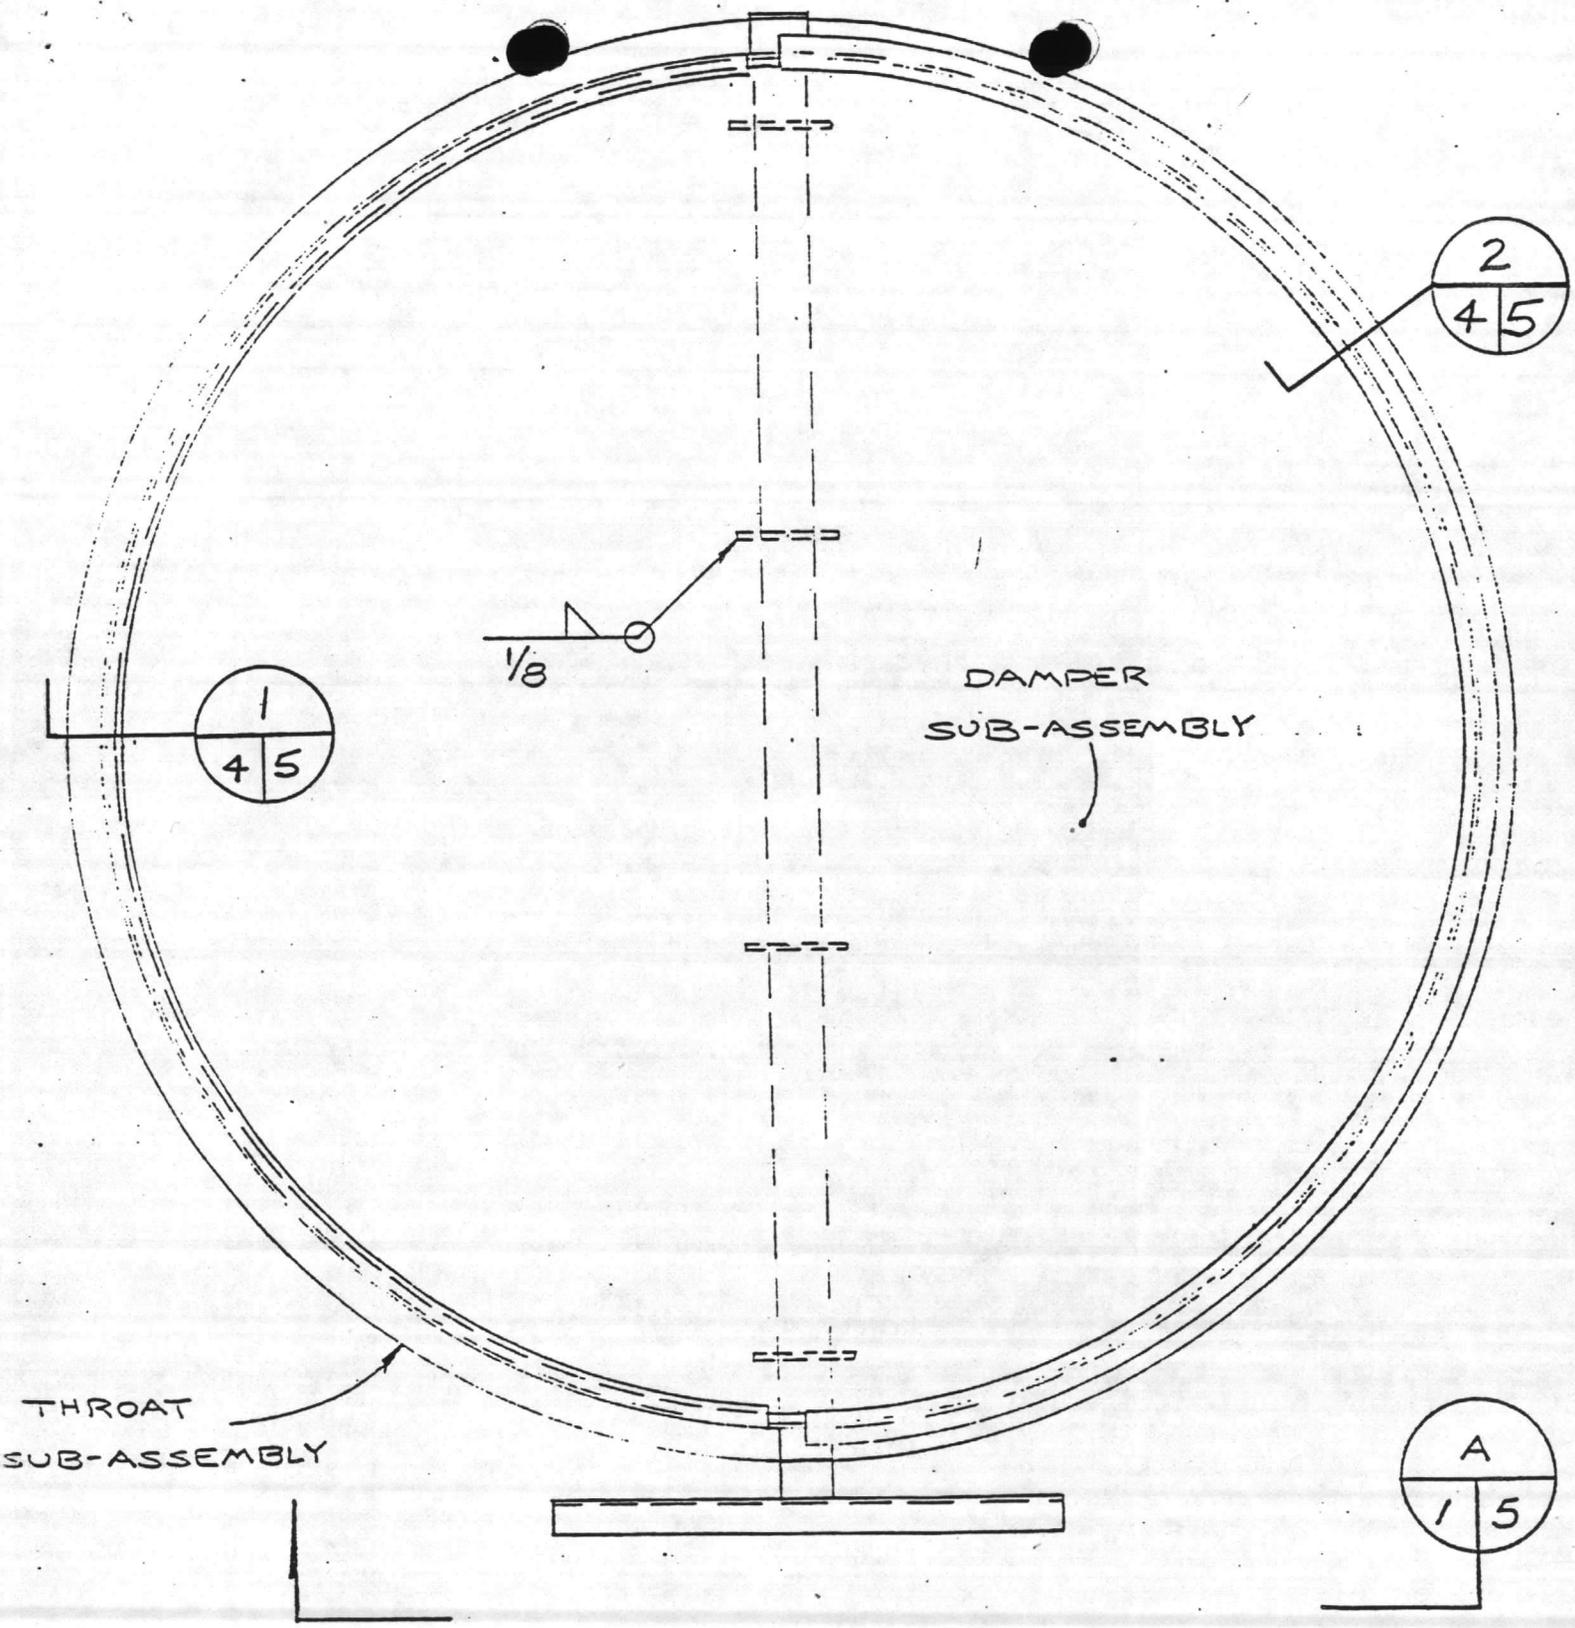
FIGURE 6

Use of a damper similar to a butterfly damper (see figures 6 & 7) investigated. Due to wind loading, the damper must be located inside the existing stack or within an extension to the stack. This arrangement would require a platform mounted on the existing stack or an extended operator drive from the base of the stack. The addition of a platform to the existing stack was not recommended structurally and extended drive mechanisms would probably not be reliable. From a maintenance standpoint, this solution would be no better than the current situation.

PLAN - STACK CAP ASSEMBLY
 SCALE: 1"=1'-0"

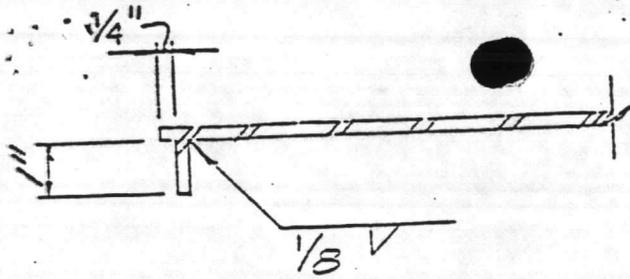
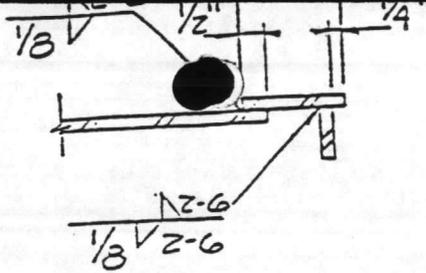
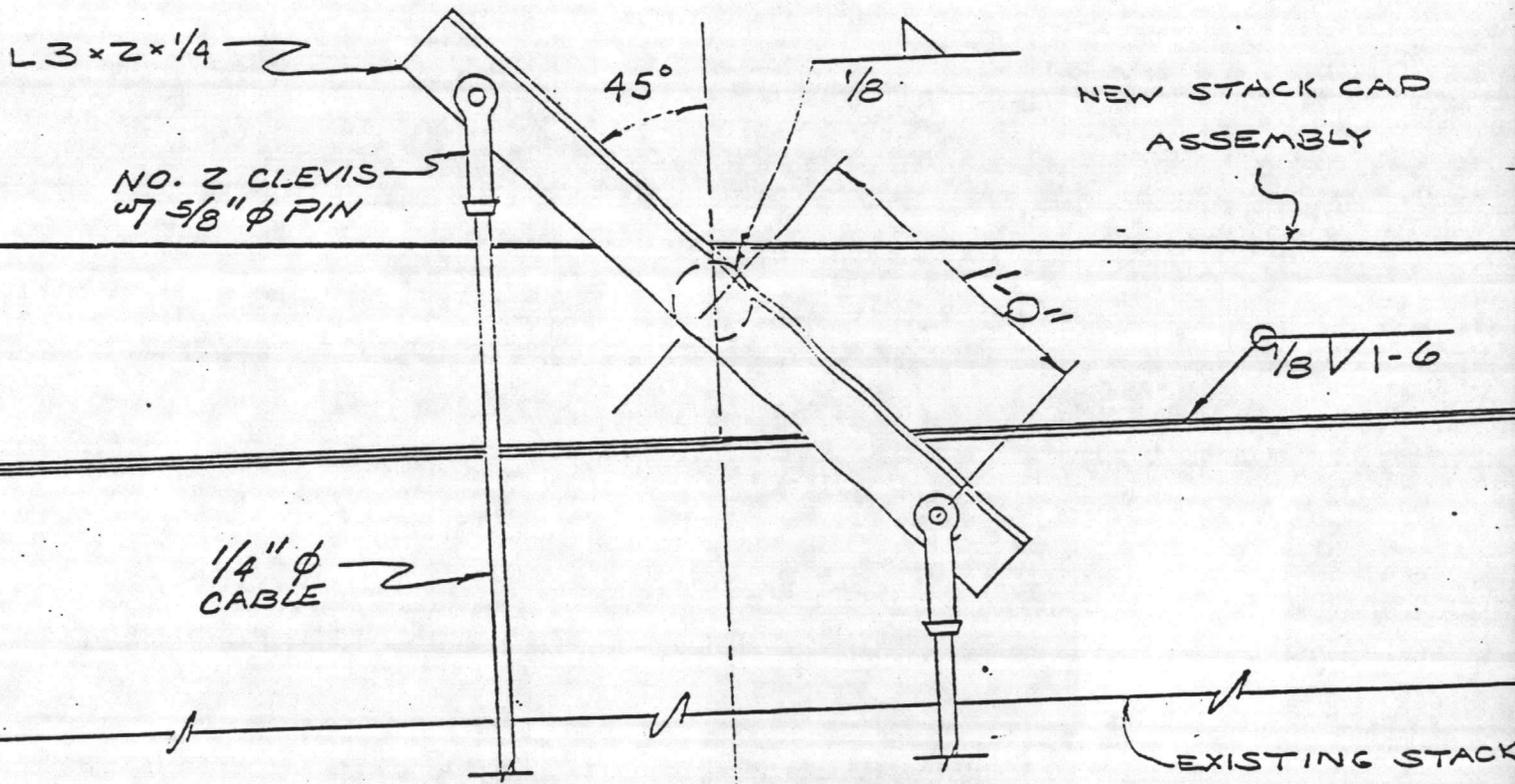
FIGURE 7

STACK CAP DETAILS
