PROVIDE AND INSTALL CONDENSATE POLISHERS FOR

BLDG G650 CAMP GEIGER HEATING PLANT

Project is located at bldg G650 Heating Plant. Project is to provide and install two condensate polishers.

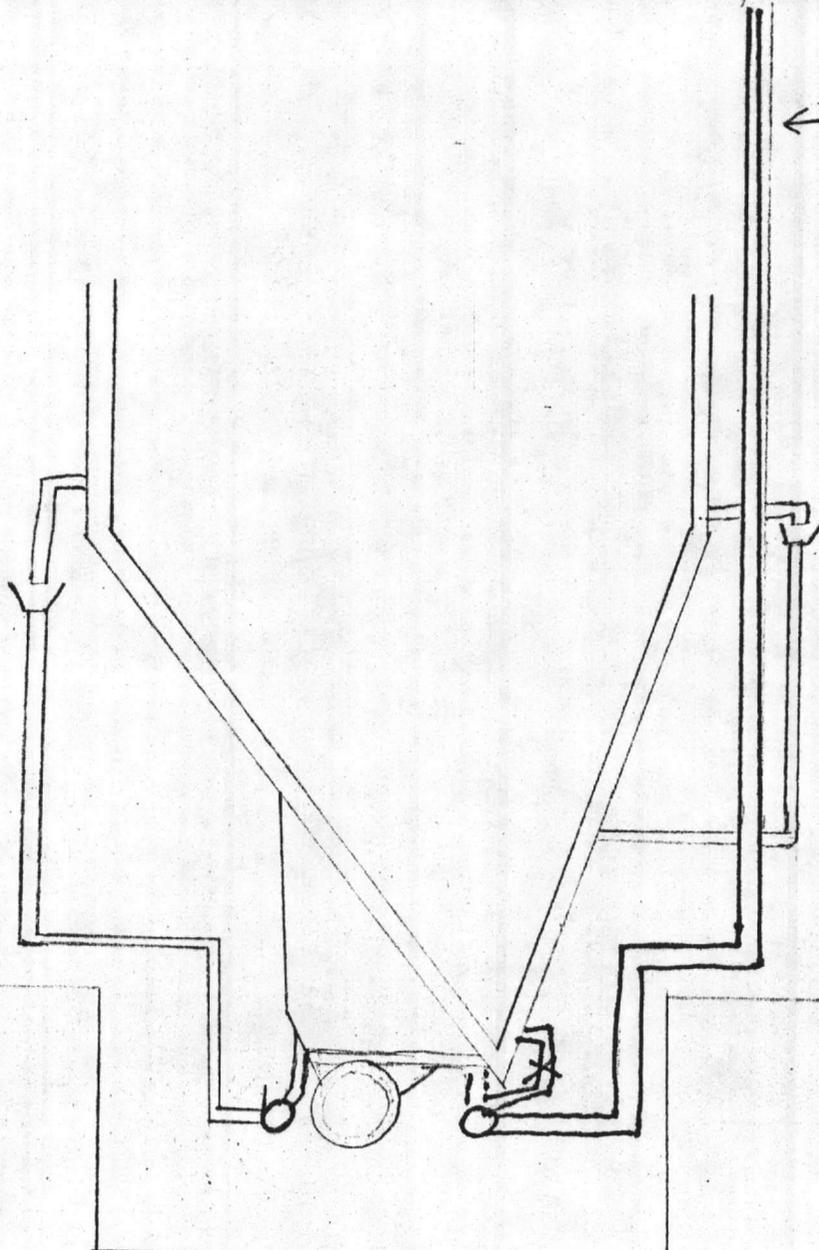
Justification: Open type drains are used for cooling water from oil coolers to gravity feed to water cooled ash hoppers. These drains are partially stopped up with scale and rust and water backup on operating floor when enough water is put in to cool hoppers. This piping should be replaced with a pressurized system to ensure a sufficient flow of water to cool hoppers.

← Drain + Cooling Water from
Borse Warner drive to Ash Hoppers

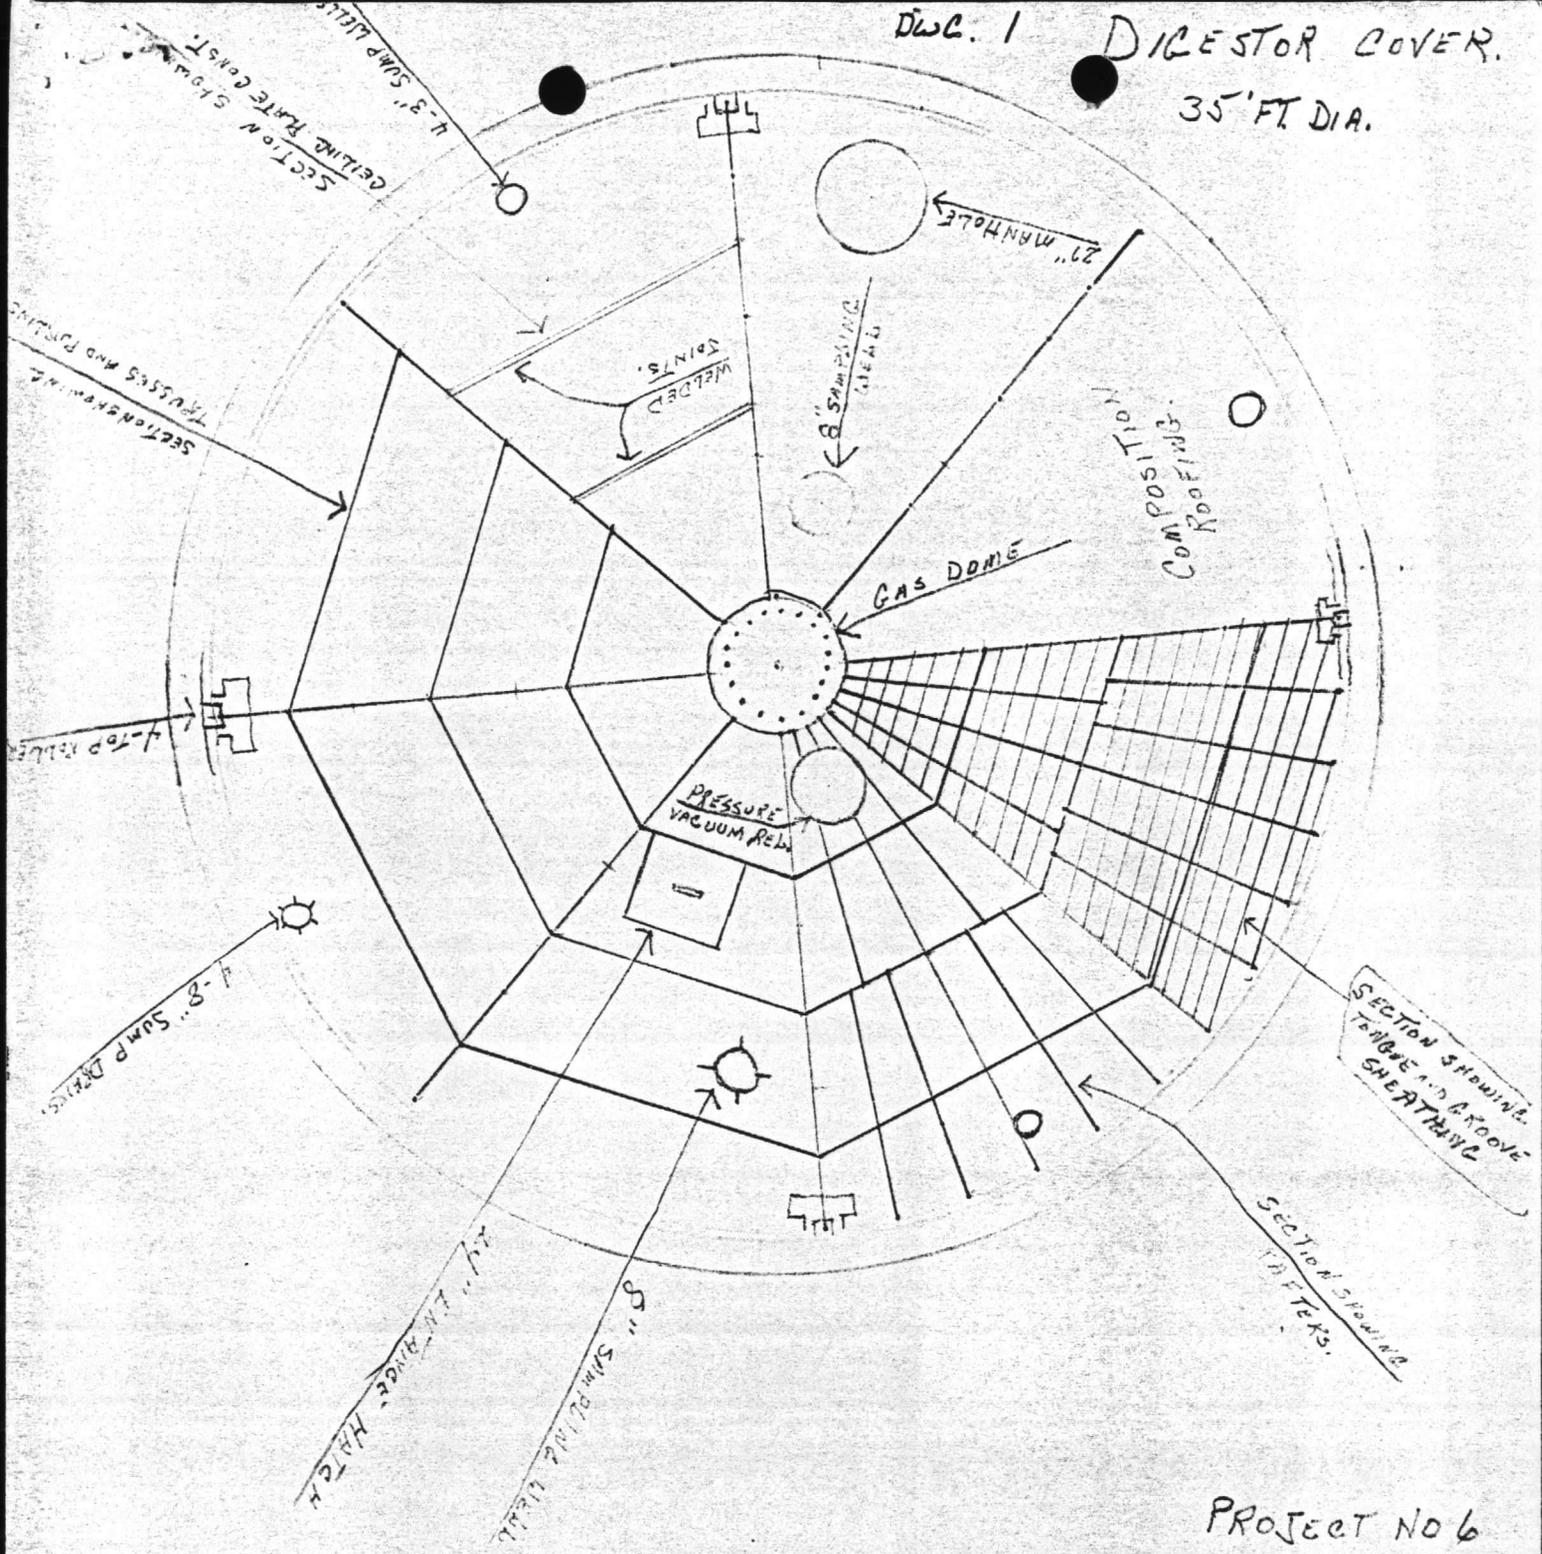
DWG. 1 DIGESTOR COVER.

Project is located at Hadnot Point Sewage Plant Bldg. 22. The digester composition roof has cracks and holes in it; the rain has kept the rafters and sheathing wet, and they have become rotten. The digester roof should be repaired. See attached sheet.

- 1- CLEAN AND PAINT ALL EXPOSED METAL.
- 2- REPLACE RAFTERS AND SHEATHING.
- 3- REPLACE COMPOSITING ROOFING.
- 4- EST. COST. \$3,000.00
- 5- THREE DIGESTORS NEEDS REPAIR.

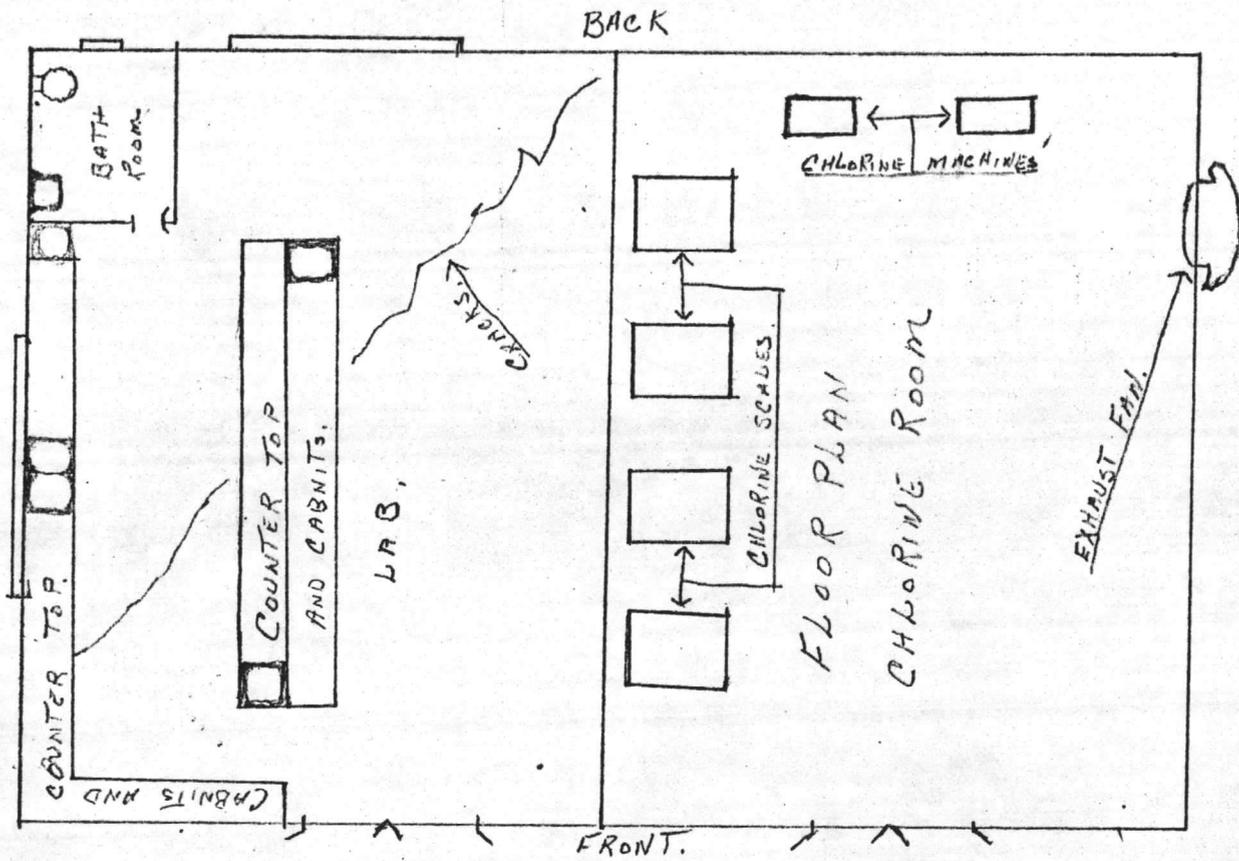
BLDG. 683
LAB. AND CHLORINE ROOM
THIS BUILDING IS IN BAD NEED OF
REPAIR OR REPLACED.
THE JAGGED LINES ARE CRACKS
IN THE WALLS AND FLOOR.

REPLACE 150,000
REPAIR 50,000

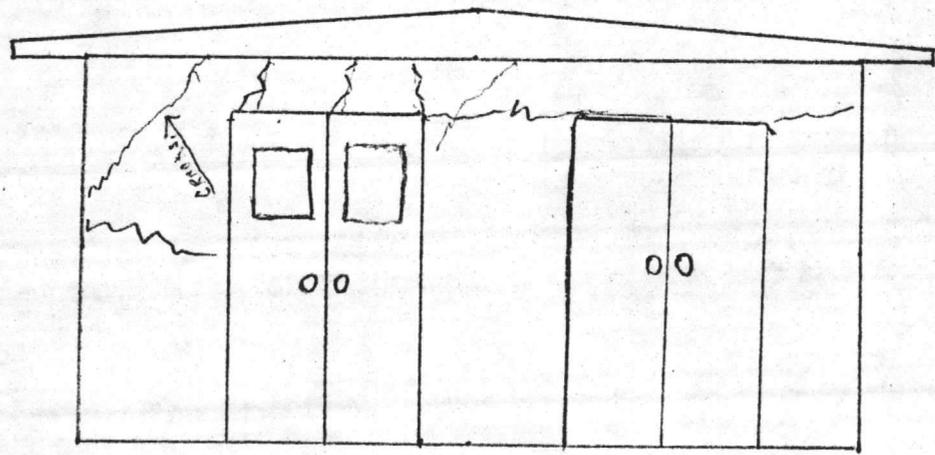
FRONT VIEW OF BLDG. 683.

Foundation and walls of building 683 are cracking and giving way. The chlorine contact chamber has cracks and a hole in the bottom, which are leaking effluent into New River. This effluent has not been fully chlorinated and the leakage into the river has the potential for violation of total coliform limits established by permit. See attached sketch.
