SUBJ: CATHODIC PROTECTION SURVEY REPORT

ENCL(1): CATHODIC PROTECTION SURVEY REPORT FOR MCB CAMP LEJEUNE & NEW RIVER

MENENDEZ-DONNELL & ASSOCIATES, INC., in association with its consultant, GENERAL CATHODIC PROTECTION SERVICES, INC., conducted a corrosion control survey of underground POL systems, water distribution system, elevated water tanks, and underground fuel tanks at the U.S. Marine Corps Air Station (Helicopter), New River, North Carolina, during October and November, 1984.

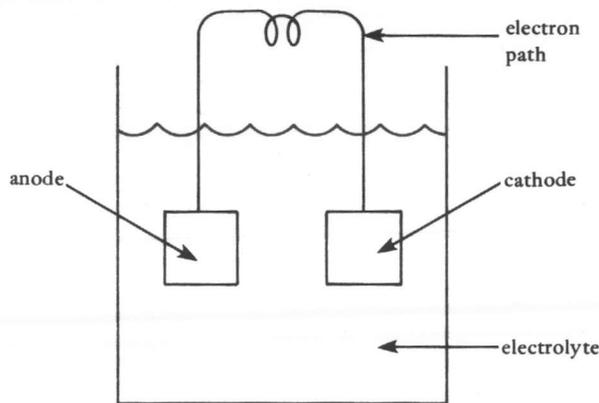
Figure 1. The electrochemical cell.

The electrochemical cell, as shown in Figure 1, has four components: an anode, a cathode, an electrolyte, and an electron path.

At the anode, a chemical reaction occurs where metal atoms give up electrons and enter the electrolyte (usually soil or water) as ions. Thus, the metal anode loses atoms and is said to "corrode."

The electrons from the corrosion of the anode flow through the electron path to the cathode (usually metal).

At the cathode, another chemical reaction occurs that uses up the electrons which were produced at the anode. Thus, there is no loss of metal (i.e., no corrosion) at the cathode.

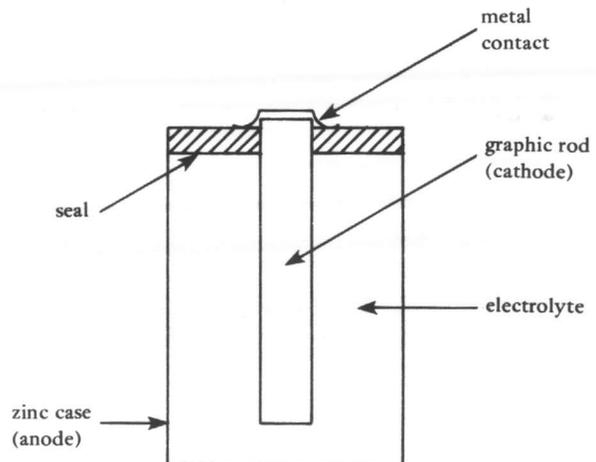
Figure 2. The dry cell battery.

An ordinary dry cell battery is a common example of an electrochemical cell. As shown in Figure 2, a dry cell consists of a zinc case which serves as an anode; a carbon rod which serves as a cathode; and a solution of ammonium chloride that is absorbed on a powder to prevent spillage and serves as the electrolyte. The electron path is furnished by the external load, such as a lamp. Until the lamp is switched on completing the circuit no current flows and no electrochemical action occurs. When the lamp is switched on, the zinc corrodes, and the electrons flow through the lamp to the cathode where they are consumed in the cathodic reaction. Thus, in a dry cell, the corrosion of zinc is harnessed to provide energy.

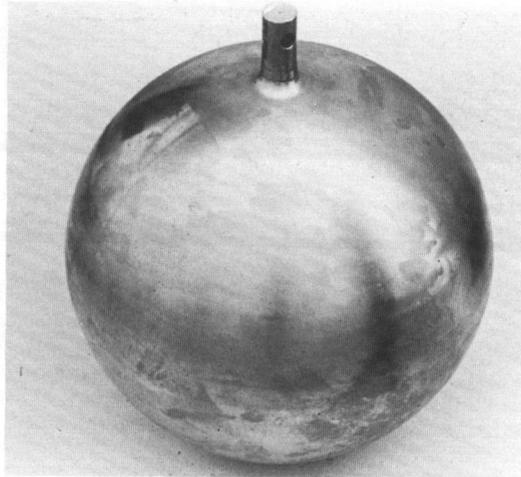
Figure 1.

*Uniform corrosion and no corrosion are a matter of degree.*

Two forms of corrosion are described in this Techdata Sheet: uniform corrosion and no corrosion. Uniform corrosion is defined as corrosion that occurs at substantially the same rate over the entire exposed surface of a metal. Rusting of steel in the atmosphere is usually uniform corrosion. Other examples of materials that normally corrode uniformly are the copper alloys and cast iron. When uniform corrosion occurs, very small electrochemical cells are established on the surface of the metal due to small differences in metal composition or the nonuniform nature of corrosion product layers that form

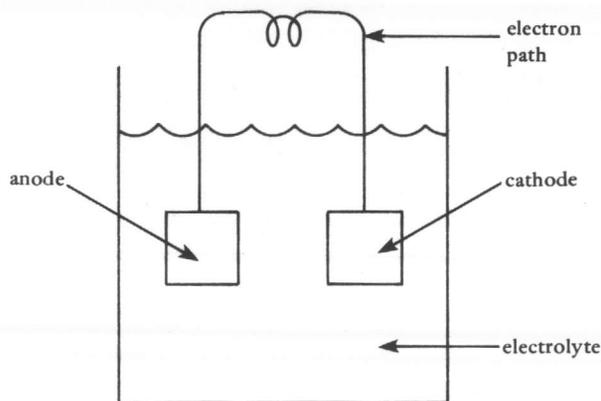
Figure 1. The electrochemical cell.

The electrochemical cell, as shown in Figure 1, has four components: an anode, a cathode, an electrolyte, and an electron path.

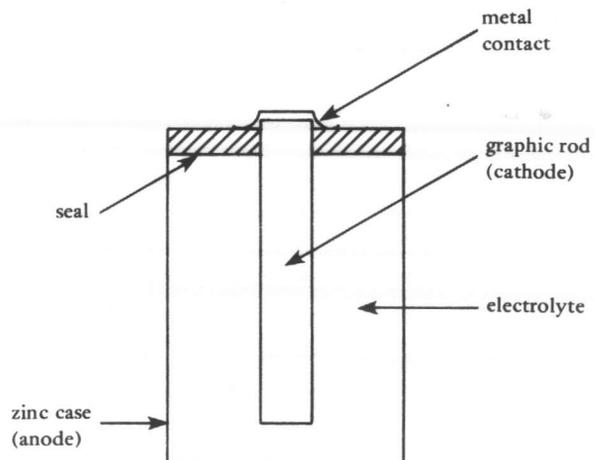
Figure 2. The dry cell battery.

An ordinary dry cell battery is a common example of an electrochemical cell. As shown in Figure 2, a dry cell consists of a zinc case which serves as an anode; a carbon rod which serves as a cathode; and a solution of ammonium chloride that is absorbed on a powder to prevent spillage and serves as the electrolyte. The electron path is furnished by the external load, such as a lamp. Until the lamp is switched on completing the circuit no current flows and no electrochemical action occurs. When the lamp is switched on, the zinc corrodes, and the electrons flow through the lamp to the cathode where they are consumed in the cathodic reaction. Thus, in a dry cell, the corrosion of zinc is harnessed to provide energy.

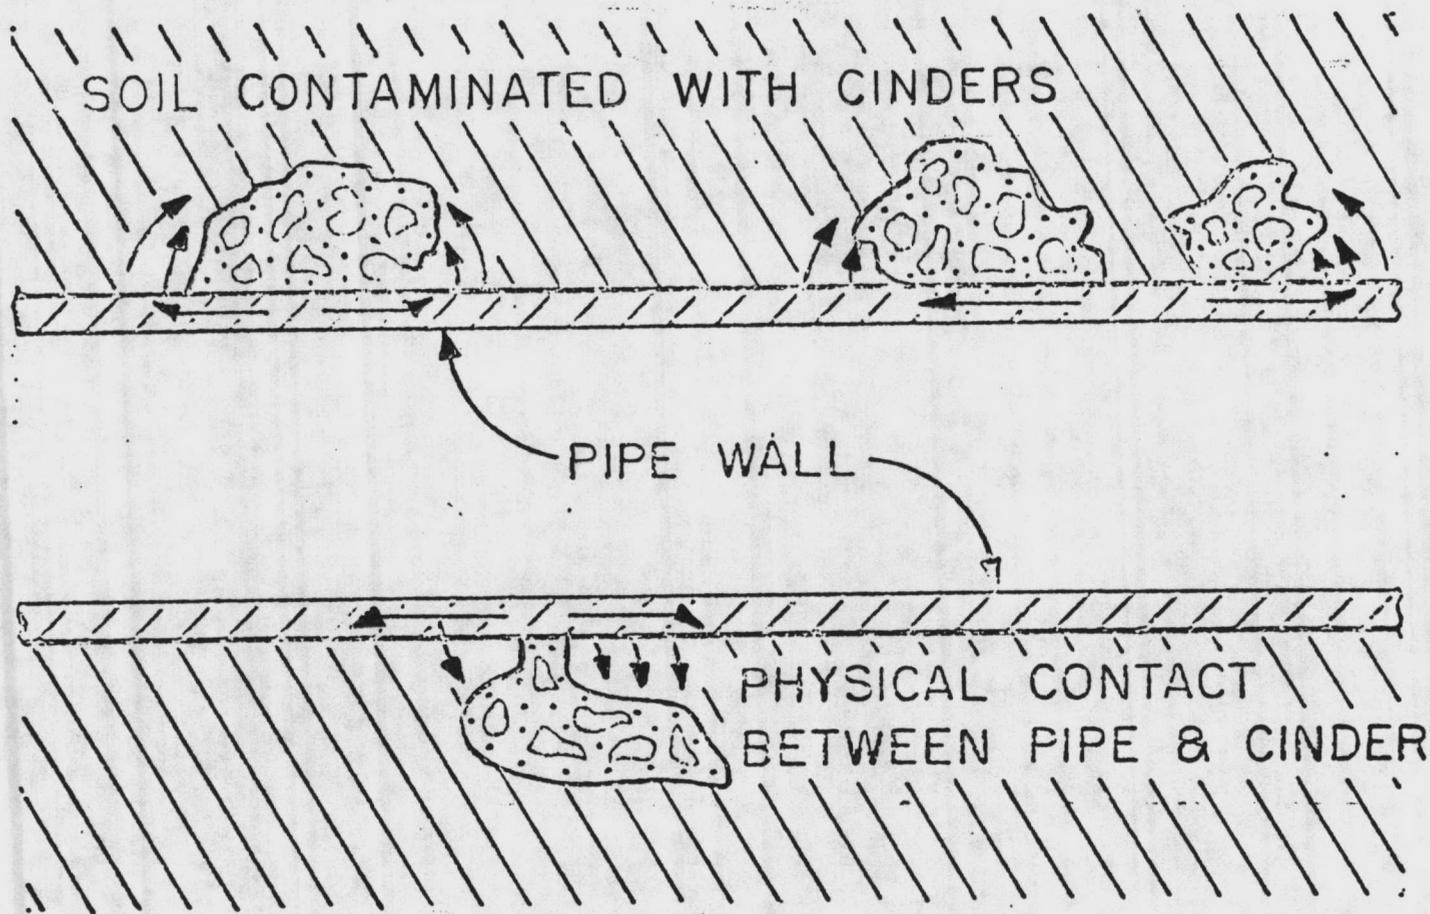
CORROSION DUE TO CINDERS

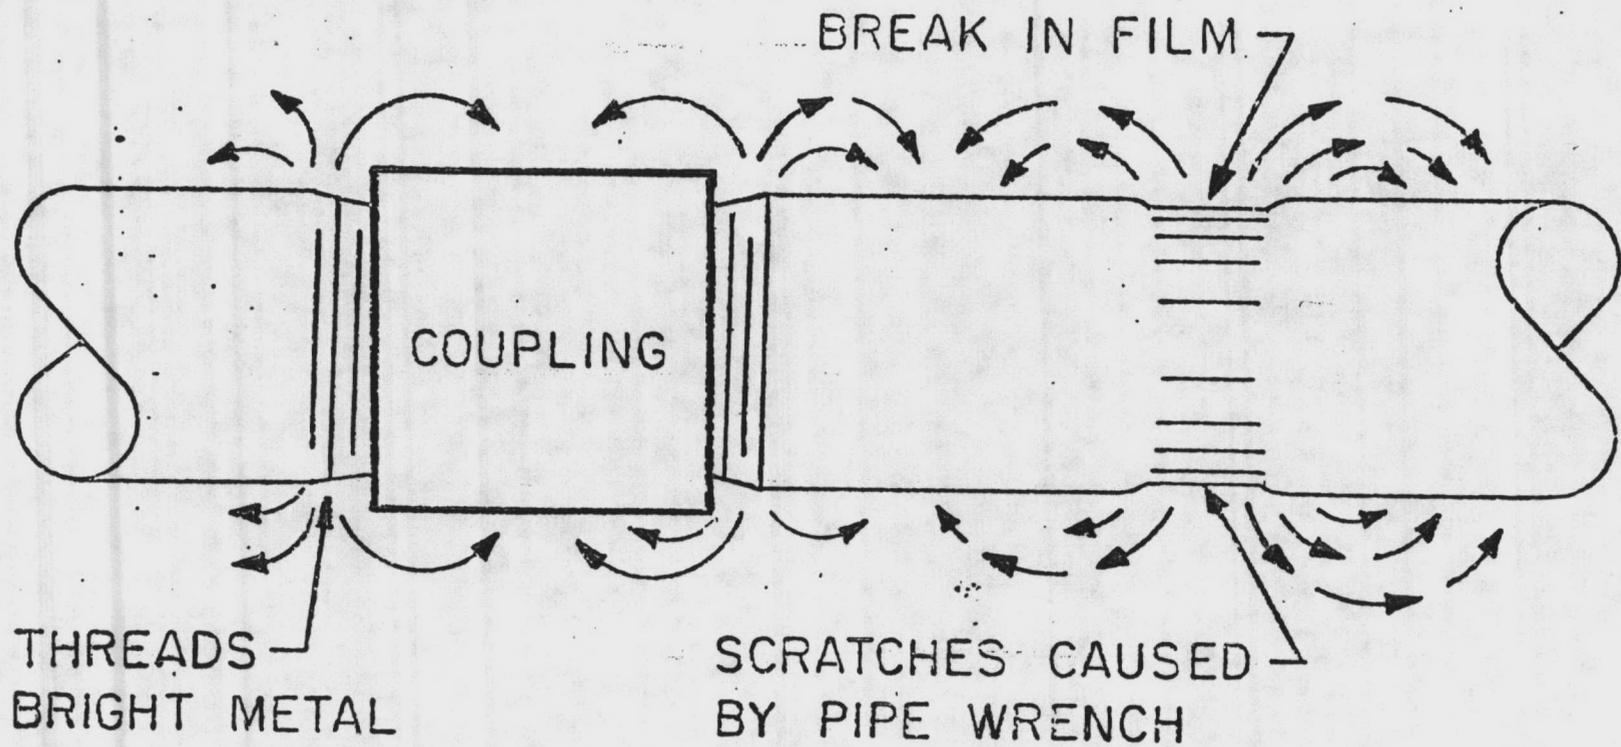
CORROSION CAUSED BY DISSIMILARITY OF SURFACE CONDITIONS

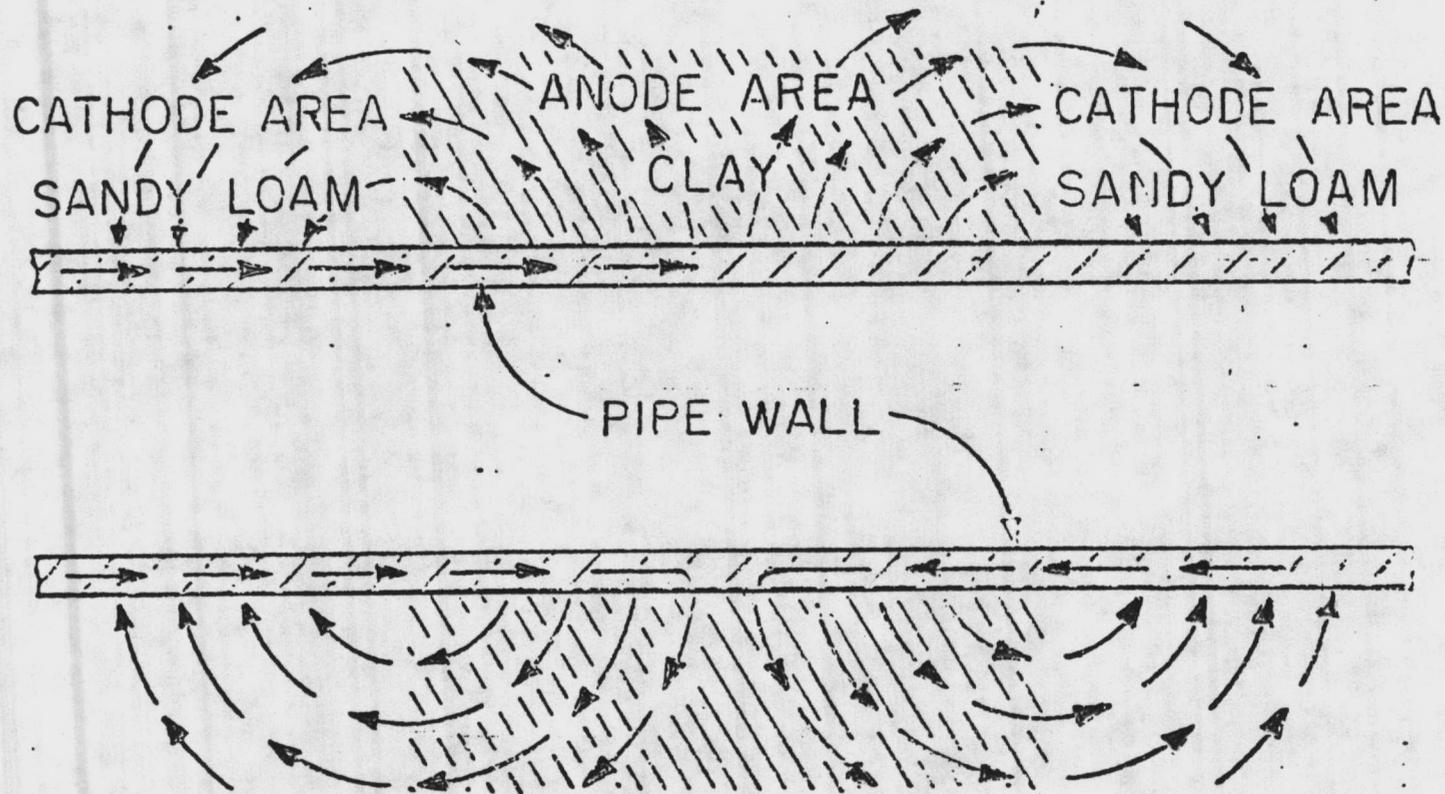
CORROSION CAUSED BY DISSIMILAR SOILS

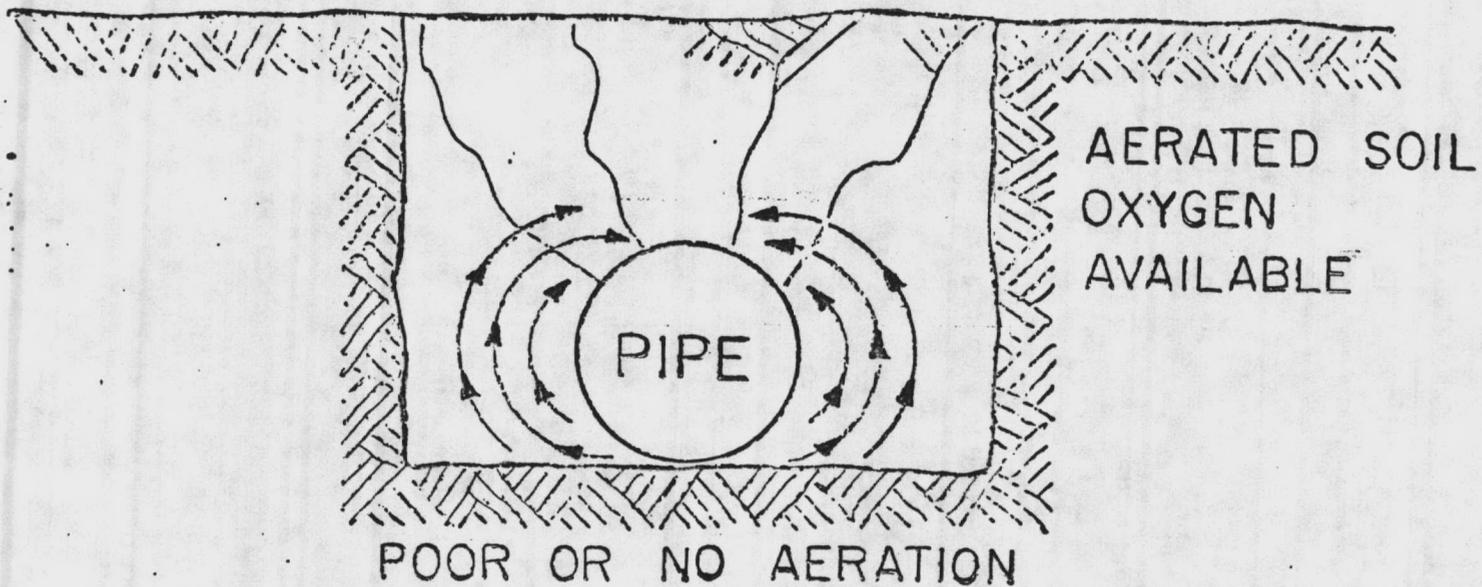
CORROSION CAUSED BY DIFFERENTIAL  
AERATION OF SOIL
