ATLANTIC DIVISION
NAVAL FACILITIES ENGINEERING COMMAND
NORFOLK, VIRGINIA 23511-6287

29 JULY 1987

Subj: STUDY REPORT OF WATER SYSTEM AT MCAS NEW RIVER AND CAMP GEIGER

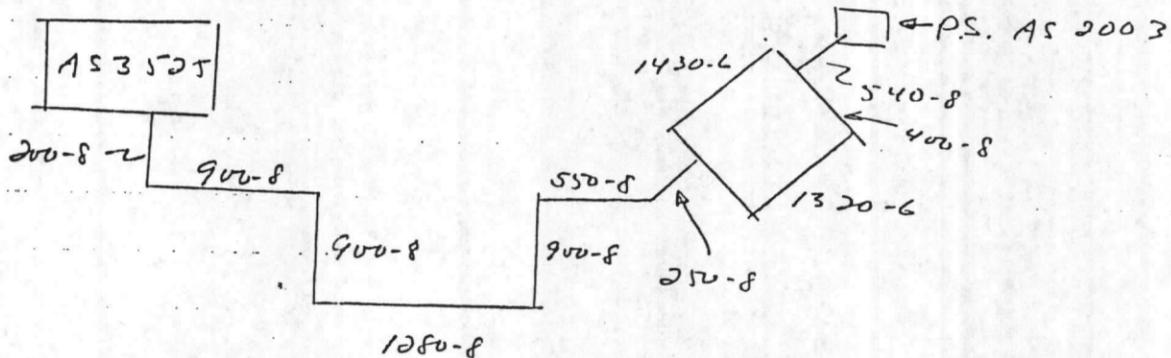
ENCL (15)

WAREHOUSE AS 3525

SPRINKLER REQ. = 1800 gpm @ 40 Lbs (XTRA HAZARD)

EQUIVALENT 8" PS AS 2003 TO WHSR AS 3525

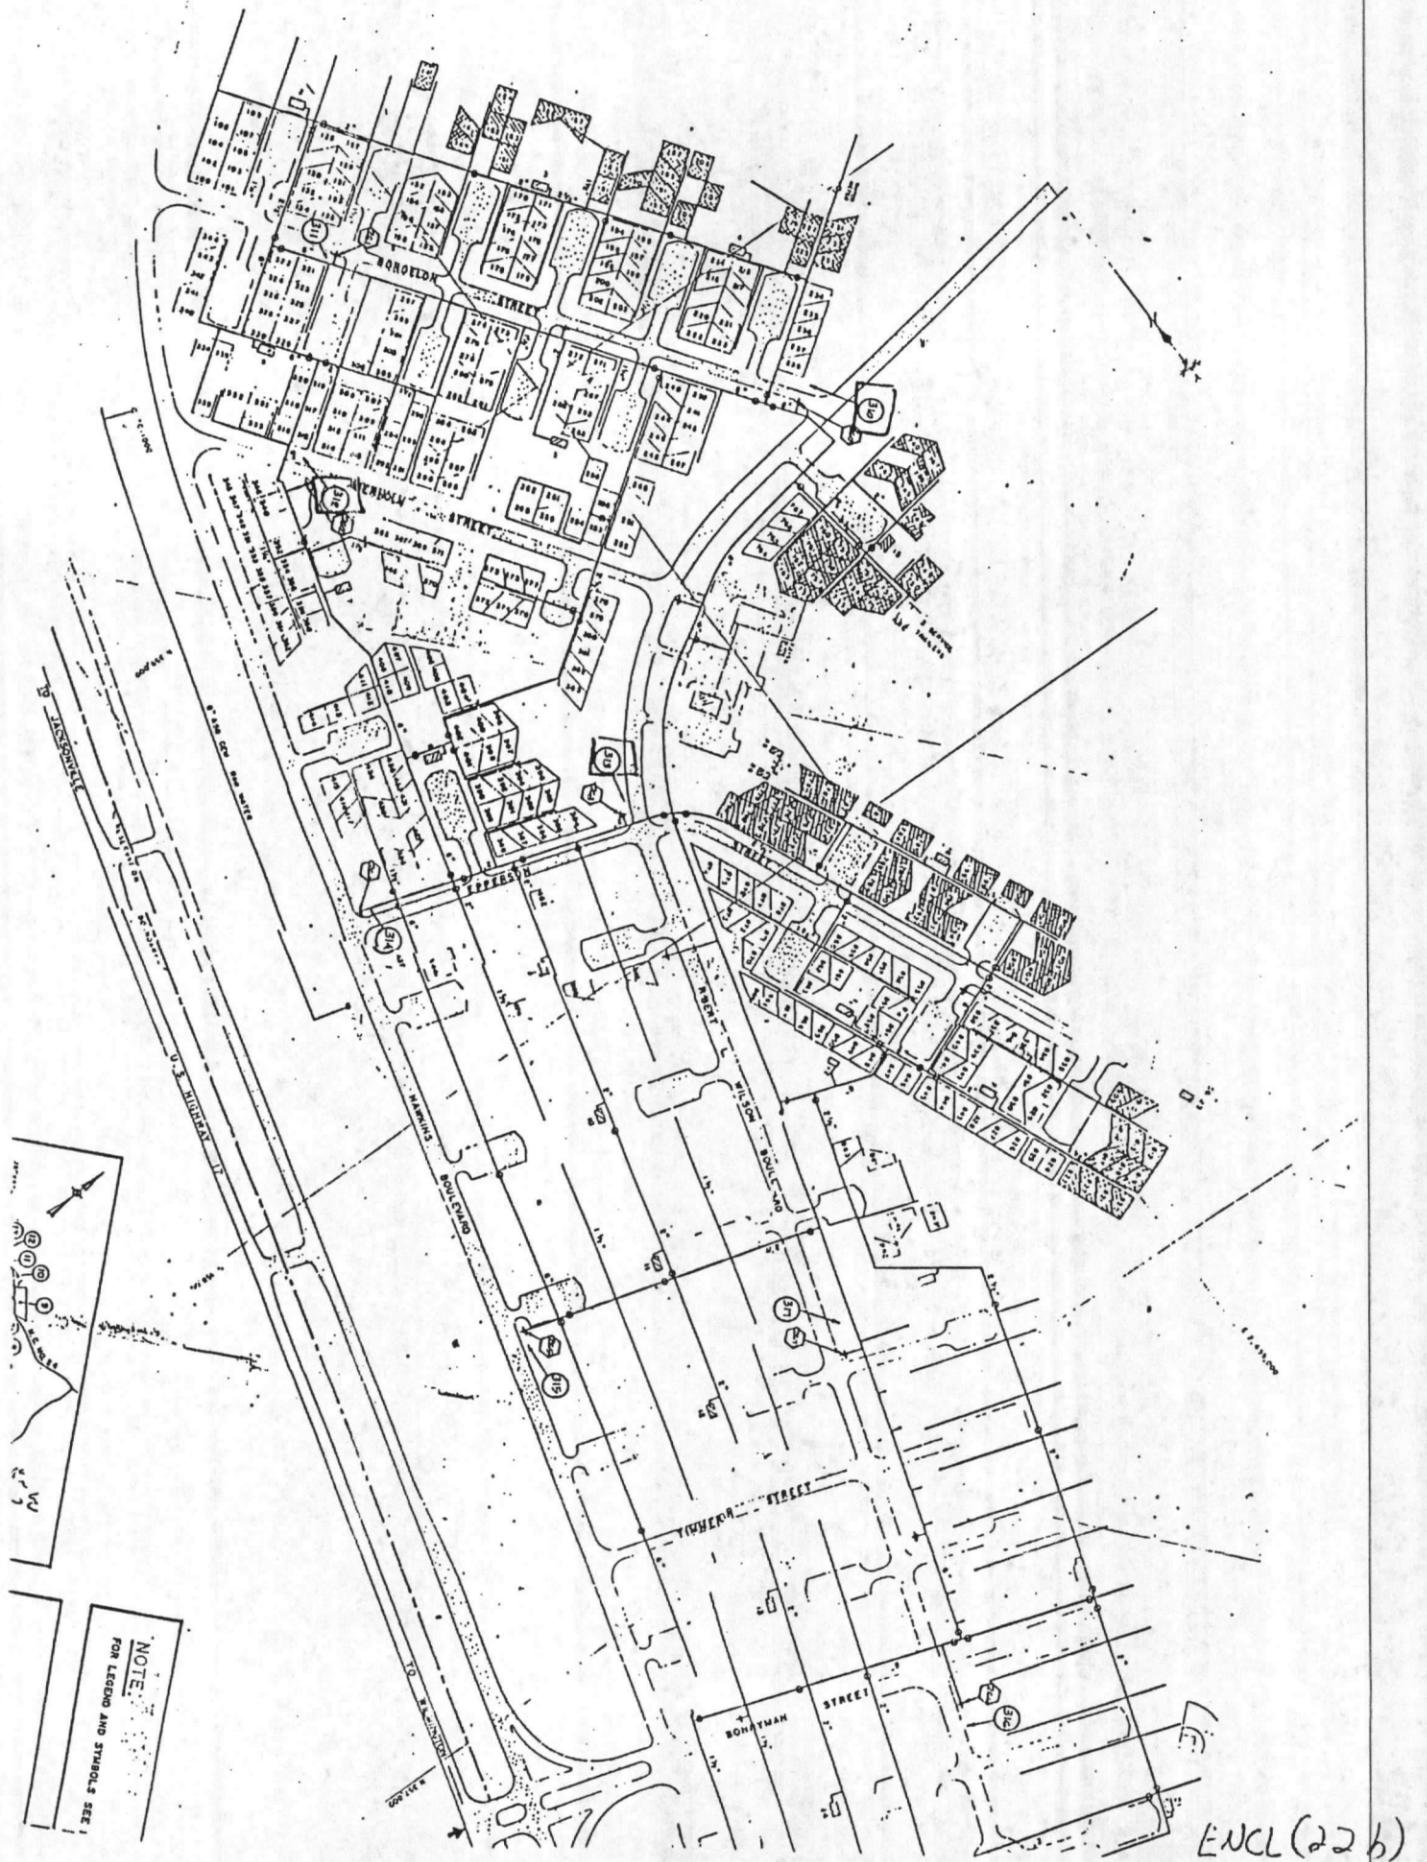
TRL PARK

Location	Potential	resistance	Comment
<u>310</u>	<u>-.555</u>	<u>4500</u>	<u>mildly corrosive</u>
<u>312</u>	<u>-.531</u>	<u>1200</u>	<u>mildly corrosive</u>
<u>313</u>	<u>-.552</u>	<u>3800</u>	<u>mildly corrosive</u>
311	-.534	25000	probably corrosive
314	-.539	15000	probably corrosive
317	-.496	6300	probably corrosive
315	-.455	17000	possibly corrosive
316	-.478	15000	possibly corrosive

TRU PARK
LOC 310-317

□ MILDLY
CORROSIVE

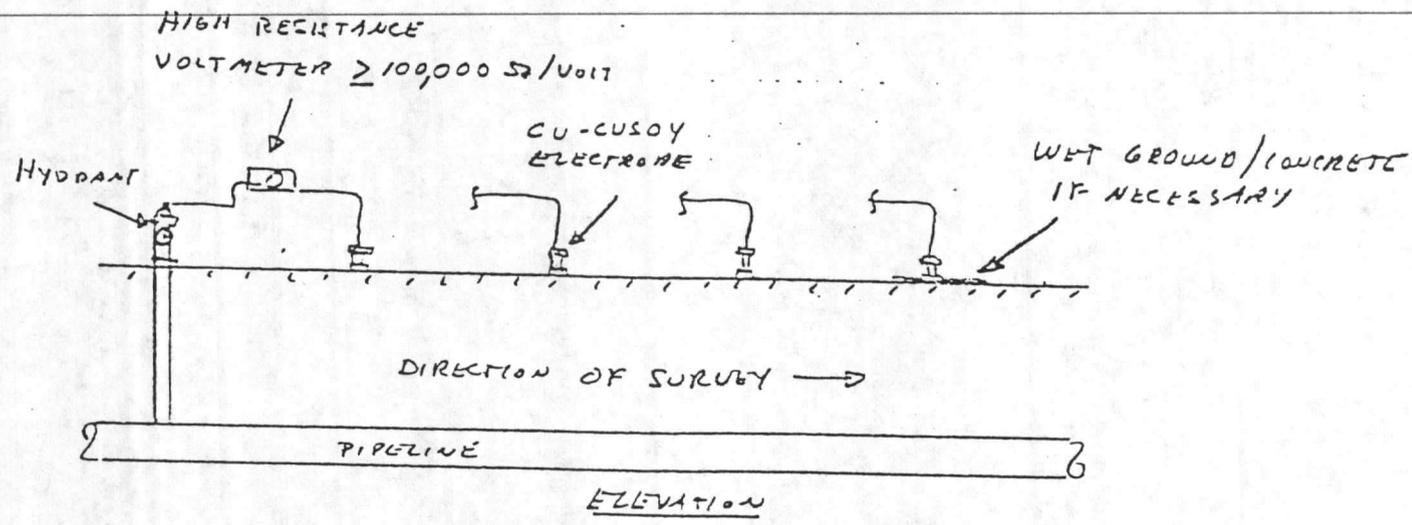
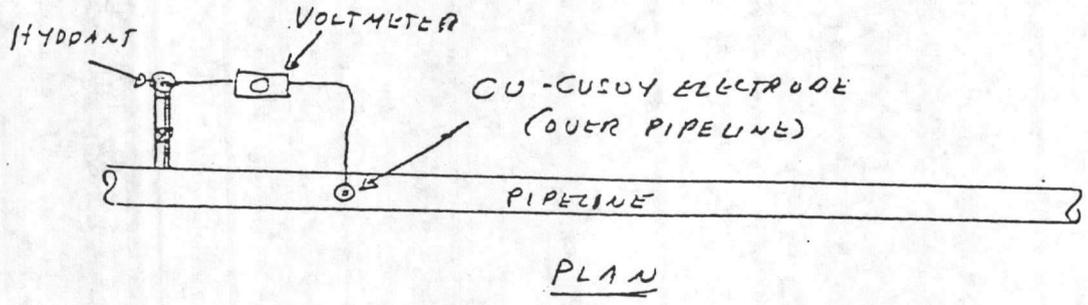
ATTACHMENT E

SOIL RESISTIVITY - COPPER SULFATE POTENTIAL RELATIONSHIPS.
