CONTRACT N62470-83-C-6148

CATHODIC PROTECTION SURVEY

MARINE CORPS BASE
CAMP LEJEUNE, NORTH CAROLINA

FINAL SUBMITTAL
January 14, 1985

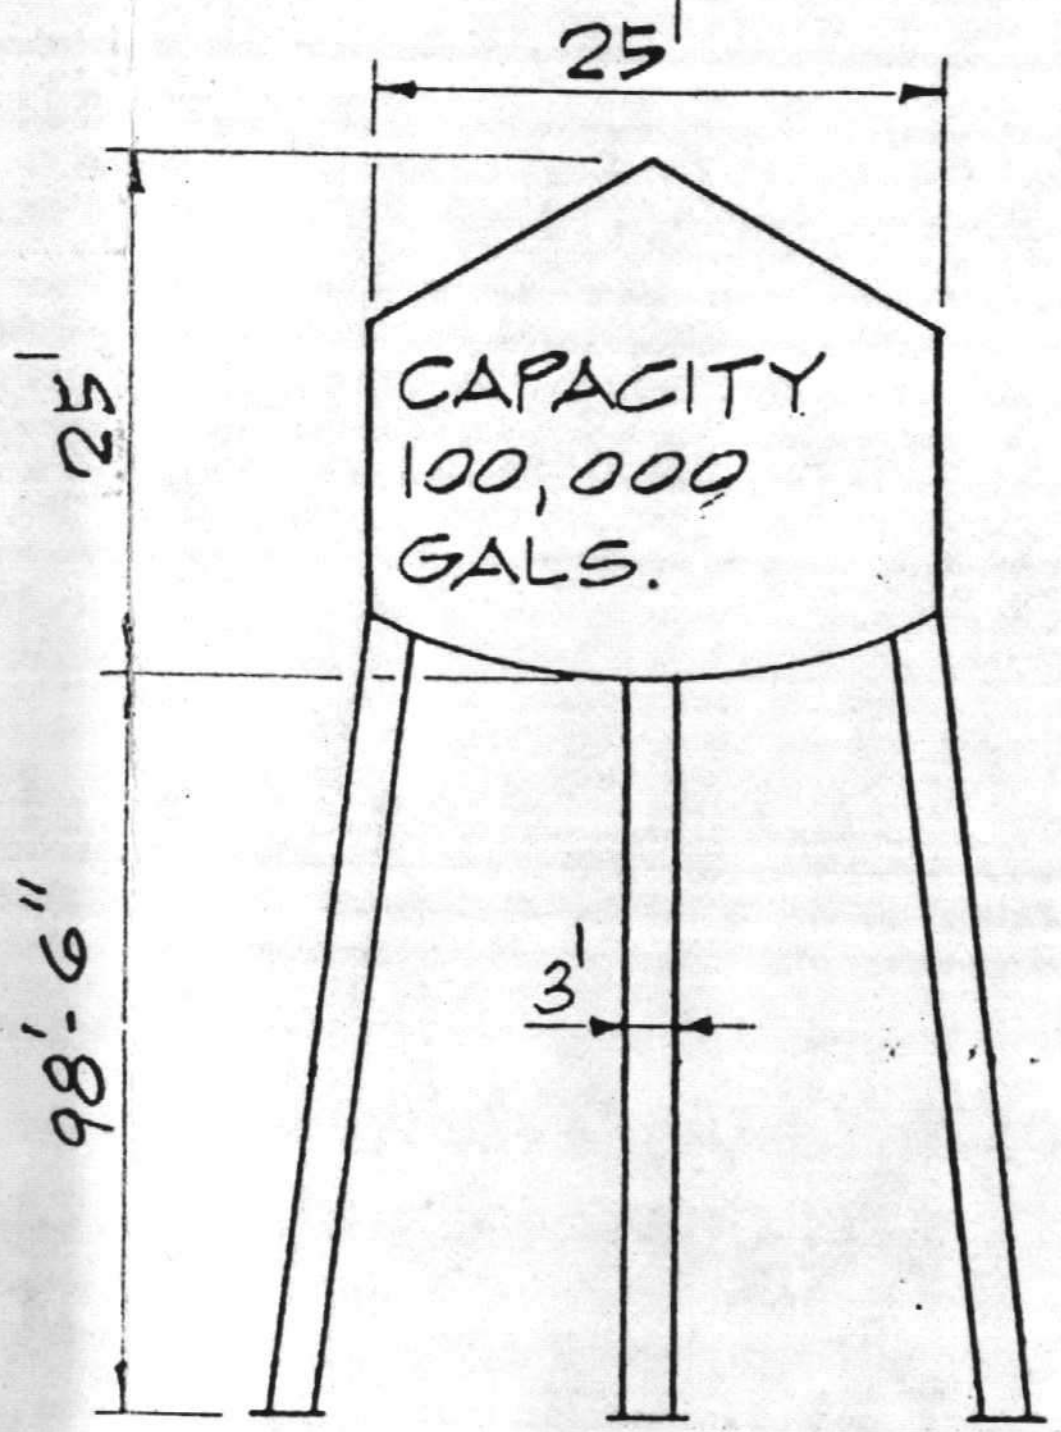
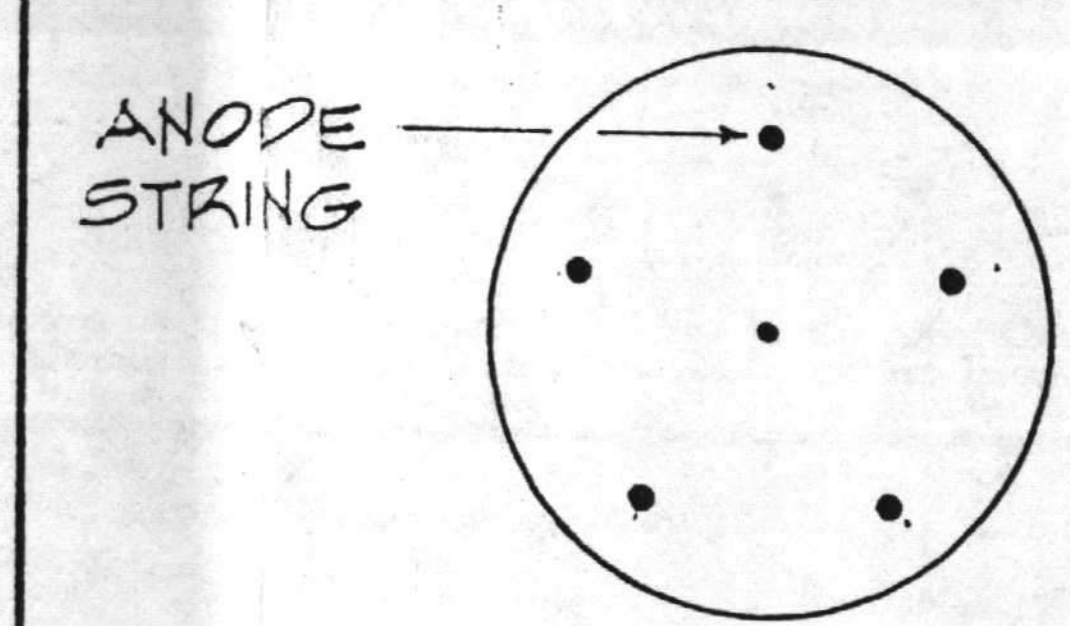
ELEVATED WATER STORAGE TANK CATHODIC PROTECTION DATA (TANK S-RR-44) AREA 17

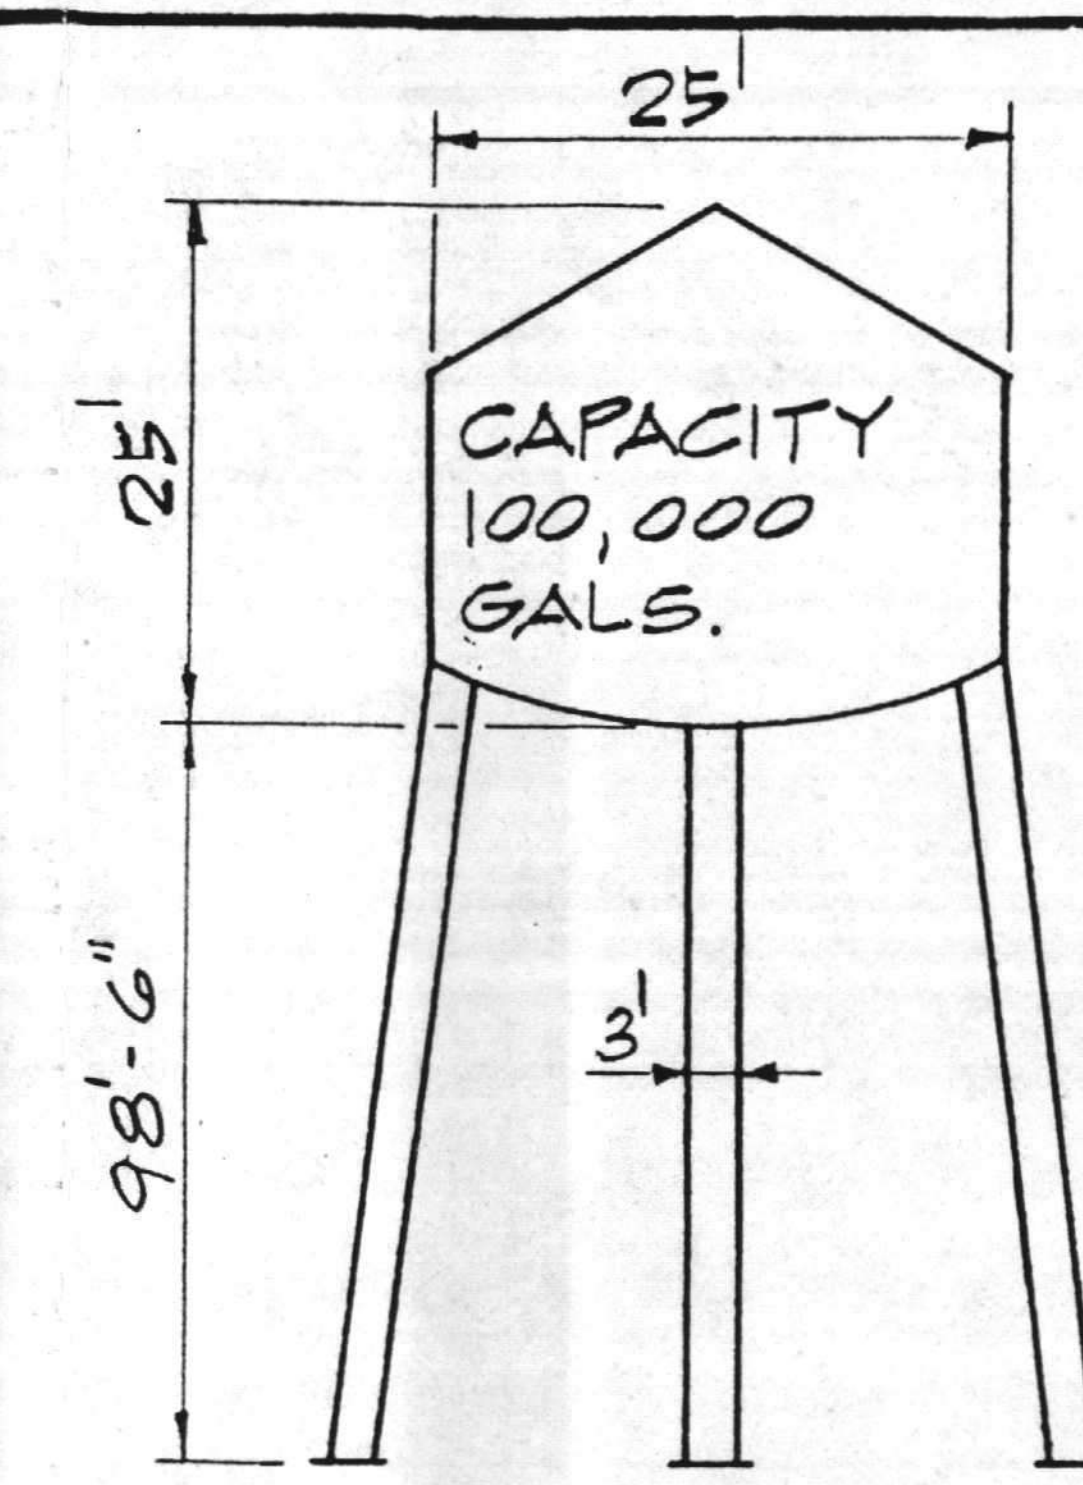
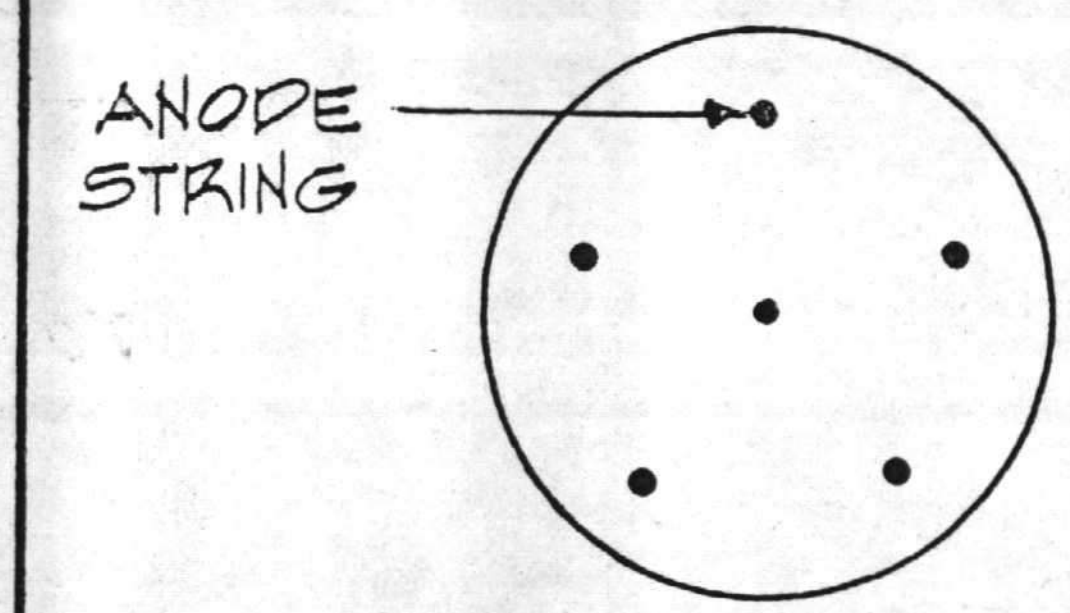
ELEVATED WATER STORAGE TANK
CATHODIC PROTECTION DATA
(TANK S-BB-25) AREA 18

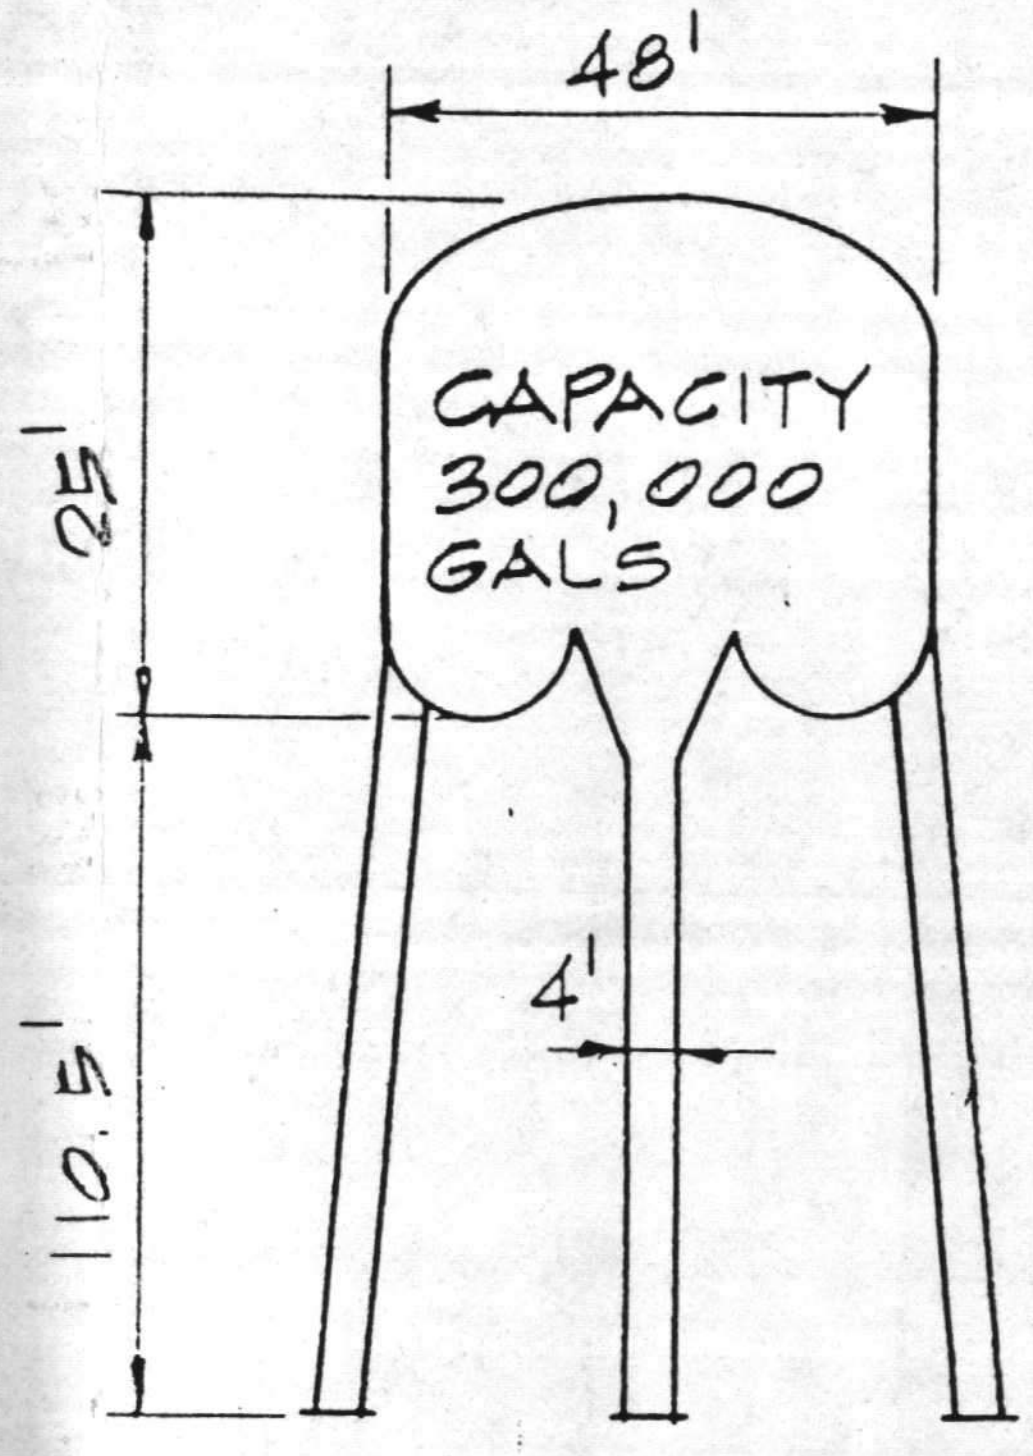
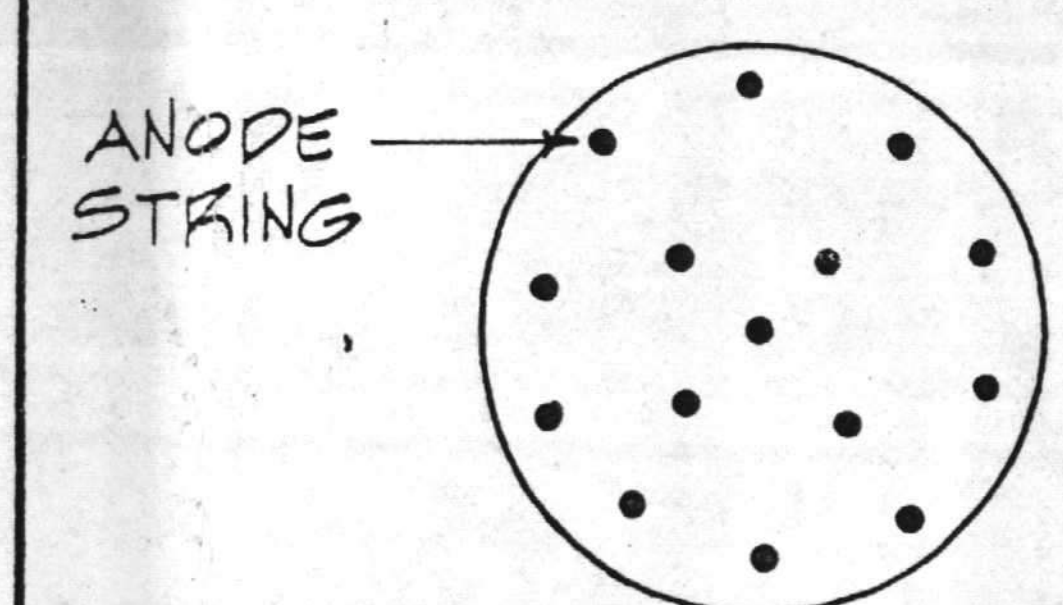
ELEVATED WATER STORAGE TANK
CATHODIC PROTECTION DATA
(TANK S-FC-314) AREA 20

a. Tank S-FC-314: Replace one missing string in inner array.

b. Tank S-FC-314: Repair the roof ladder and the air vent on top of tank, and replace the damaged condulet on top of tank.

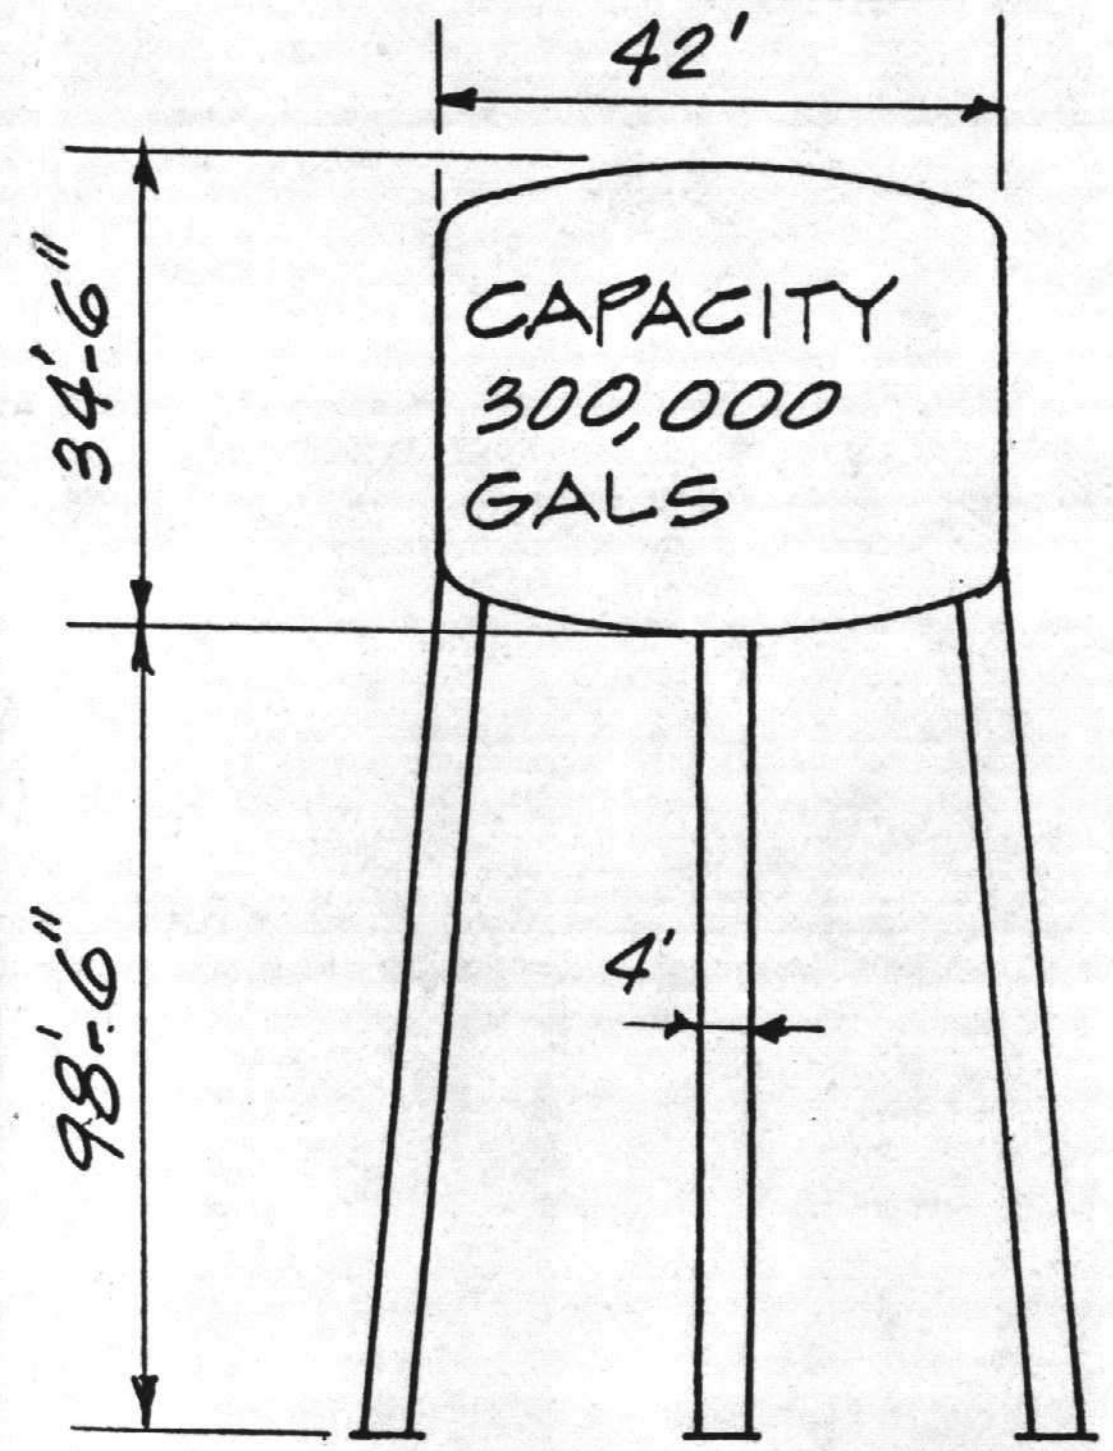
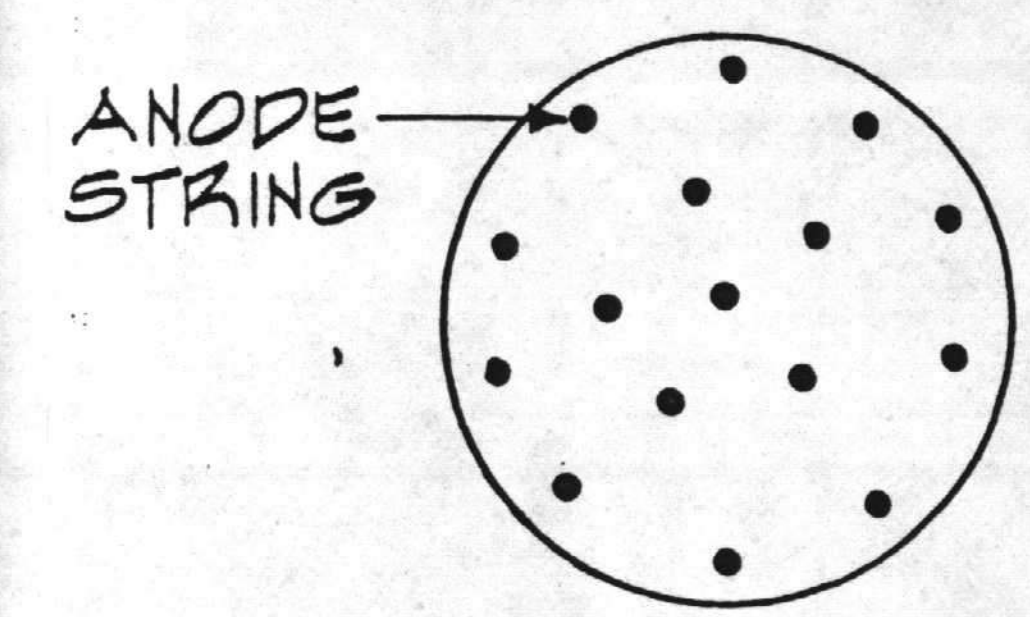
ELEVATED WATER STORAGE TANK
CATHODIC PROTECTION DATA
(TANK S-29) AREA 3

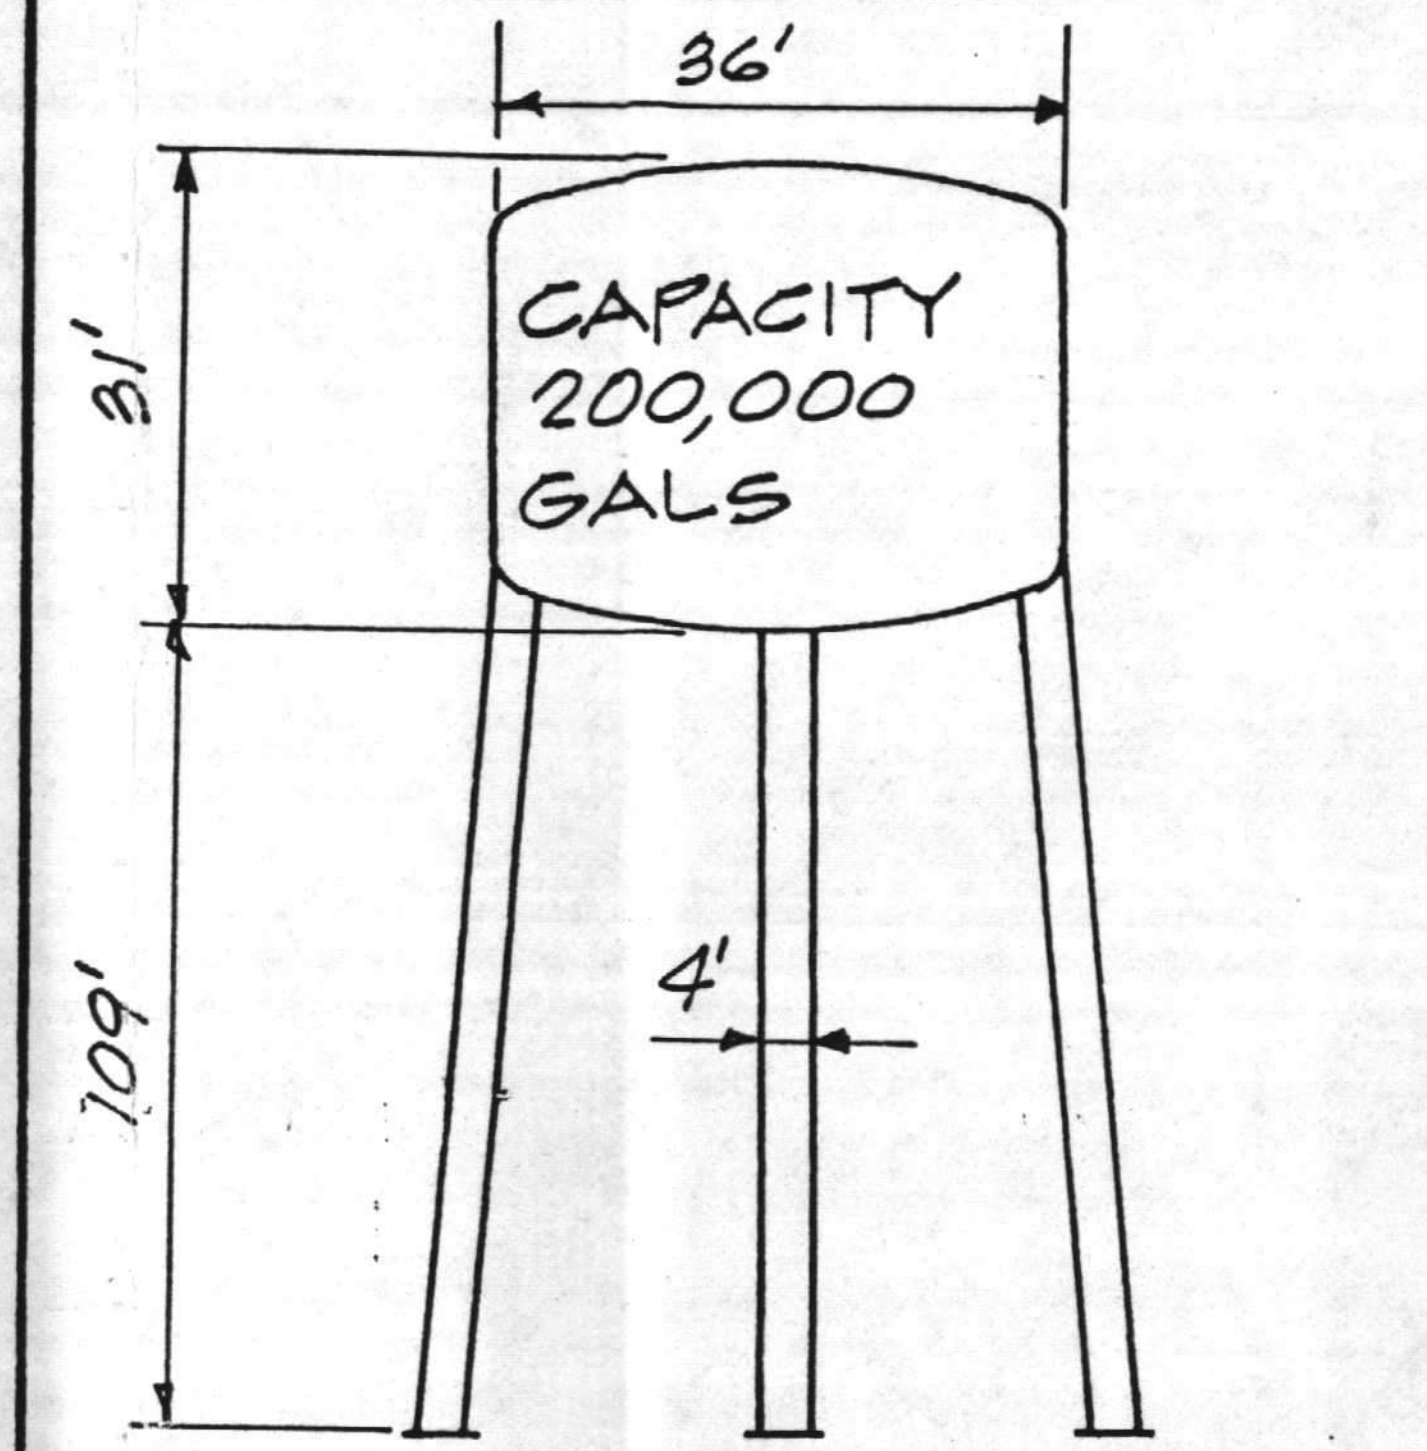
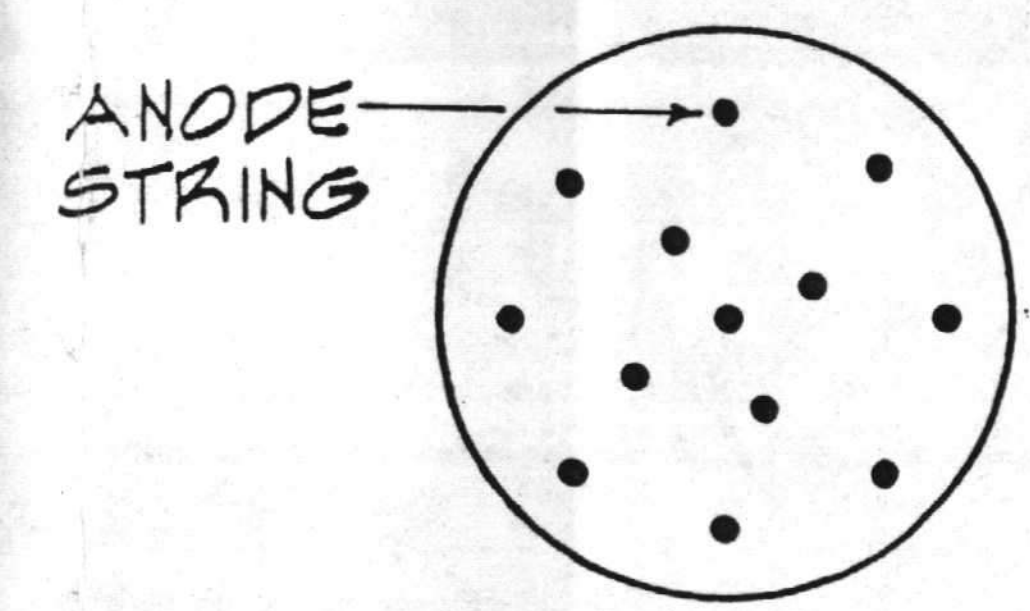
ELEVATED WATER STORAGE TANK
CATHODIC PROTECTION DATA
(TANK S-2323) AREA 7
