SUBJECT: Metallographic Report

Attached is our laboratory report of the metallographic examination of a failed tube from the No. 1 Power Recovery Boiler. This failure was detected on June 3 at a point near the mud drum in the bottom row of tubes entering the drum on the side away from the furnace (the cooler side). The actual failure was in the shape of a "V" approximately 3/16" diameter on the inside surface of the tube culminating in the pinhole on the outside surface. Just adjacent to this V-shaped hole was a heavy layer of what appeared to be pure copper approximately 3/8" diameter and 0.025" in thickness. The top and the bottom of the tube were not indicated, but there was a slightly acid attacked channel area which we assumed to be the bottom of this nearly horizontal swaged tube. The copper plated area and the pinhole failure are located in approximately the 7 o'clock position relative to this acid damaged area. Further, it should be noted that the pinhole failure is in the transition zone of the swaged tube.

SUBJECT: Failed Boiler Tube
Lab #D7592

TO E. K. Lederach
FROM F. H. Seels
SUBJECT Procter & Gamble, Ivorydale Plant
No. 4 Boiler, Crossover Tube Corrosion

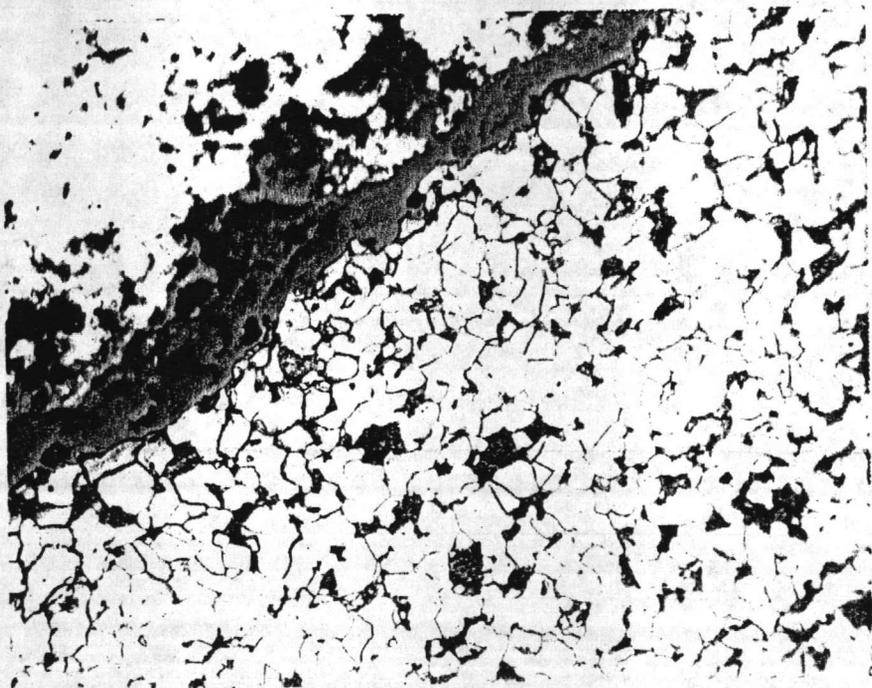
Figure 2

A specimen, which was a cross section of the failure, was mounted, polished, etched and examined microscopically. A photomicrograph was taken of the microstructure in the failed area at 360X (Figure 2).

The microstructure directly under the plugged area appeared to be normal. Lamellar pearlite and dense colonies of spheroidized carbides were observed in the microstructure near the interface of the base metal of the tube and the copper plug (Figure 2).

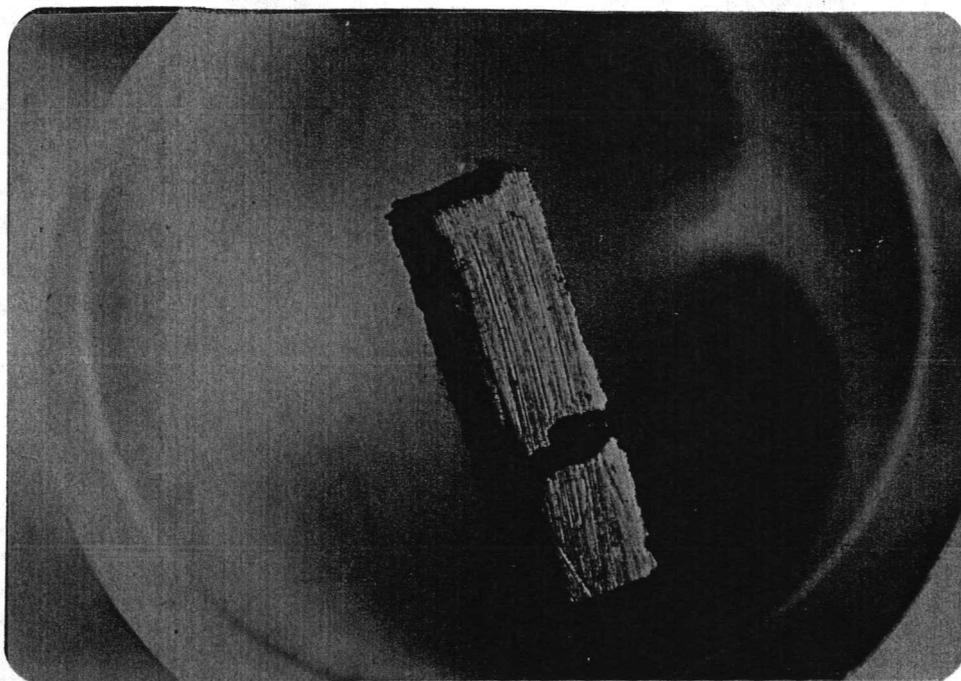
A copper plug was observed in the area of the failure (Figure 1). Figure 3 shows the cross section of the copper plug and tube wall in the area of the failure.

Some form of a concentrated corrosion attack around or under the copper plug appeared to have caused the pinhole failure. Evidence as to the exact nature of the attack was not observed in the examination.

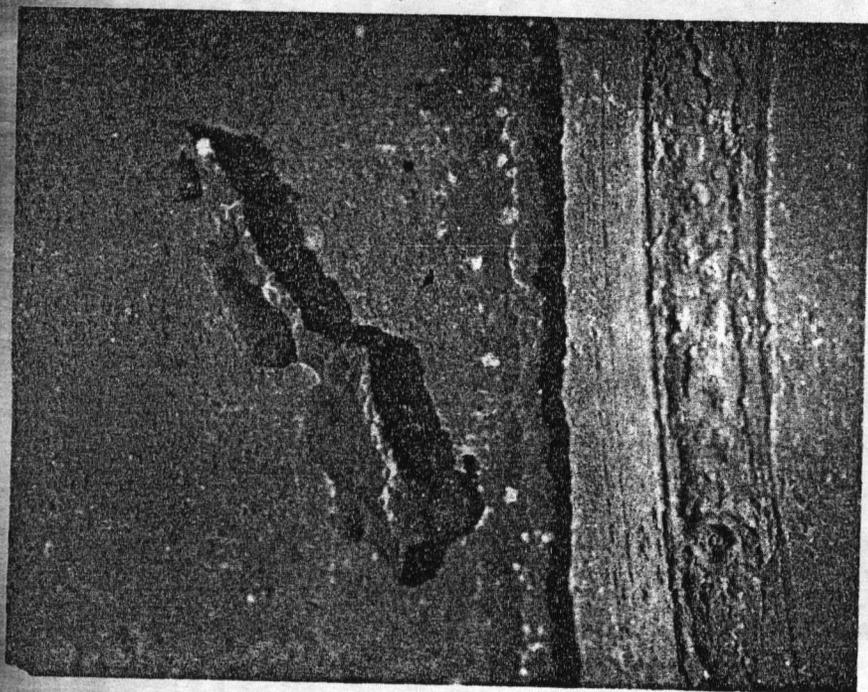
PHOTO 2 Specimen As Received, Area Upstream From Weld

1. Gross metal loss in a circumferential band immediately upstream of a weld. The weld is a precisely engineered distance from the tube inlet/header connection. The weld is associated with a reduction in inside tube diameter.

4. Some corrosion channels are oriented circumferentially (i.e., adjacent to weld, Photo 2); some are longitudinal (Photo 3); some are at (approximately) 45° angles (Photo 2); some have an altered orientation and are L-shaped.

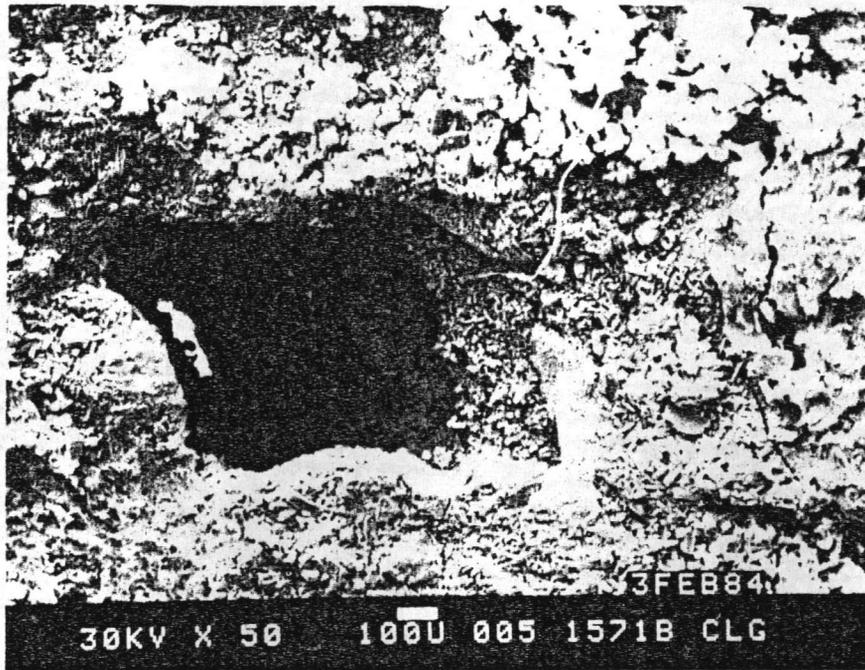
Photos 4 and 5 show a hole formed in the surface deposit. The hole is one of several small cavities visible in Photo 3. Photo 4 shows flow damage to the deposit coating; a deposit analysis is given below:

Features of the hole, particularly the undercutting and the channel configuration, indicate an erosion process with flow direction from right to left. Curiously, this flow orientation is opposite the direction of bulk fluid flow, indicating the influence of local flow eddies. A stepwise penetration of the deposit structure is evident in Photos 4 and 5. A secondary effect of local turbulence can be seen in the distinctive crystal growth patterns shown in the center of Photo 5. Although it may be that metal loss is associated with the hole, this was not studied. The important observation is that substantial mechanical forces were needed to excavate a relatively thick and protective deposit layer.

PHOTO 4 Details of Cavity Shown in Lower Left of Photo 2

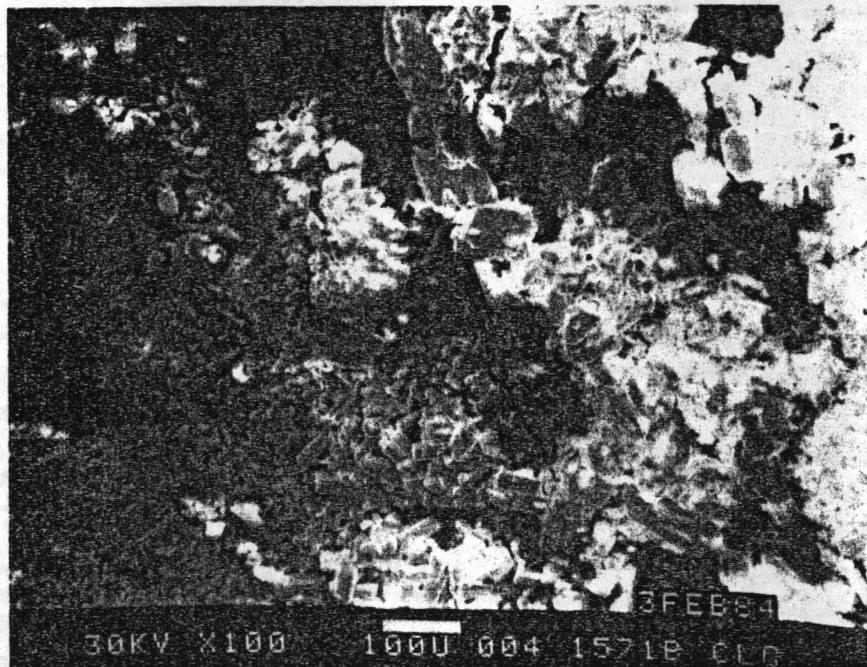
PHOTO 5 Closeup of Photo 4, Showing Stepwise Effect of Turbulence On Crystal Growth

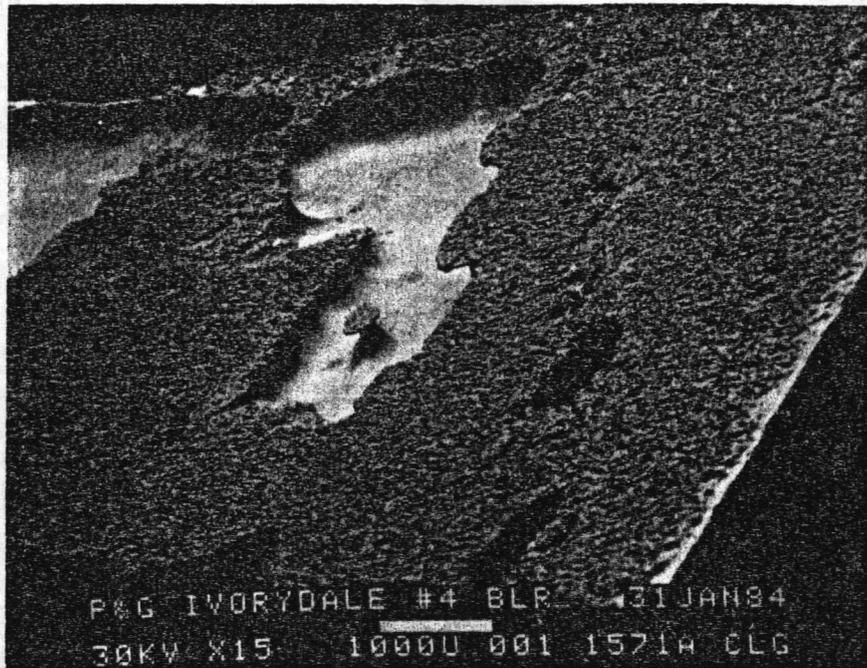
Photos 6 through 15 are part of a comprehensive study of specimen B. Specimen B is representative of the banded area downstream from the weld, where surface deposits are notably smooth and metal loss in a clustered pattern of small irregularly shaped pits.

PHOTO 6 Segment B in Photo 1,
Oblique View Showing Undercut Features

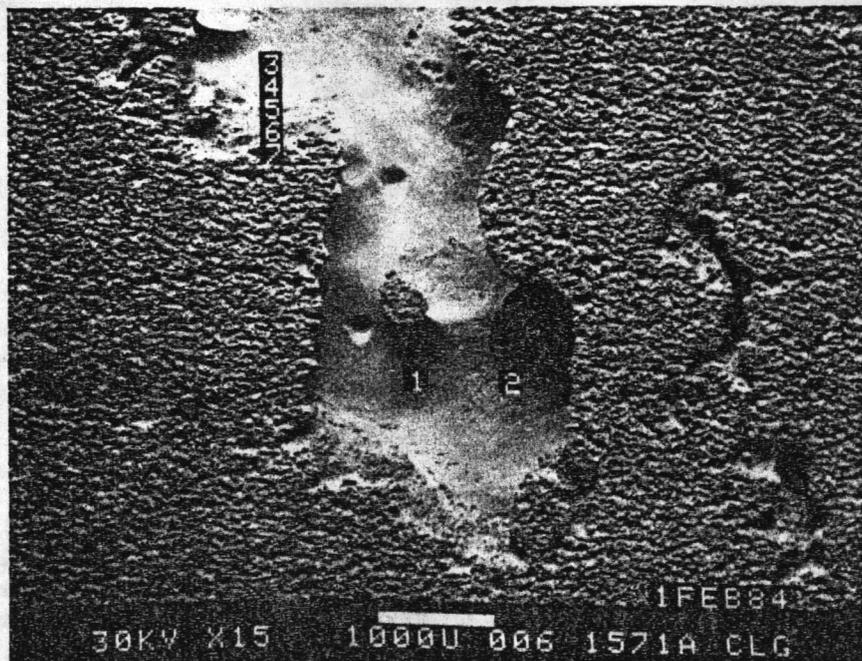
PHOTO 7 Top View of Center Area in Photo 6

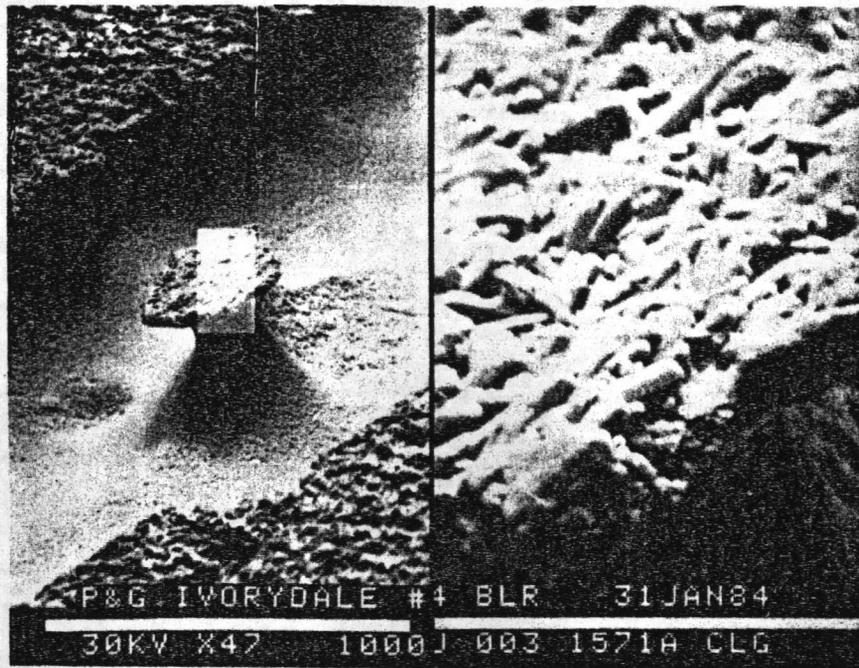
Photos 10 and 11 show additional close-up views of features near the pillar. The pillar is the result of a flow stagnation zone and serves to illustrate the peculiarities of localized turbulence.

PHOTO 10 Closeups of Pillar Shown in Photos 6 and 7

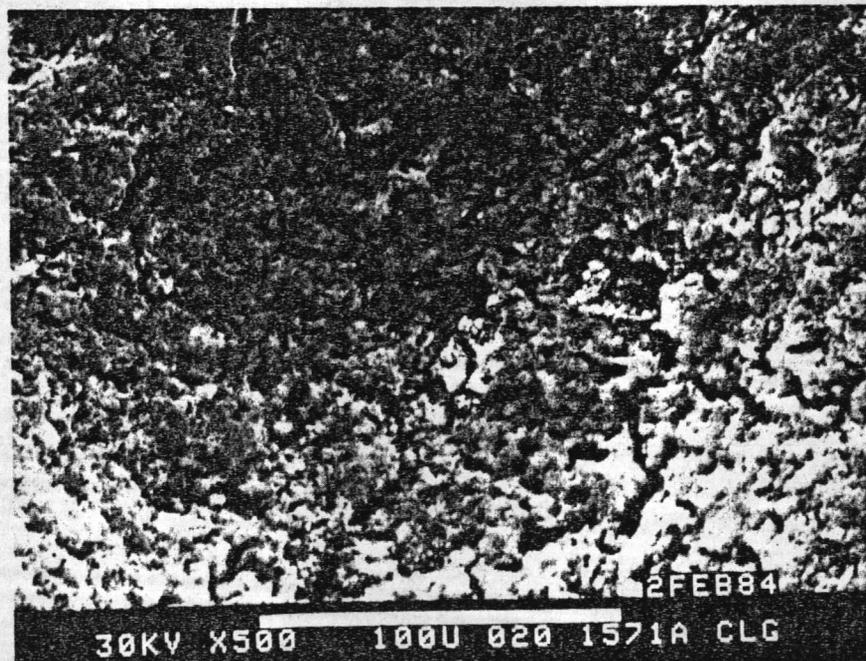
PHOTO 11 Closeup Of Pock At Left of Pillar

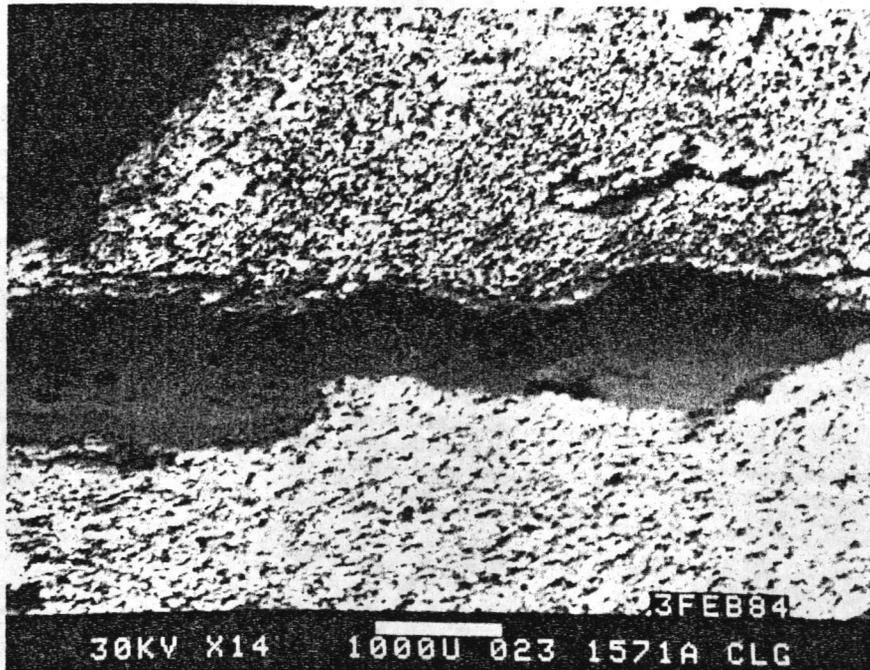
Photos 12 and 13 show details of metal loss on the side of the channel. From the vantage point of Photo 12, the bulk flow appears to be from top to bottom. Thus, there is evidence of bidirectional flow; axially as shown by Photo 7; and longitudinally as shown by Photo 12. Further

PHOTO 12 View Showing Secondary Pocks In Side Of Eroded Channel, Oblique View of Area in Photo 7

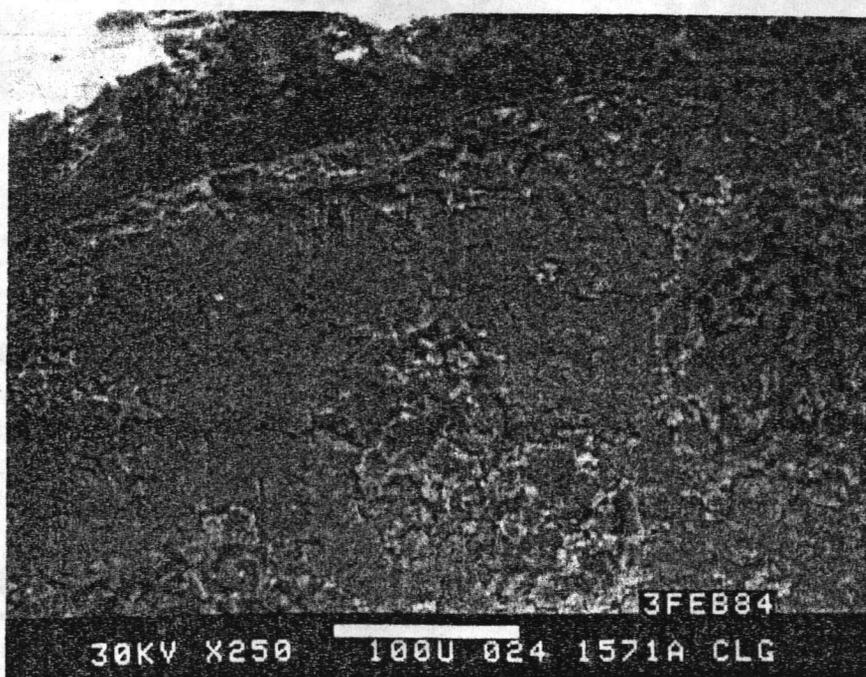
Photo 13 is a view of the top edge of the erosion channel in Photo 12. The deposit metal interface shows an even radius of curvature, thus indicating flow effects. The iron oxide surface on the side wall of the channel shows many fissures and pock marks, both of which I judge to be the results of mechanical damage due to cavitation. The pocks are clearly in a area of reduced pressure (a trailing edge) based on the above observations of bulk flow. Since the expected flow is a steam/water mixture it would follow that any abrupt pressure drop could lead to a rapid sequence of bubble nucleation, and bubble collapse.

PHOTO 13 Closeup Of Photo 12 Showing Details of Pocks and the Interface Between Tube Metal and Surface Deposits

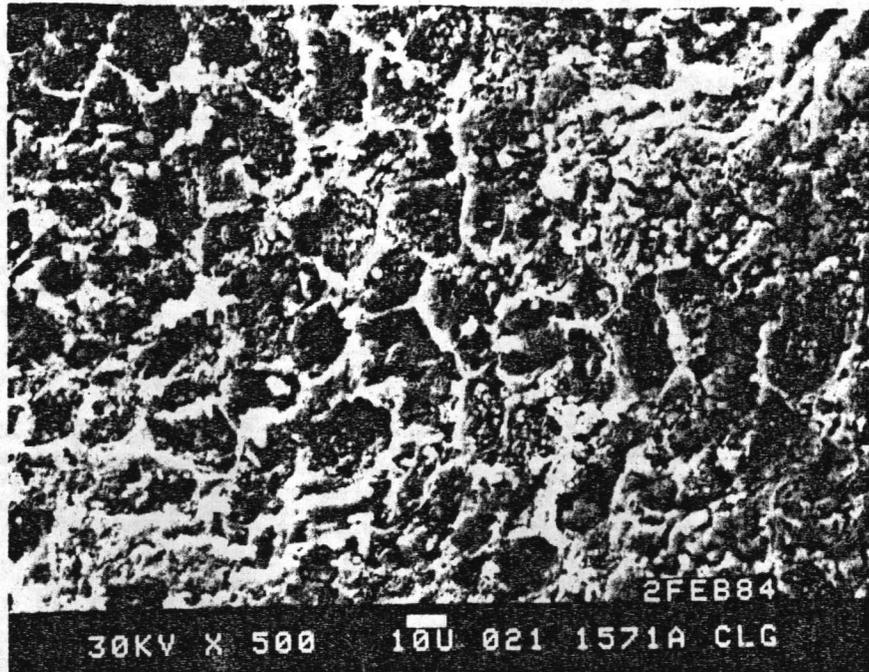
Photos 14 and 15 show close-up views of a pock in the floor of erosion channel shown in Photo 7. Although similar to other areas of freshly eroded areas (i.e., Photos 8, 9, 11, 13). Photo 14 coincidentally shows the remnants of grain boundaries. Grain boundaries are more resistant to mechanical deformation than is the grain interior. Photo 15 is a close-up view of the classical 120° angles formed by the junction of three grains.

PHOTO 14 Closeup Of Secondary Poek In Floor of Primary Erosion Channel; Area Shown At Top, Center of Photo 7

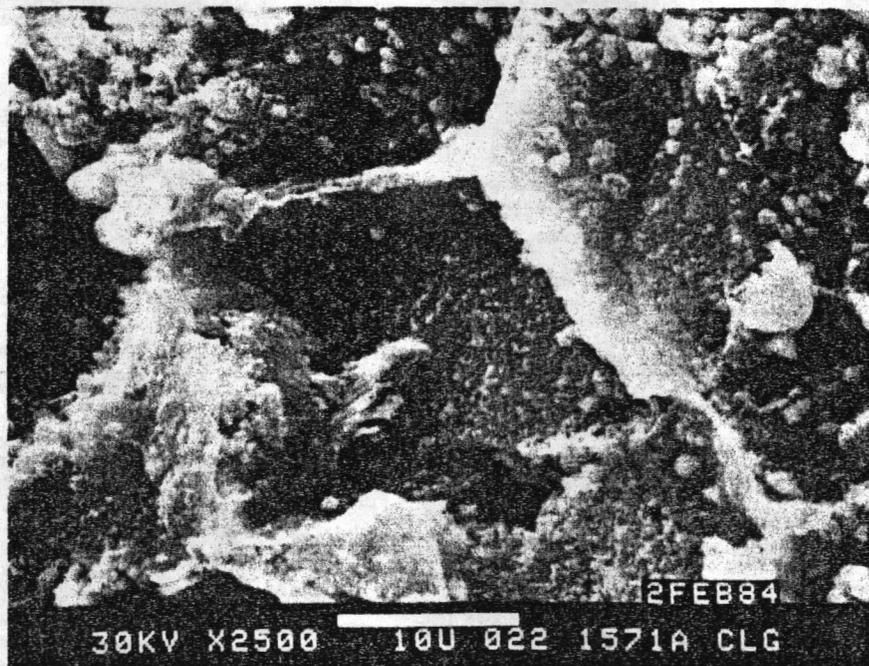
PHOTO 15 Closeup Of Photo 15 Showing Remnants Of Comparatively Hard Grain Boundaries

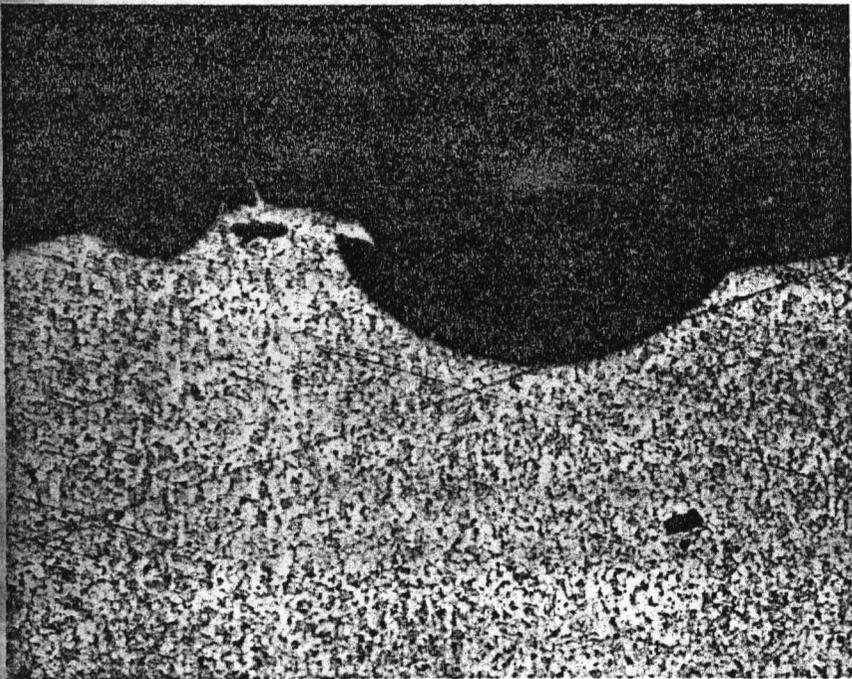
Photos 18 and 19 show the upstream and downstream ends of an erosion channel in Specimen C. The undercut shelf on the upstream side (Photo 18), and the gradual tapering of metal loss combined with redeposition of material (Photo 19) are typical features of the erosion-corrosion process.

PHOTO 18 Segment C Polished Cross Section,
Nital Etch 50X

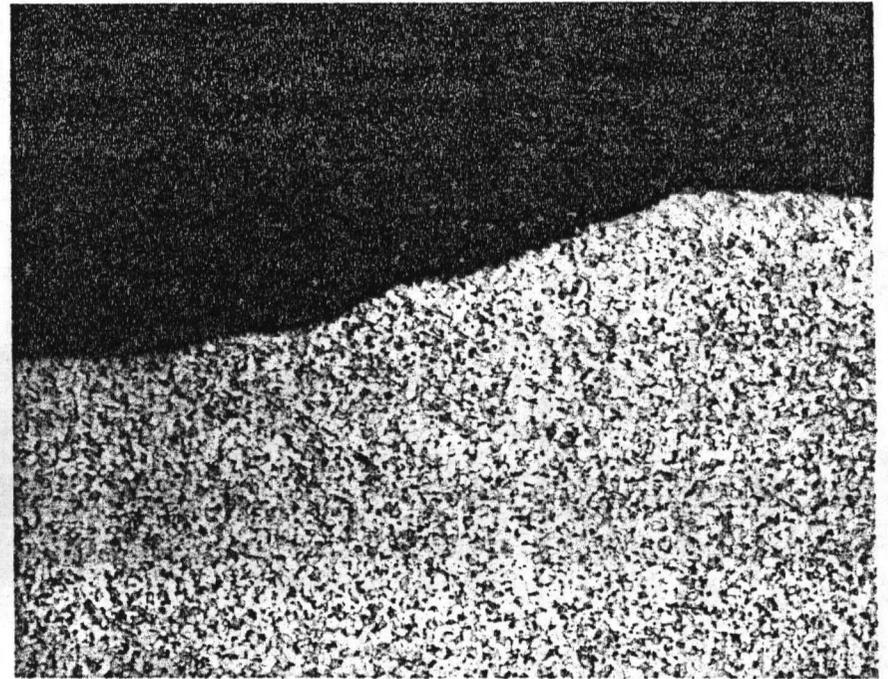
PHOTO 19 Termination Of Erosion Channel Shown In
Photo 21 50X

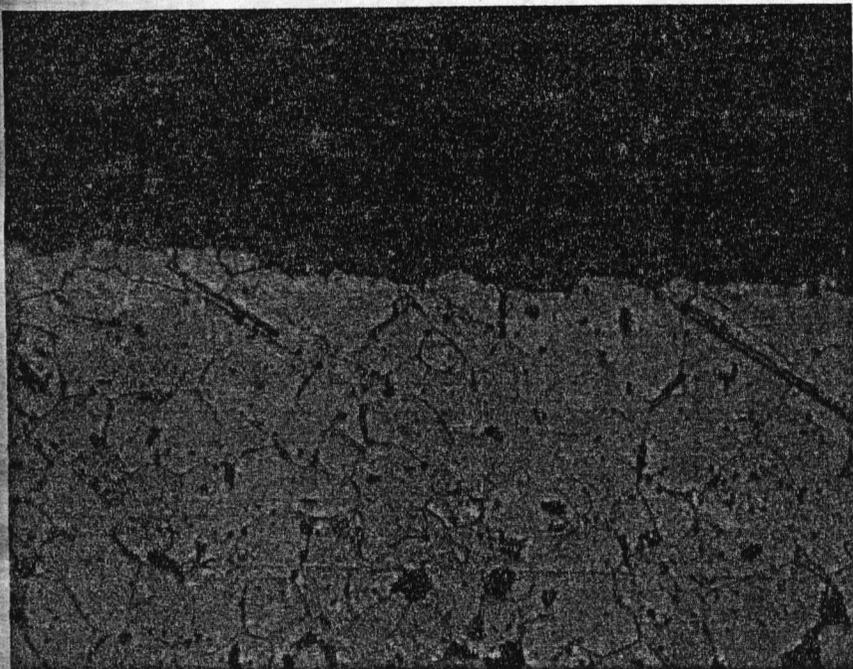
Photos 20 and 21 show the metal/metal oxide interface of non-eroded and eroded surfaces, respectively. The "saw-tooth" periodicity of metal loss evident in Photo 21 is highly indicative of severe turbulence and may be associated with cavitation.

PHOTO 20 500X Closeup Of Non-Eroded Metal Surface

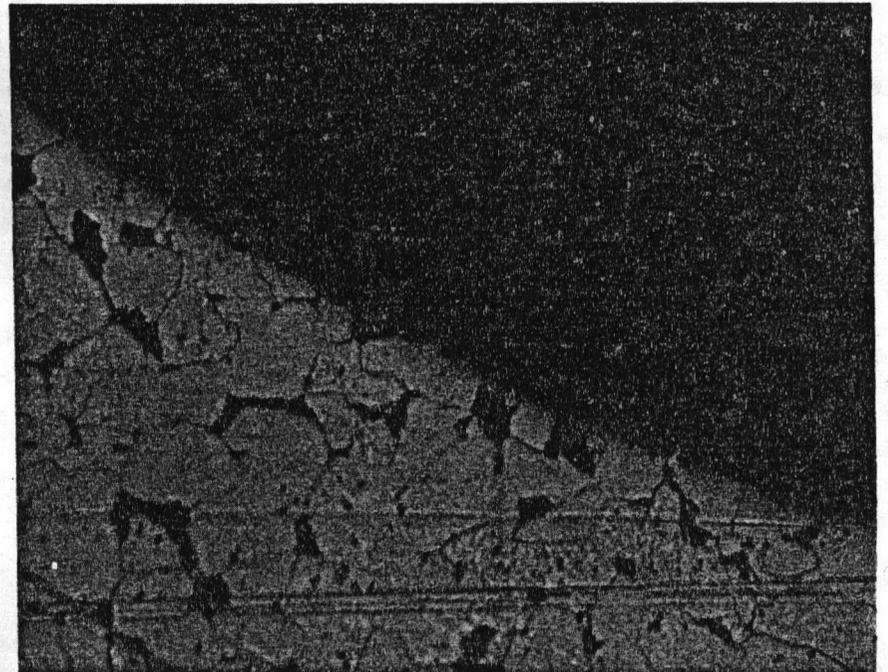
PHOTO 21 500X Closeup Of Eroded Metal Surface

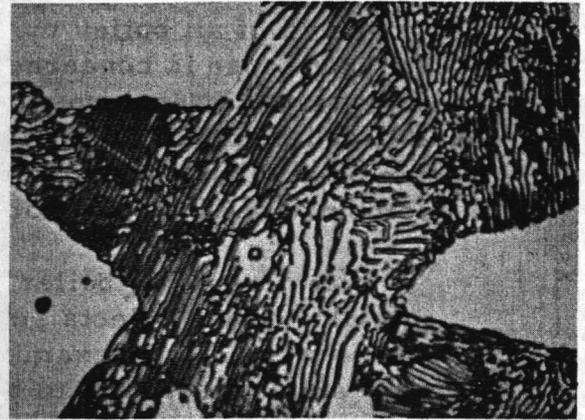
Figure 3 2000X

Low carbon boiler steel with its 0.2% carbon will in the normal condition generally have a structure similar to that shown in Figure 3. The structure is made up of a pattern of light-colored iron grains called ferrite interspersed with dark-colored pearlite (iron and iron carbide). Notice that the pearlite is made up of very fine layers in this normal, lamellar condition. These lamellae or layers of carbide show the first signs of the effect of overheating. At 900° F these layers begin to break down and coalesce into spheres. Evidence of incipient breakdown usually indicates that the metal has been heated to at least 900° F. At higher and higher temperatures the carbides become more and more distinctly spheroidal. When completely so, the metal is said to be spheroidized, and such a structure, illustrated in Figure 4, indicates that temperatures above 1000° F were reached.

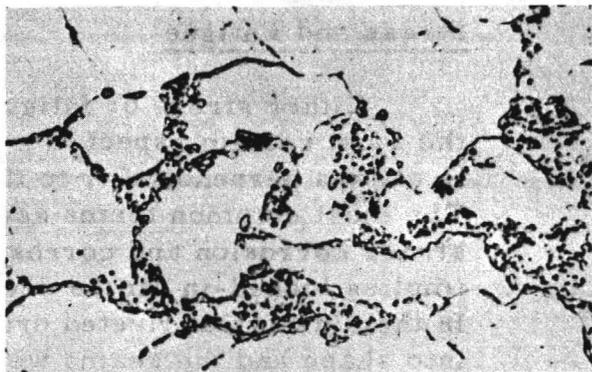
Figure 5

At still higher temperatures, the dense colonies of spheroidized carbides begin to disperse and gradually migrate to the ferrite grain boundaries. Such a structure is shown in Figure 5. This indicates that temperatures near 1200° F had been reached. After the carbides have concentrated at the grain boundaries, they begin to disappear and the metal becomes decarburized. Decarburization occurs at temperatures well above 1300° F. At temperatures of this magnitude intergranular oxide penetration, generally from the outer surface, begins to take place. Such penetration is shown in Figure 6. This metal has practically been burned to a crisp, probably at temperatures as high as 1600° F.

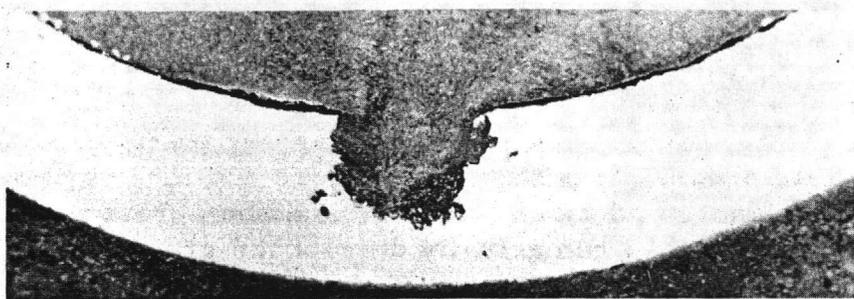
Figure 8

Observe, for example, the tube surface shown in Figure 8. Even the untrained eye might suspect that this is due to acid attack. It has a rough, etched appearance, and the pitting is usually undercut.

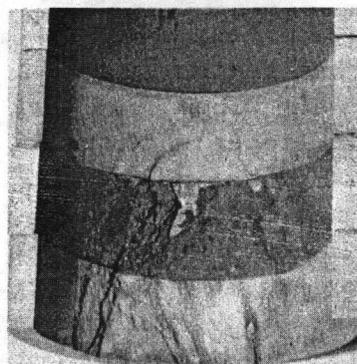
Figure 9

Caustic gouging, on the other hand, leaves the tube wall very smooth, as shown in Figure 9. It may be irregular and bumpy, but generally the surface itself will be smooth. Oxygen pitting also may leave behind a fairly smooth surface, but in this case the pits will be widely separated and a series of distinct pits will be observed.

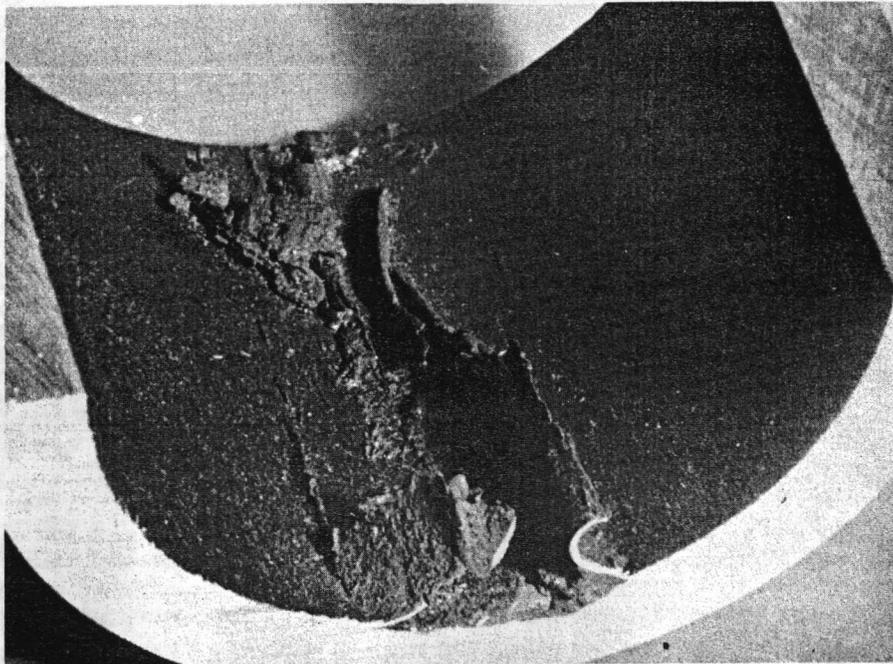
Figure 11

Since we've already introduced rare type failures, let's go one step further and consider failures due to faulty tubes. Surprisingly, perhaps, this is the least frequent cause of failures we come across. All six of the cases we have seen were due to the presence of a "pipe" in the ingot from which the tube was made. The appearance of a failure from this cause is quite characteristic. A portion of the tube wall peels

away from the wall, oftentimes not unlike a layer of paint peeling away from a rain gutter. An example is shown in Figure 11.

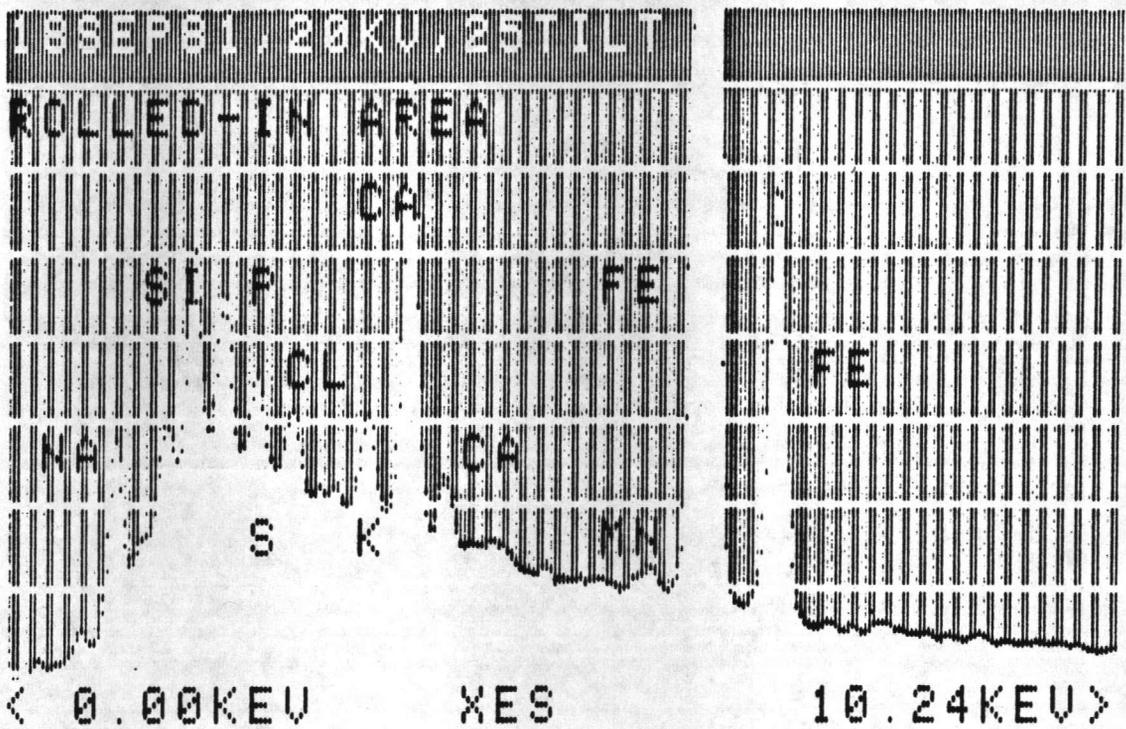
FIGURE 2

X-ray Spectrum for Location A
on Specimen No. 3

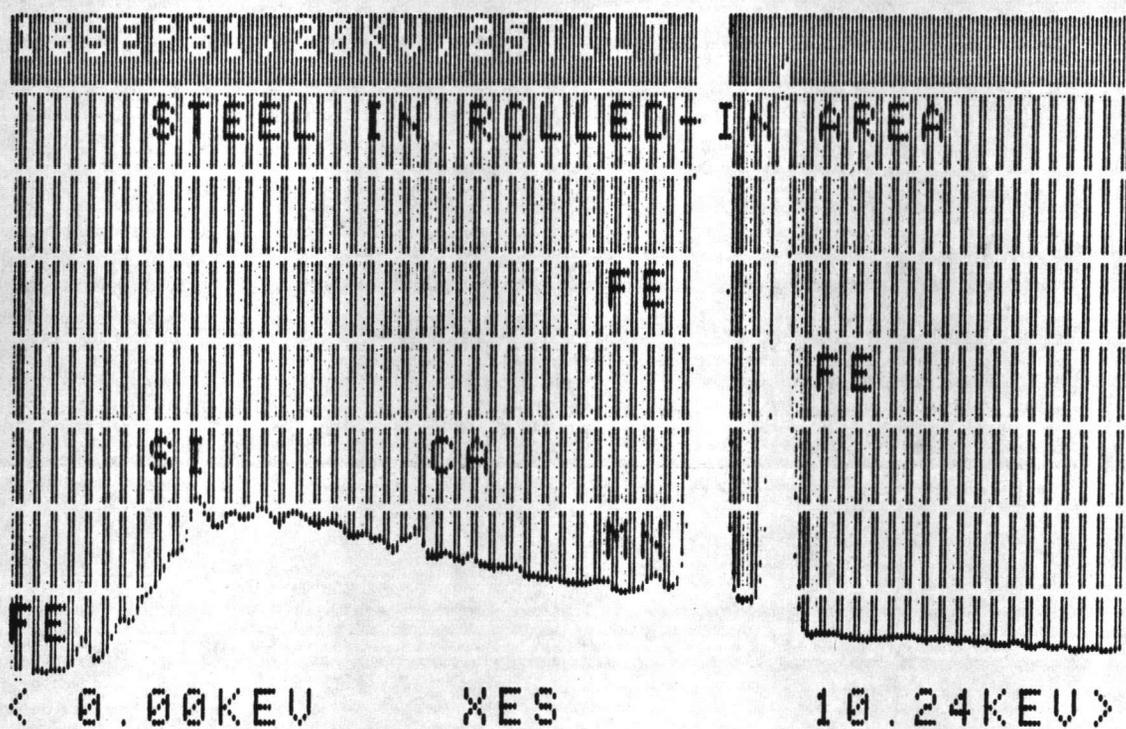
FIGURE 3

X-ray Spectrum for Location A
on Specimen No. 7

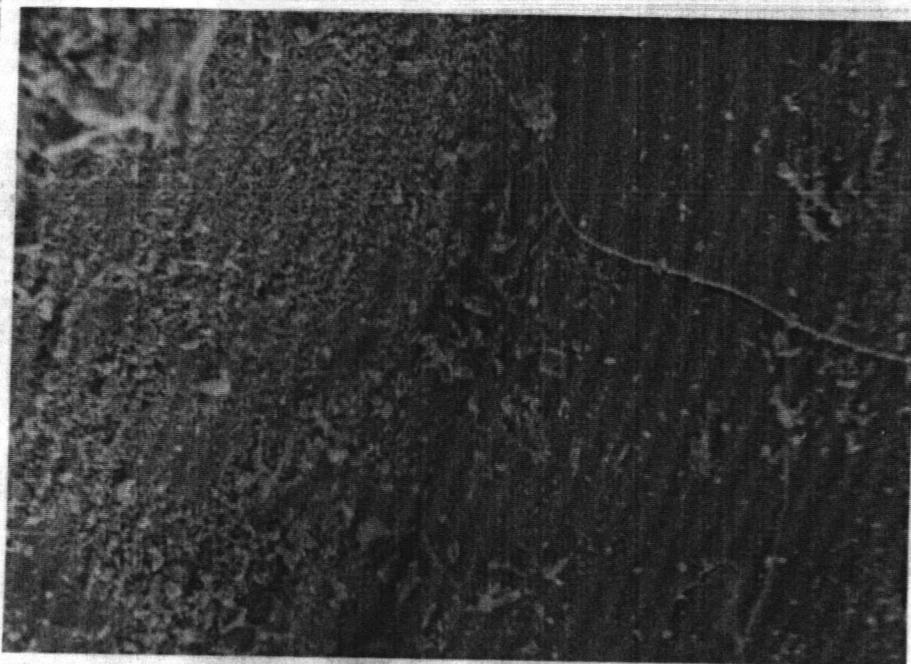
PHOTO 3

Close-up of Deposit/Metal
Interface in Photo 2 (440x)

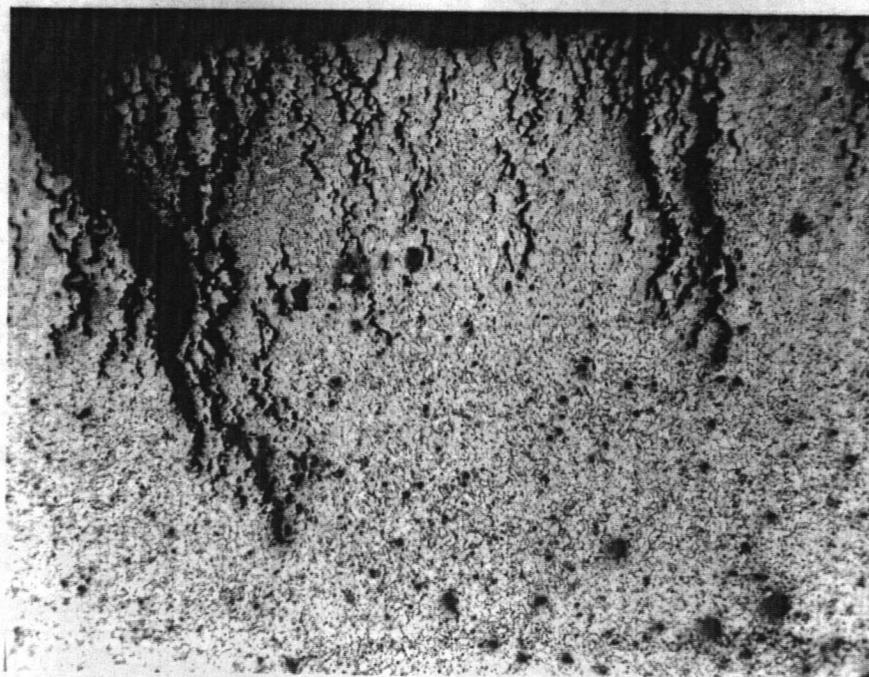
Figure 2

O.D. Cross Section Near Fracture

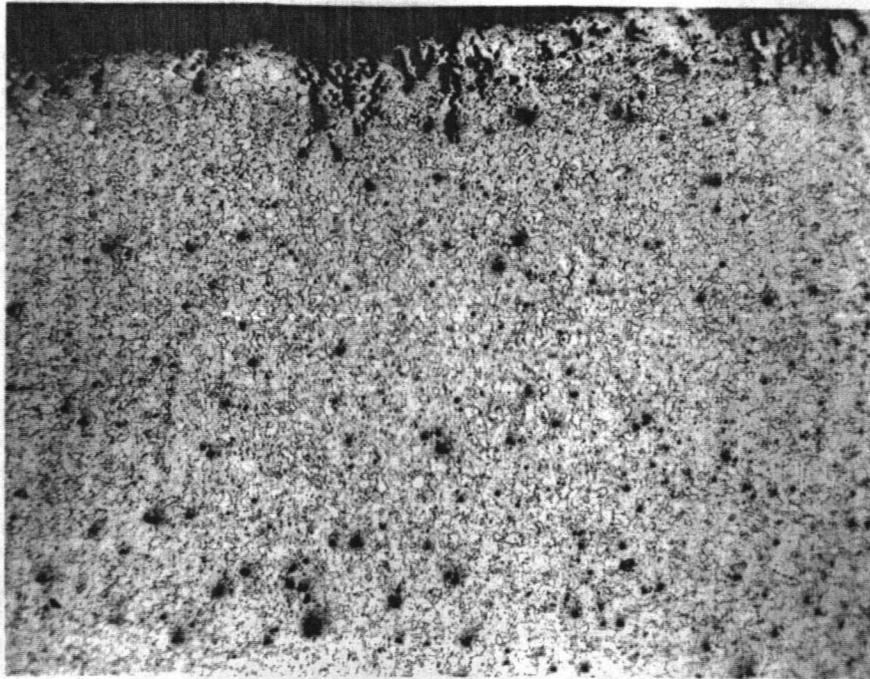
Figure 3

I.D. Cross Section Near Fracture

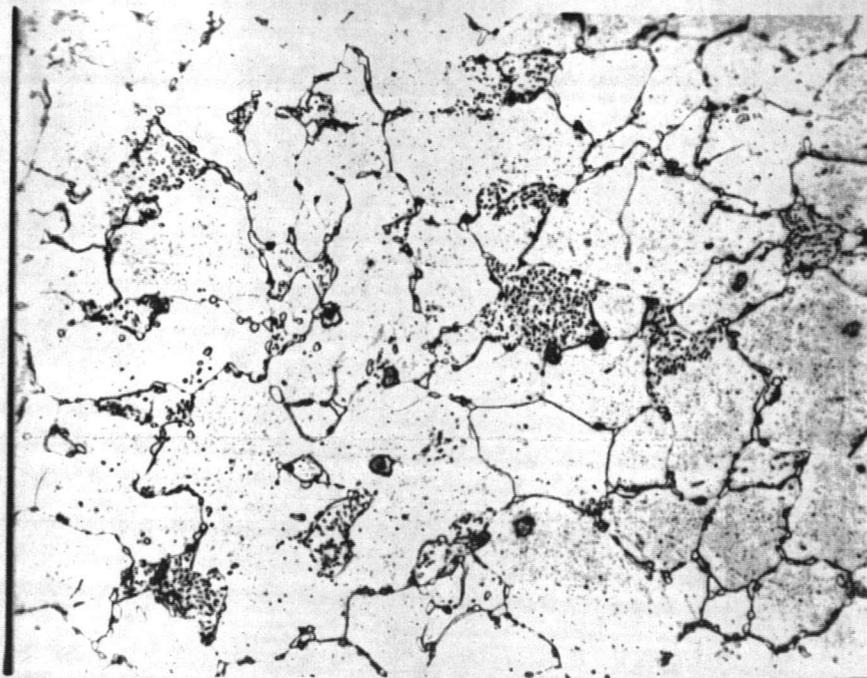
Figure 4

Microstructure in Center of Tube Wall
Near Fracture

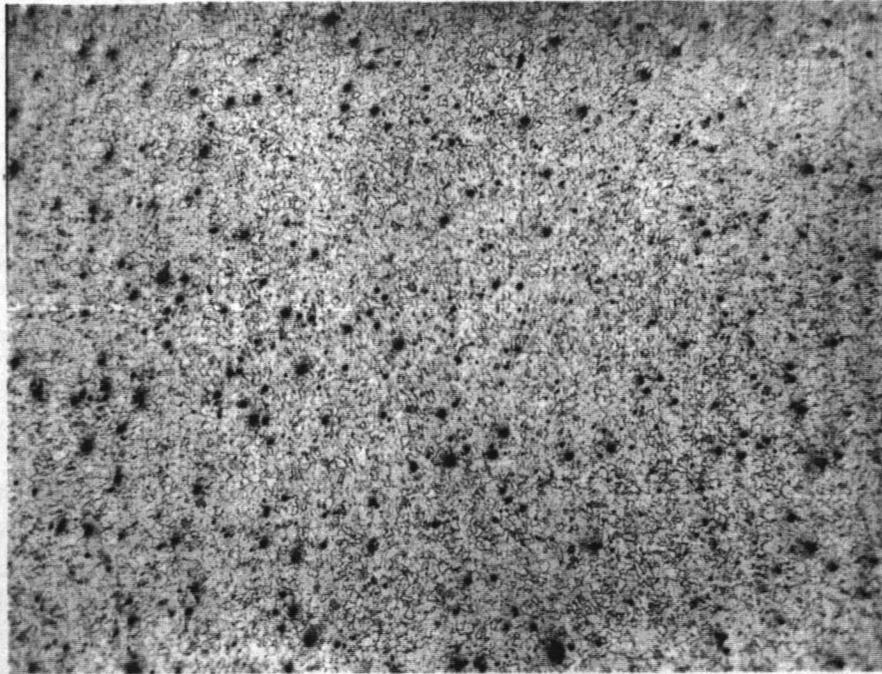
Figure 5

O.D. Cross Section Away From Fracture

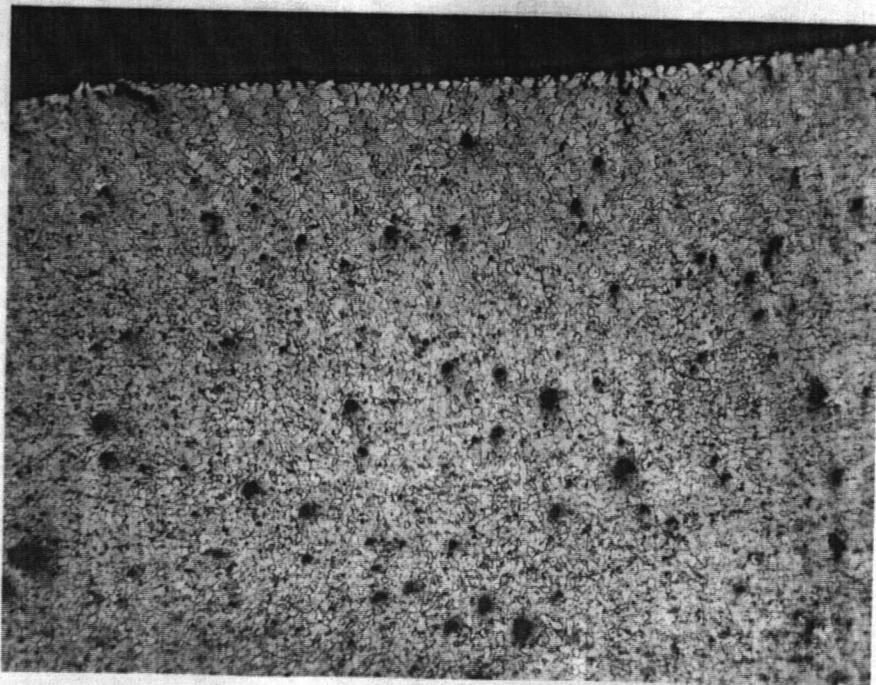
Figure 6

I.D. Cross Section Away From Failure

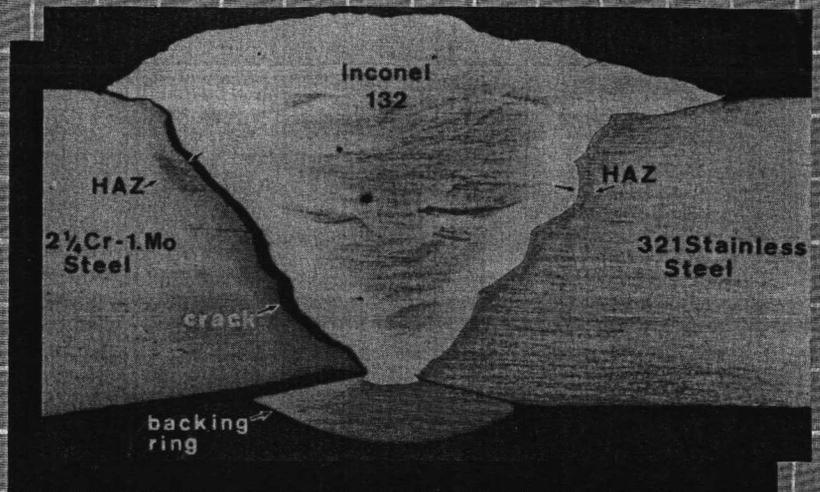
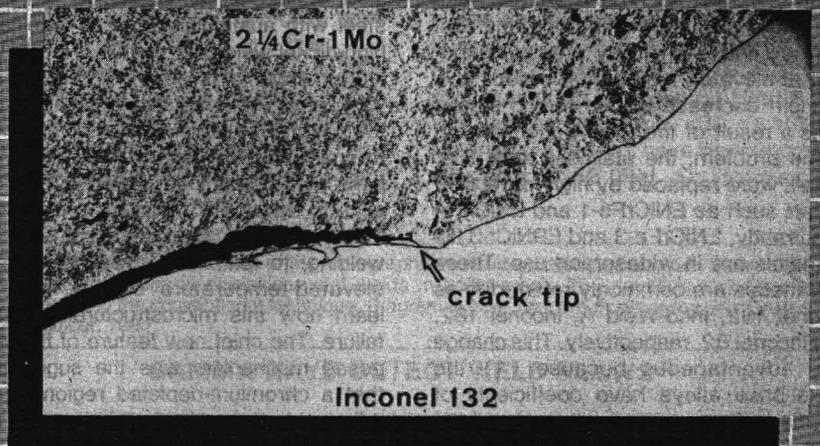
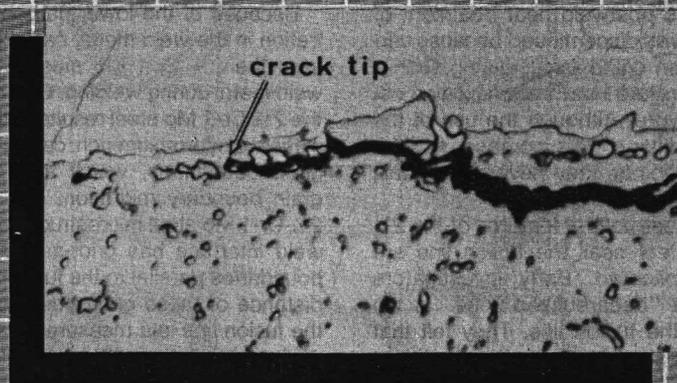
The microstructure of a typical dissimilar-metal weld failure between 2 1/4 Cr-1 Mo steel and type 316 stainless steel steam pipes welded with the high-nickel ENiCrFe-1 (Inconel 132) filler metal that failed after more than 17 years (about 150,000 hours) of service is shown in Figure 1. It is a low-ductility failure that occurred in the 2 1/4 Cr-1 Mo steel near the fusion line (Figure 1b). For all such failures made with high-nickel filler metals, several distinct microstructural features are observed in the 2 1/4 Cr-1 Mo steel near the fusion line. A row of precipitate particles forms in the grain boundaries of the 2 1/4 Cr-1 Mo steel parallel to the fusion line about 10-15 μm from the fusion line (about one grain width) (Figure 1c), and although not found in the microstructure of Figure 1, microvoids occasionally form in conjunction with the grain boundary precipitates. The crack propagates along these grain boundaries parallel to the fusion line.

Figure 1. Photomicrograph of a failed dissimilar-metal weld joint (a) showing a cross section of the joint (magnification 3x), (b) at higher magnification (50x) showing that the crack propagates in the ferritic steel very near the fusion line, and (c) at a still higher magnification (3000x) showing how the crack propagates through a grain boundary that contains carbide precipitates.

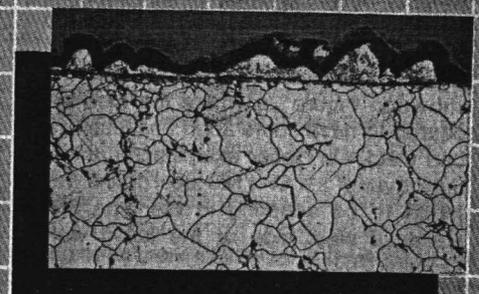
a, b

Figure 2. Photograph of a failed and unfailed induction-pressure weld between Type 347 stainless steel and 2 1/4 Cr-1 Mo steel, and (b) photomicrograph of cross section of fracture surface showing grains of 2 1/4 Cr-1 Mo steel adhering to the type 347 stainless steel (100x). The adhering grains indicate that the crack propagated in the 2 1/4 Cr-1 Mo steel about one grain width from the fusion line.

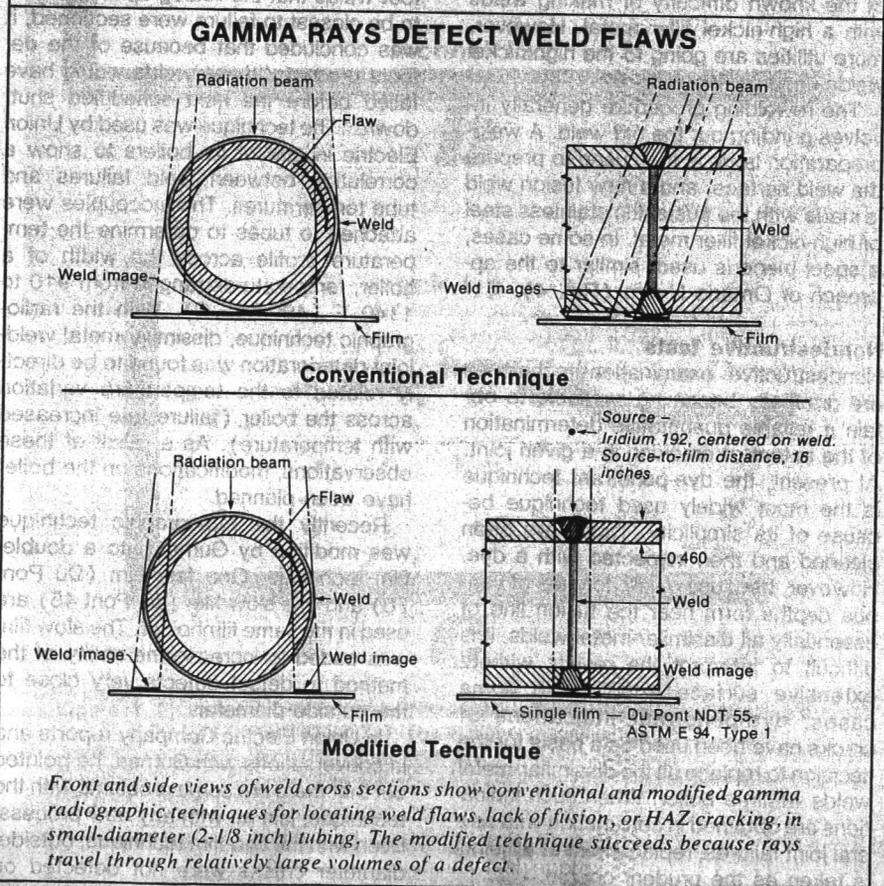
Figure 3. Schematic diagram of the radiographic technique developed at Union Electric Co. for detecting flaws in dissimilar-metal welds in boiler tubes. The modified technique is compared to the conventional technique. Diagram is from *Welding Engineering and Design*, September 1981.

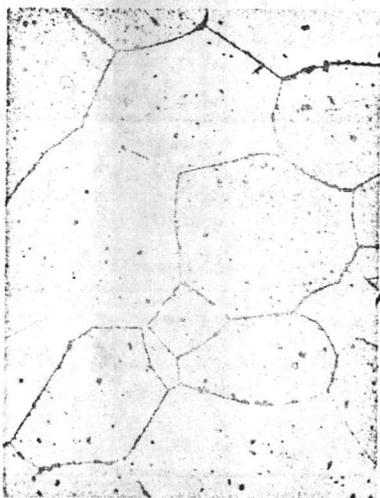
Figure 3

DECARBURIZATION

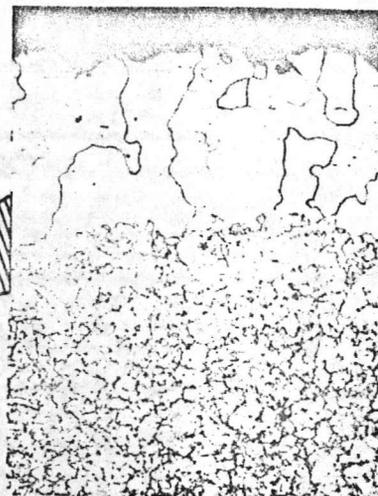
Figure 4

GRAIN GROWTH

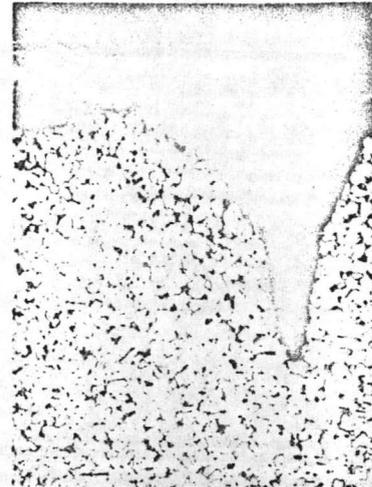
Figure 7 shows a corrosion fatigue crack. This condition occurs under repeated cyclic stress, where the normal protective oxide on the steel surface is repeatedly broken and reformed at the expense of the metal. The resultant progressive cracking, primarily across the grains, leads to ultimate failure of the steel. Heating is not a primary factor in corrosion fatigue cracking, but will accelerate failure.

CORROSION FATIGUE

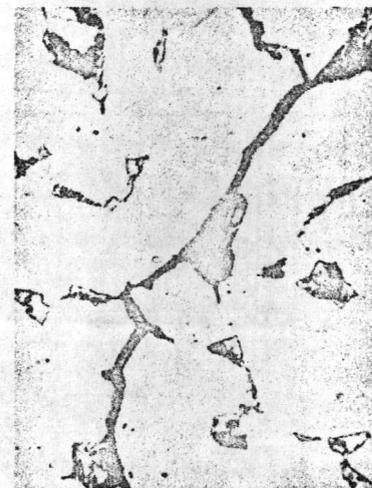
Figure 8 shows caustic cracking. It occurs in the grain boundaries and originates at a surface. The cracks are always continuous. The following four conditions must be present to cause caustic cracking of steel.

CAUSTIC CRACKING
