SUBJECT: Metallographic Report

Attached is our laboratory report of the metallographic examination of a failed tube from the No. 1 Power Recovery Boiler. This failure was detected on June 3 at a point near the mud drum in the bottom row of tubes entering the drum on the side away from the furnace (the cooler side). The actual failure was in the shape of a "V" approximately 3/16" diameter on the inside surface of the tube culminating in the pinhole on the outside surface. Just adjacent to this V-shaped hole was a heavy layer of what appeared to be pure copper approximately 3/8" diameter and 0.025" in thickness. The top and the bottom of the tube were not indicated, but there was a slightly acid attacked channel area which we assumed to be the bottom of this nearly horizontal swaged tube. The copper plated area and the pinhole failure are located in approximately the 7 o'clock position relative to this acid damaged area. Further, it should be noted that the pinhole failure is in the transition zone of the swaged tube.

SUBJECT: Failed Boiler Tube
Lab #D7592

TO E. K. Lederach
FROM F. H. Seels
SUBJECT Procter & Gamble, Ivorydale Plant
No. 4 Boiler, Crossover Tube Corrosion

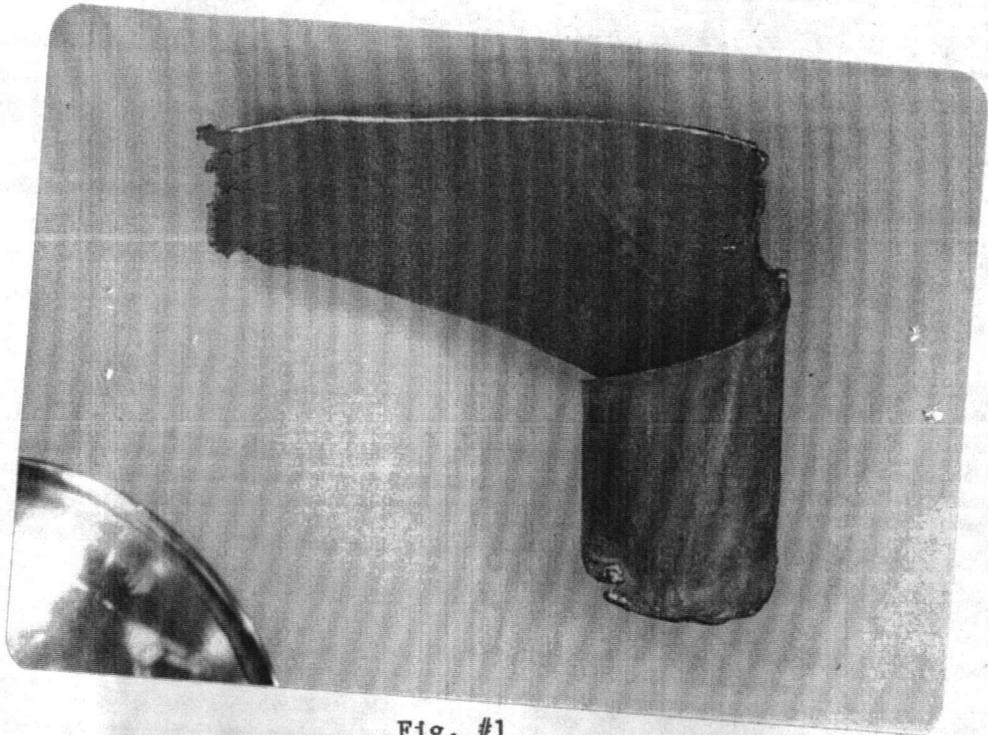
Fig. #1

The failure, which consisted of a thick edged wide open burst, (Fig. #1) was located in an area where the inside wall surface of the tube was severely pitted. (Fig. #2) Several other short shallow cracks were located adjacent to the edge of the primary failure.

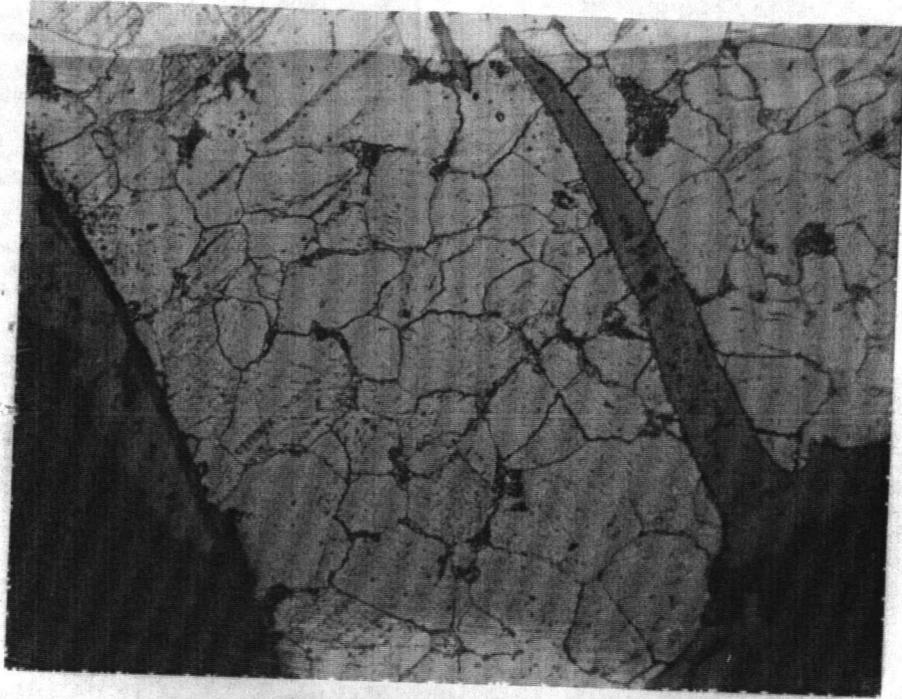
The cracks were blunt, transgranular and originated on the inside wall surface. (Fig. #3)

The grain structure adjacent to the edge of the failure did not show evidence of plastic deformation (grain elongation). (Figs. #3 & #4)

It appears that a combination of corrosion and fatigue were the causes of failure as evidenced by the severe pitting on the inside wall surface and the blunt transgranular cracks. The lack of plastic deformation along the failed edge indicated that creep had not occurred.

Fig. #3 Grain structure adjacent to the inside wall surface near edge of failure. 360X

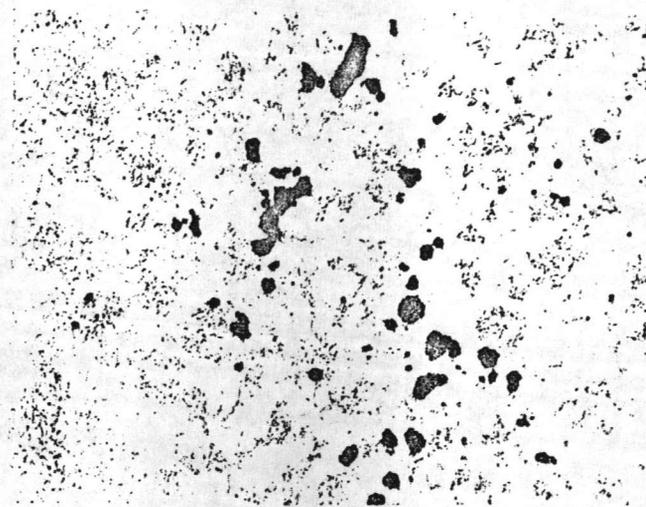
Fig. 2—Photomicrograph of the graphitized zone in the cracked valve material shown in Fig. 1. Heat-affected zone on left; base metal on right (500X)

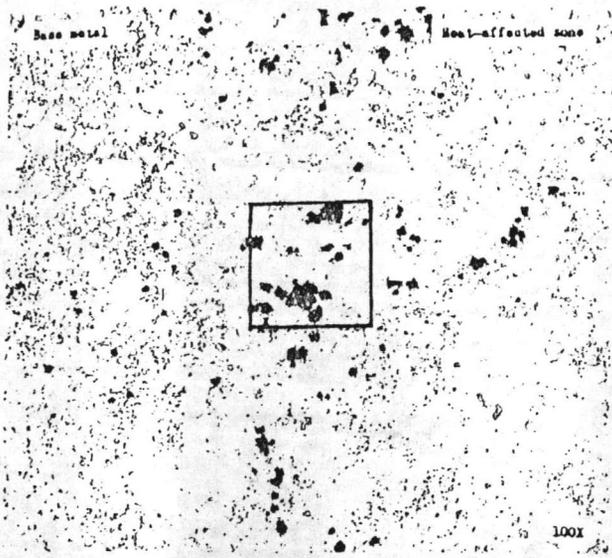
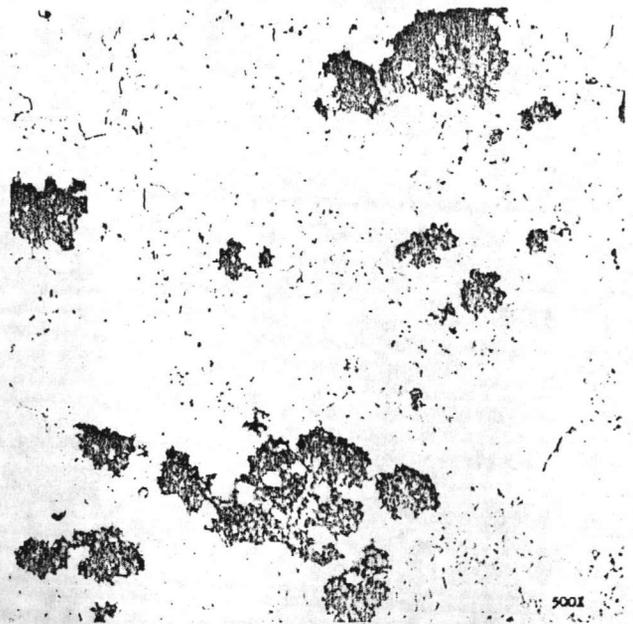
(d) "Heavy" graphitization.

Graphite Observed in Microstructure	Bend Angle
Mild	Over 90°
Moderate	45-90°
Heavy	30-45°
Severe	15-30°
Extremely severe (dangerous)	Below 15°
