PROVIDE AND INSTALL CONDENSATE POLISHERS FOR

BLDG G650 CAMP GEIGER HEATING PLANT

Project is located at bldg G650 Heating Plant. Project is to provide and install two condensate polishers.

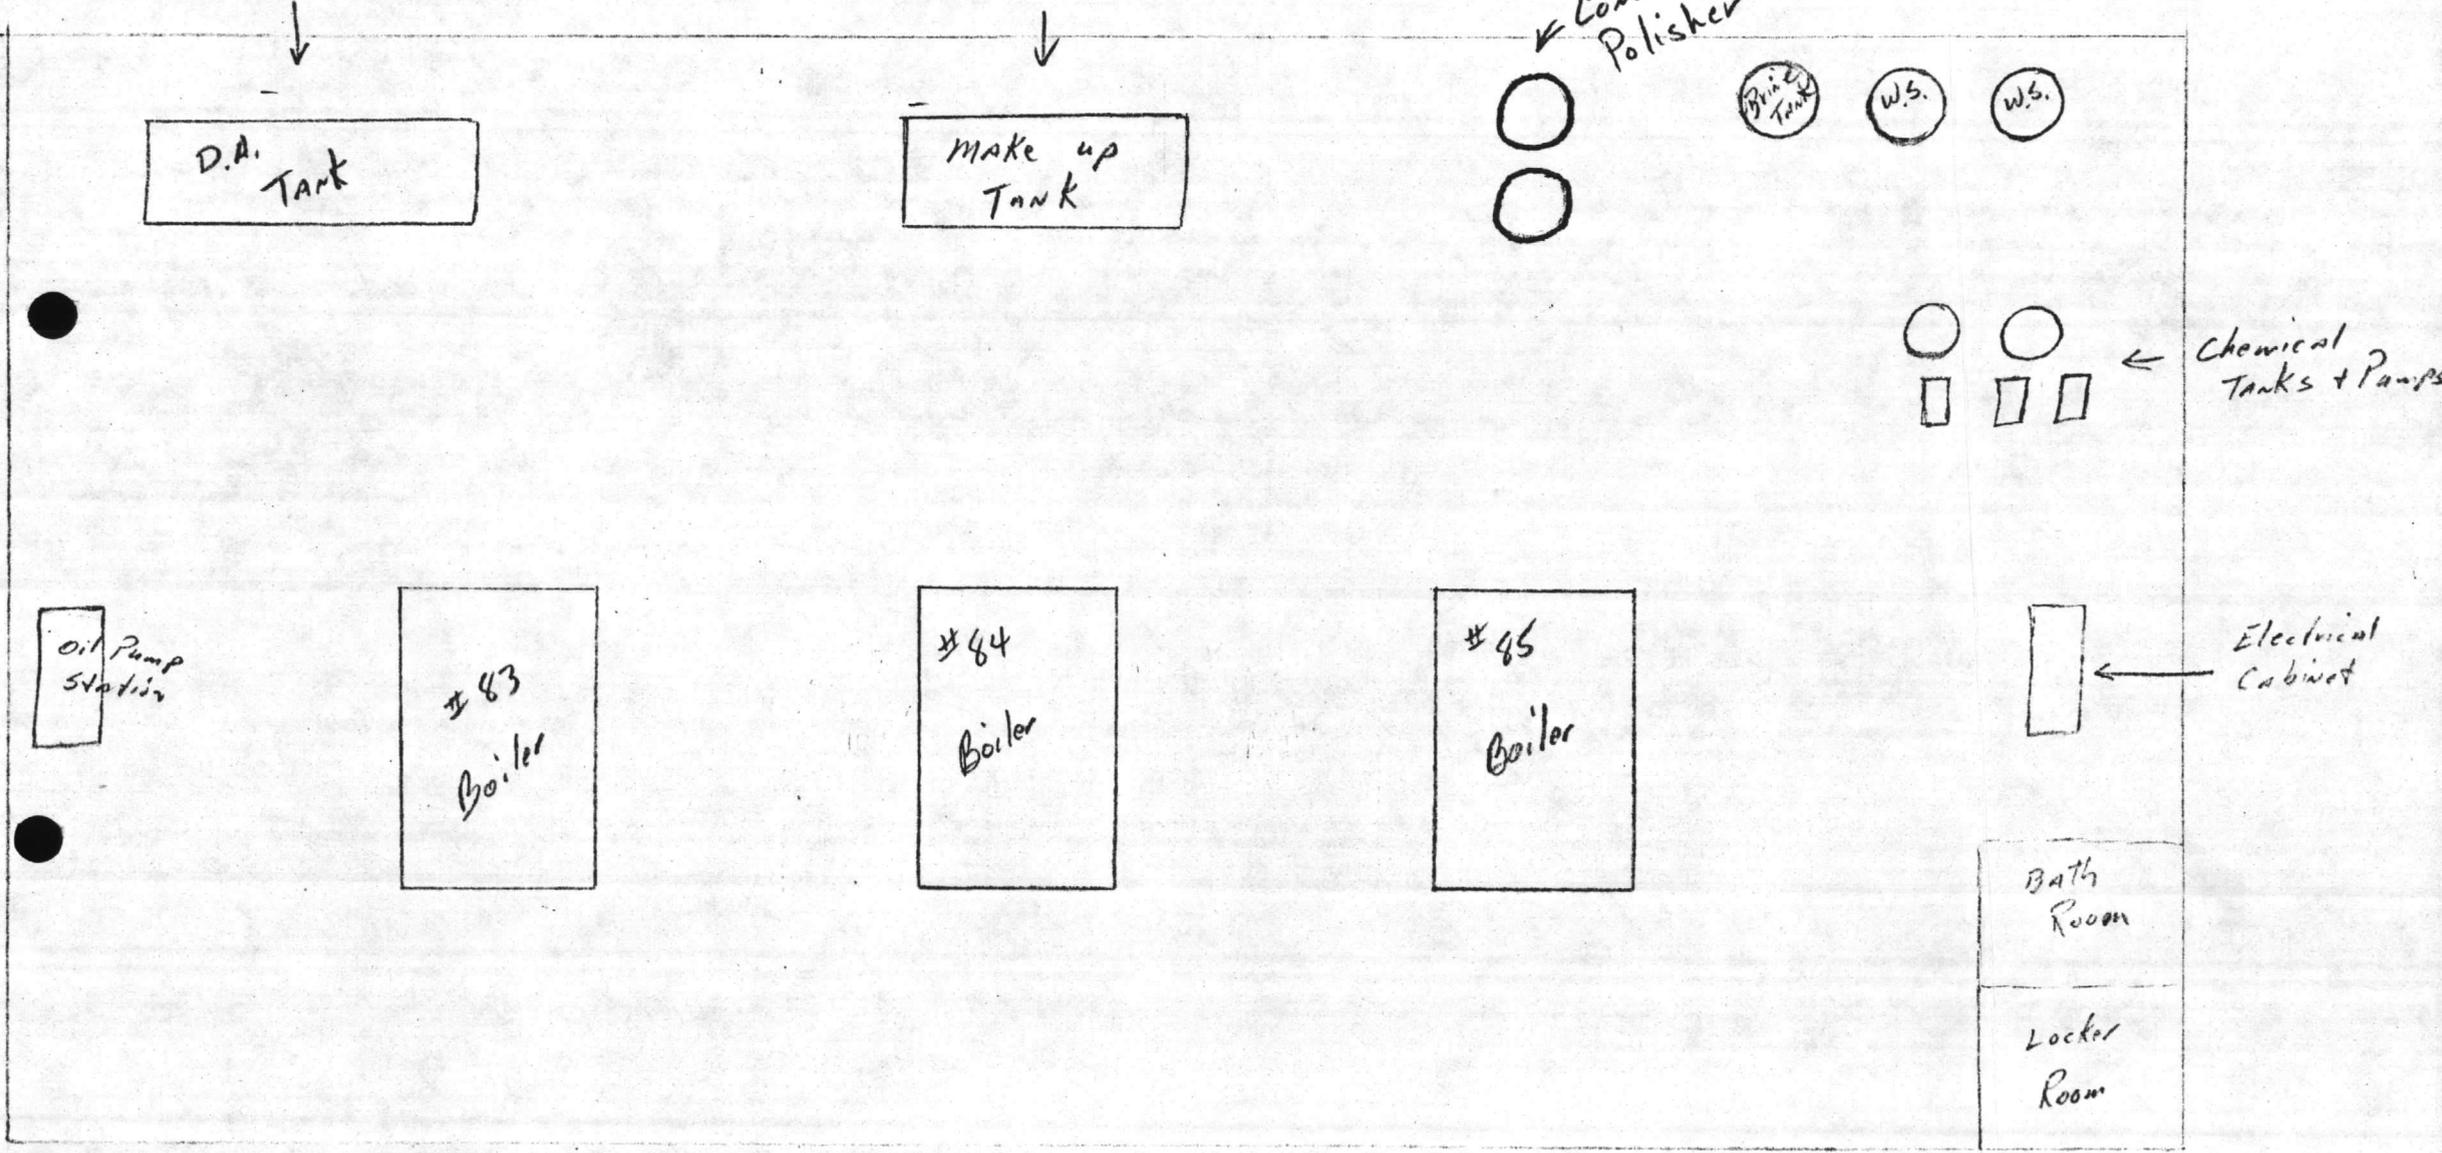
G 650

Justification: Condensate polishers are needed to filter out iron rust picked up in condensate return line and brought back to boiler plant. This iron is baking out in boiler drums and tubes requiring more use of chemicals to maintain on line treatment and also more maintenance of the water side to get boiler ready for certification. This accumulation of iron rust in the boiler causes heat loss and lower efficiency.

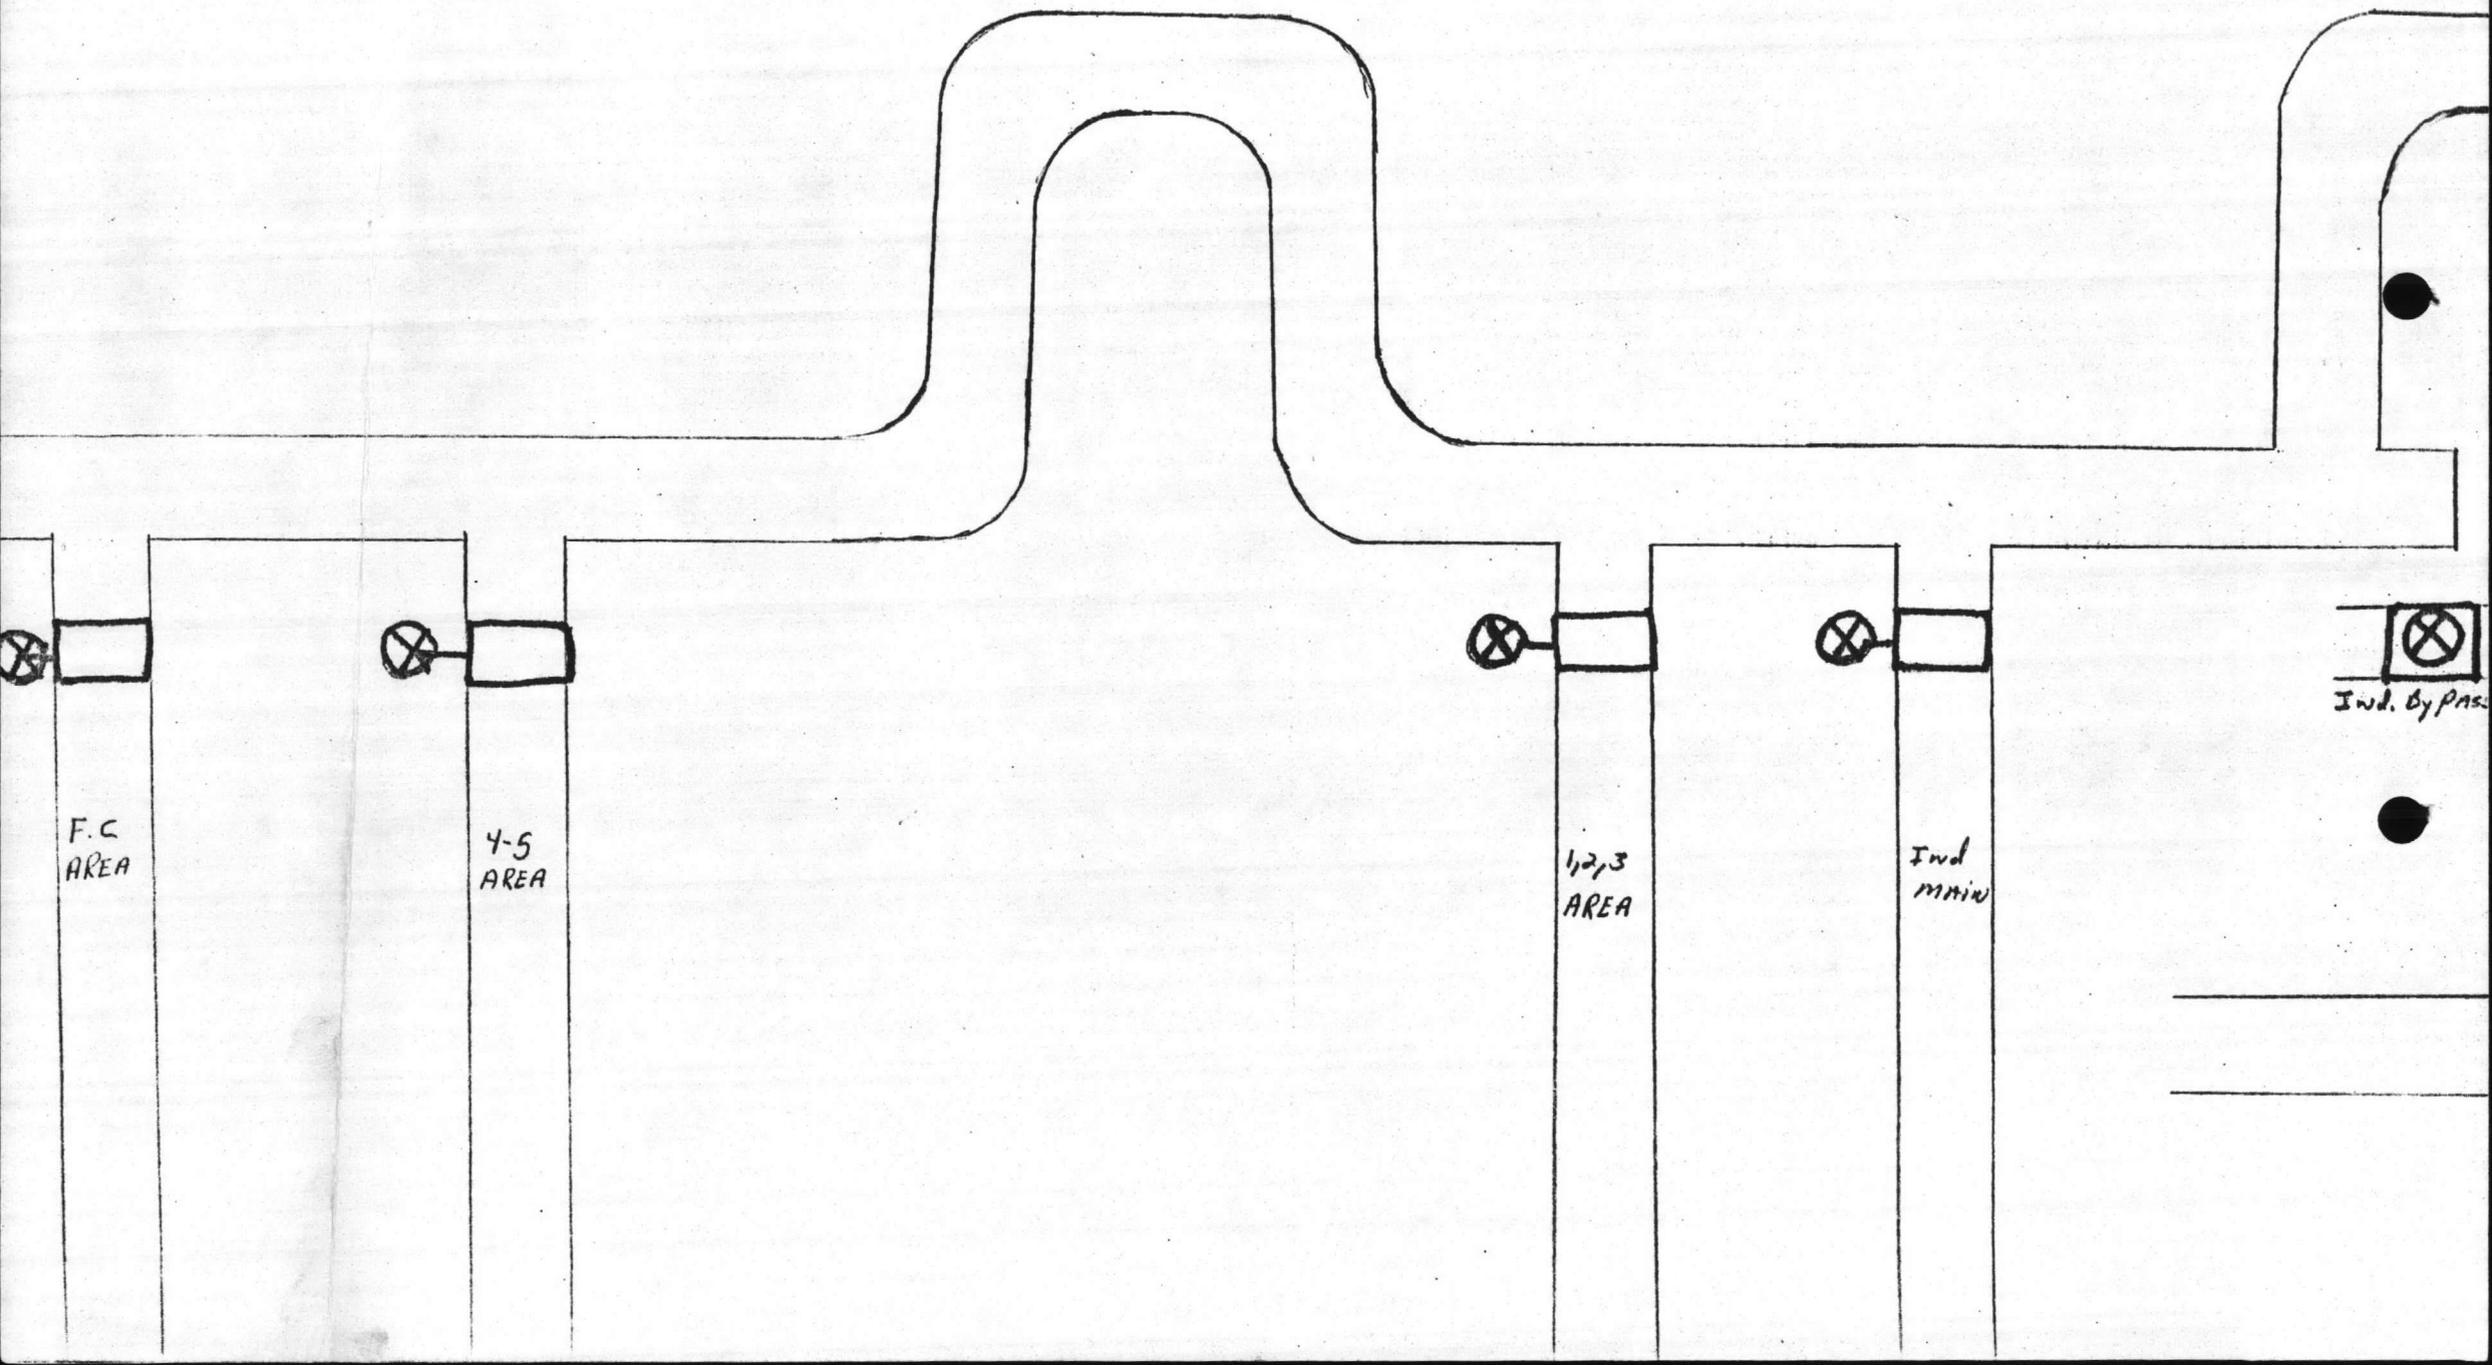
#1 Main Steam Header Bldg. 1700

Justification: Motorized or hydraulic valves are needed on the five area valves in order to maintain steam pressure in plant during power failures, sudden surges in load demands due to cutting lines in or out, water in steam tunnels, possible line eruptions in the areas and emergencies which might occur within the plant. There are three men on operations at this plant and during the situation listed, there is not enough personnel to take care of the boilers and man these valves at the same time.

Project is located at Bldg 1700 Heating Plant. Project is to replace five Area Stop Valves with Motorized Valves, areas 1, 2, 3, 4 and 5 - French Creek Area, Industrial Area and Industrial Area Bypass.

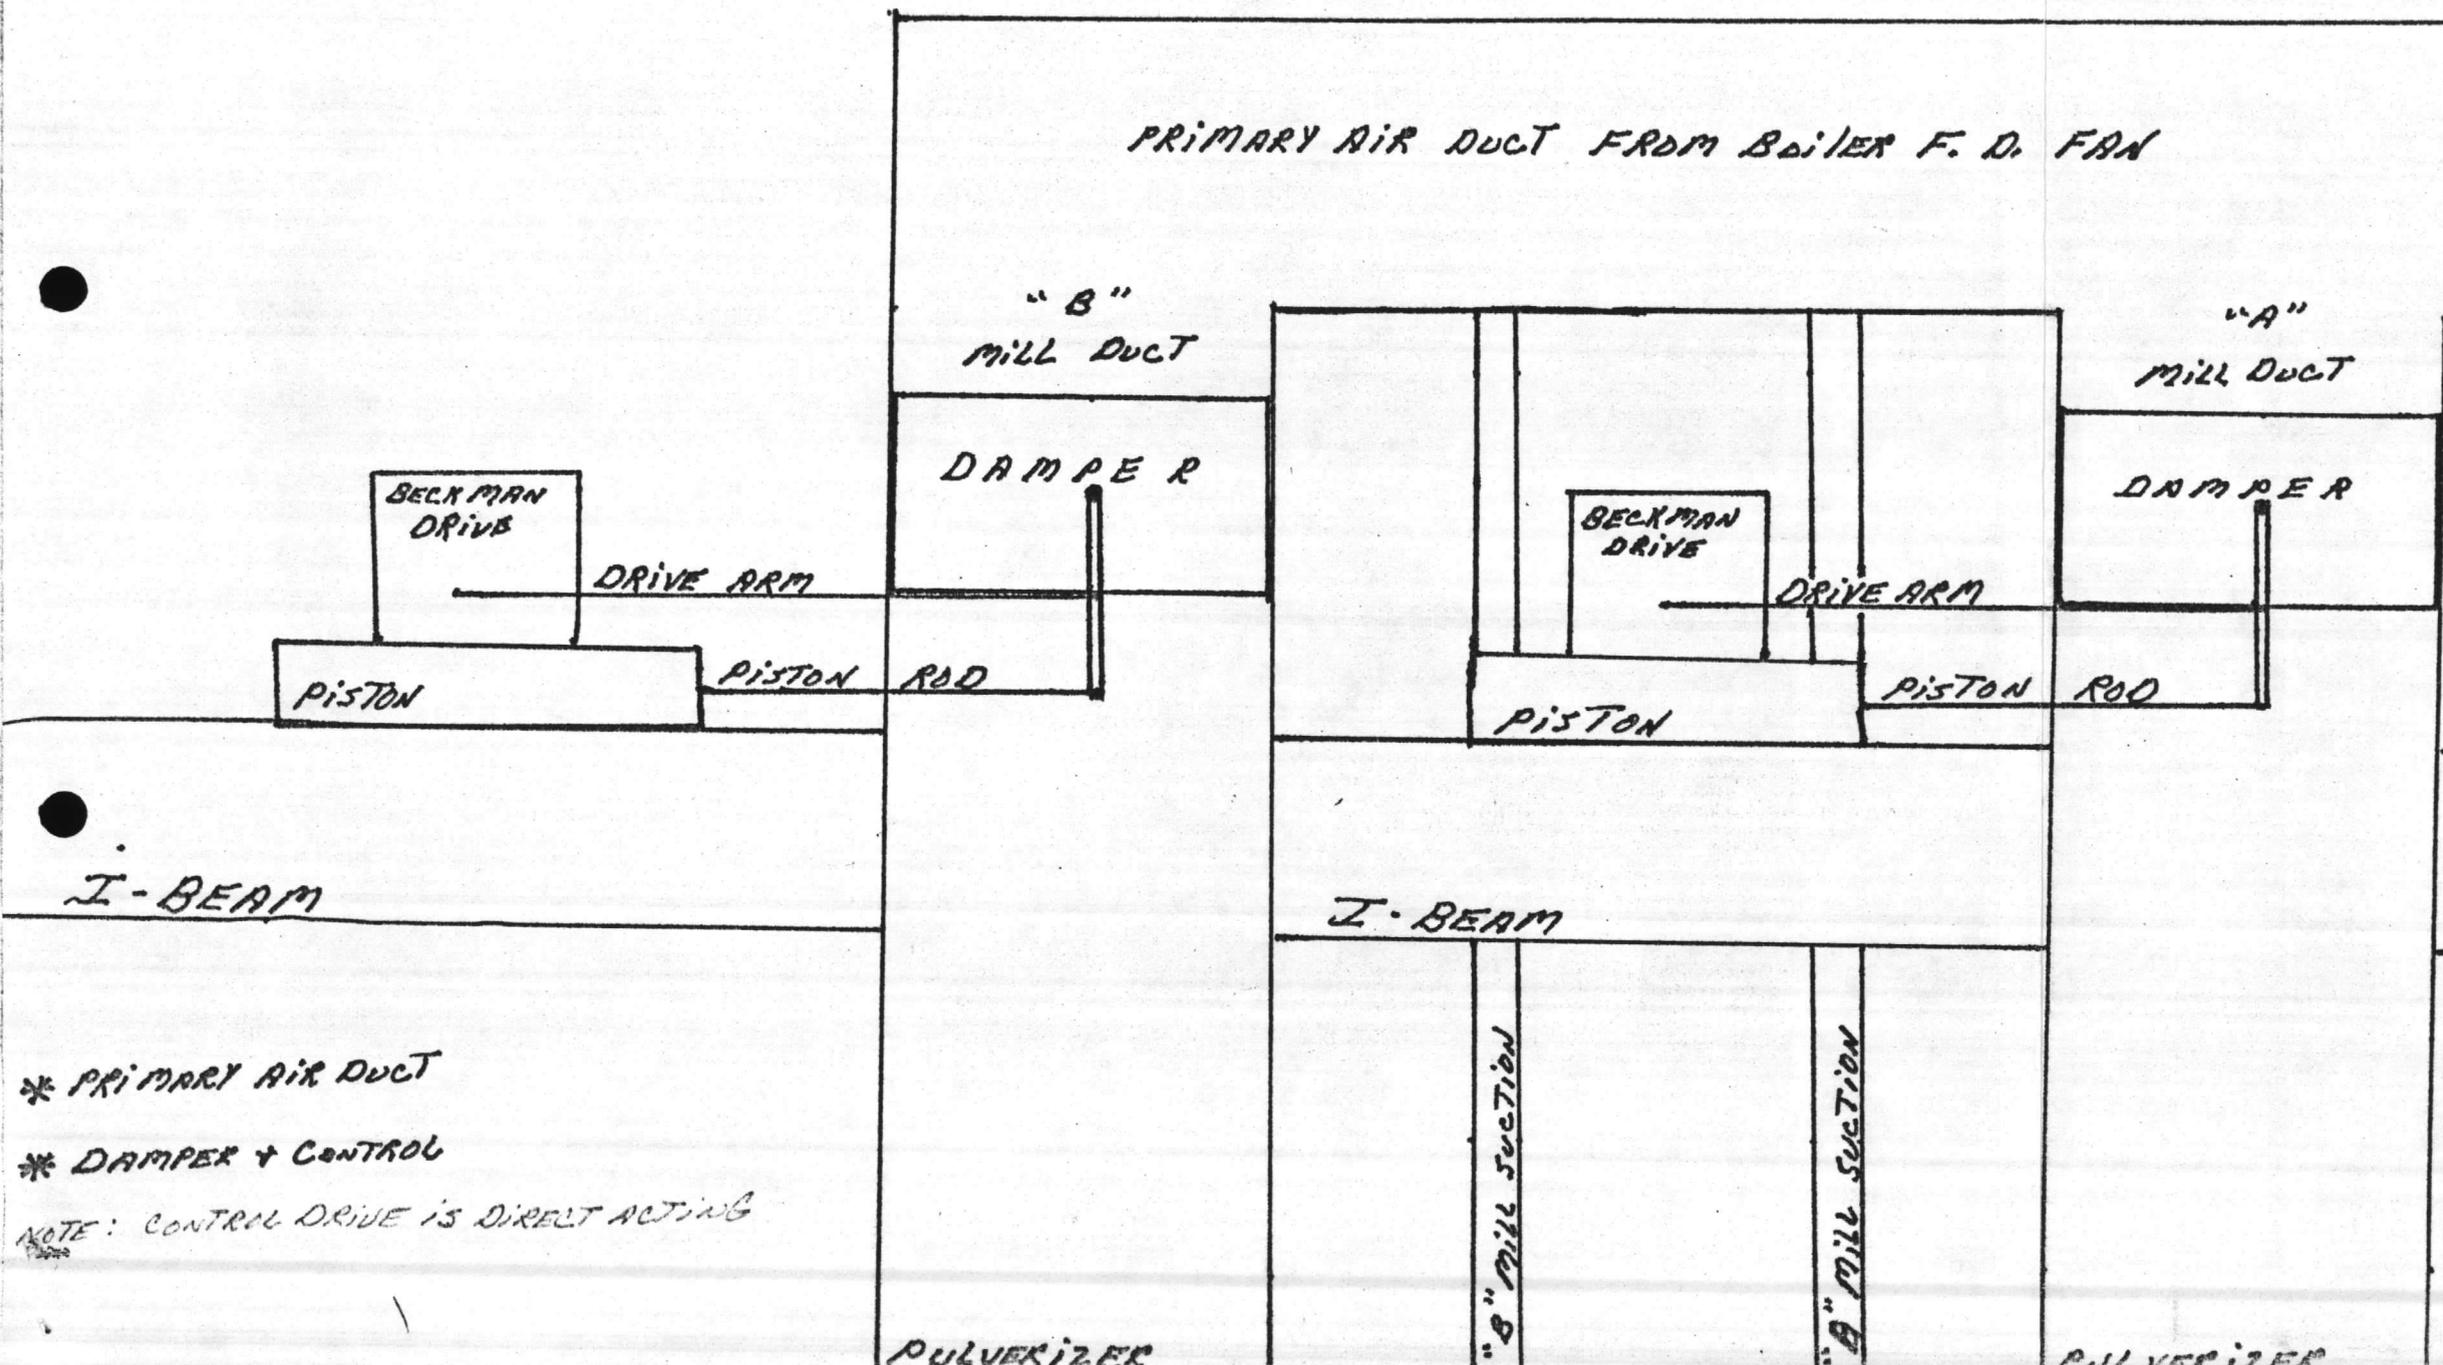
BOTTOM VIEW

Justification: These chutes have worn holes in them and have been patched. They are worn thin enough that it is not feasible to weld. The dampers are worn to the extent they will not close off the primary air when firing on oil, causing the coal in the above chute to overheat and catch on fire. This also hampers the proper amount of primary air being submitted to the pulverizer for good combustion. The drivers for these dampers are obsolete and parts are not available. They were once operated by water and have been changed to air. These cylinders are worn to the extent they are leaking causing dampers to be sluggish and often hand in one position.

Project is located at Bldg 1700 Central Heating Plant Hadnot Point. Project is to replace eight inlet coal chutes, sixteen discharge coal chutes, eight primary air dampers and eight damper drivers.

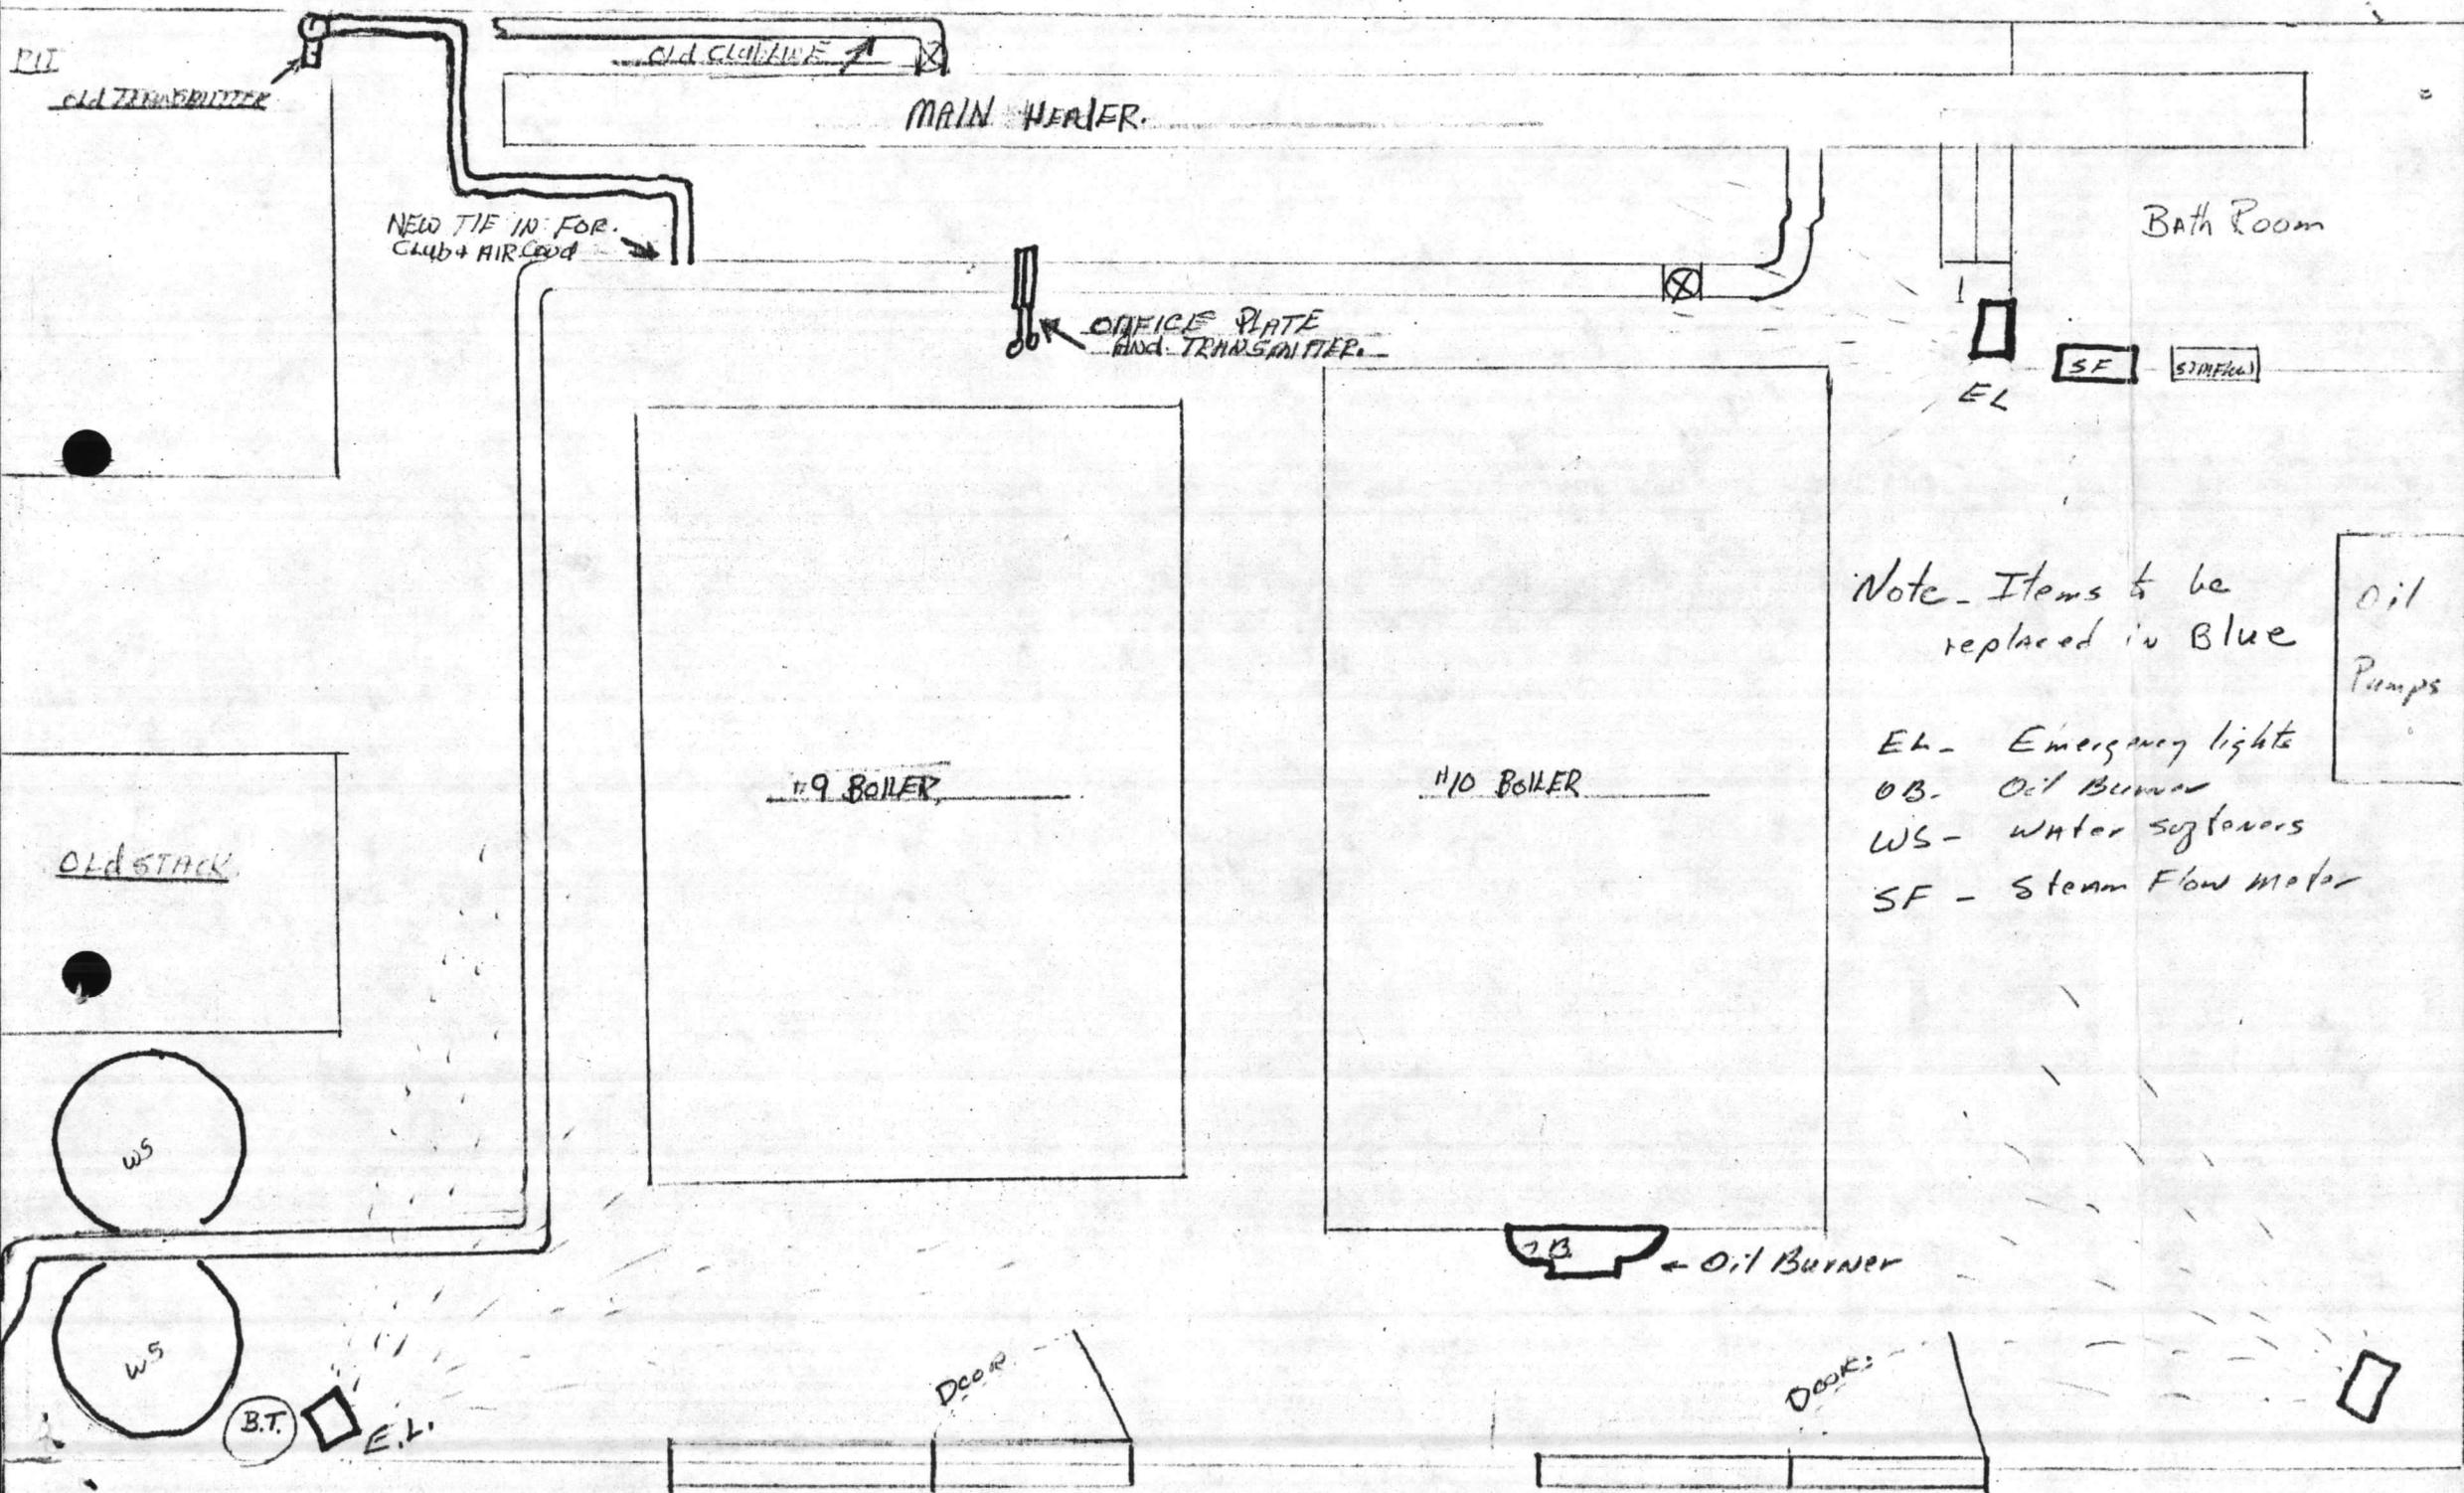
Justification: Tanks are corroded and have thin spots in walls. Multiport valves are corroded and pitted to the extent the valves will not seat properly. These softeners are manually operated and due to the upcoming unmanning of plants, automatic softeners will be essential to operation.

Project is located at Bldg 2615 Heating Plant. Project is to provide two water softeners.

Note - Items to be replaced in Blue

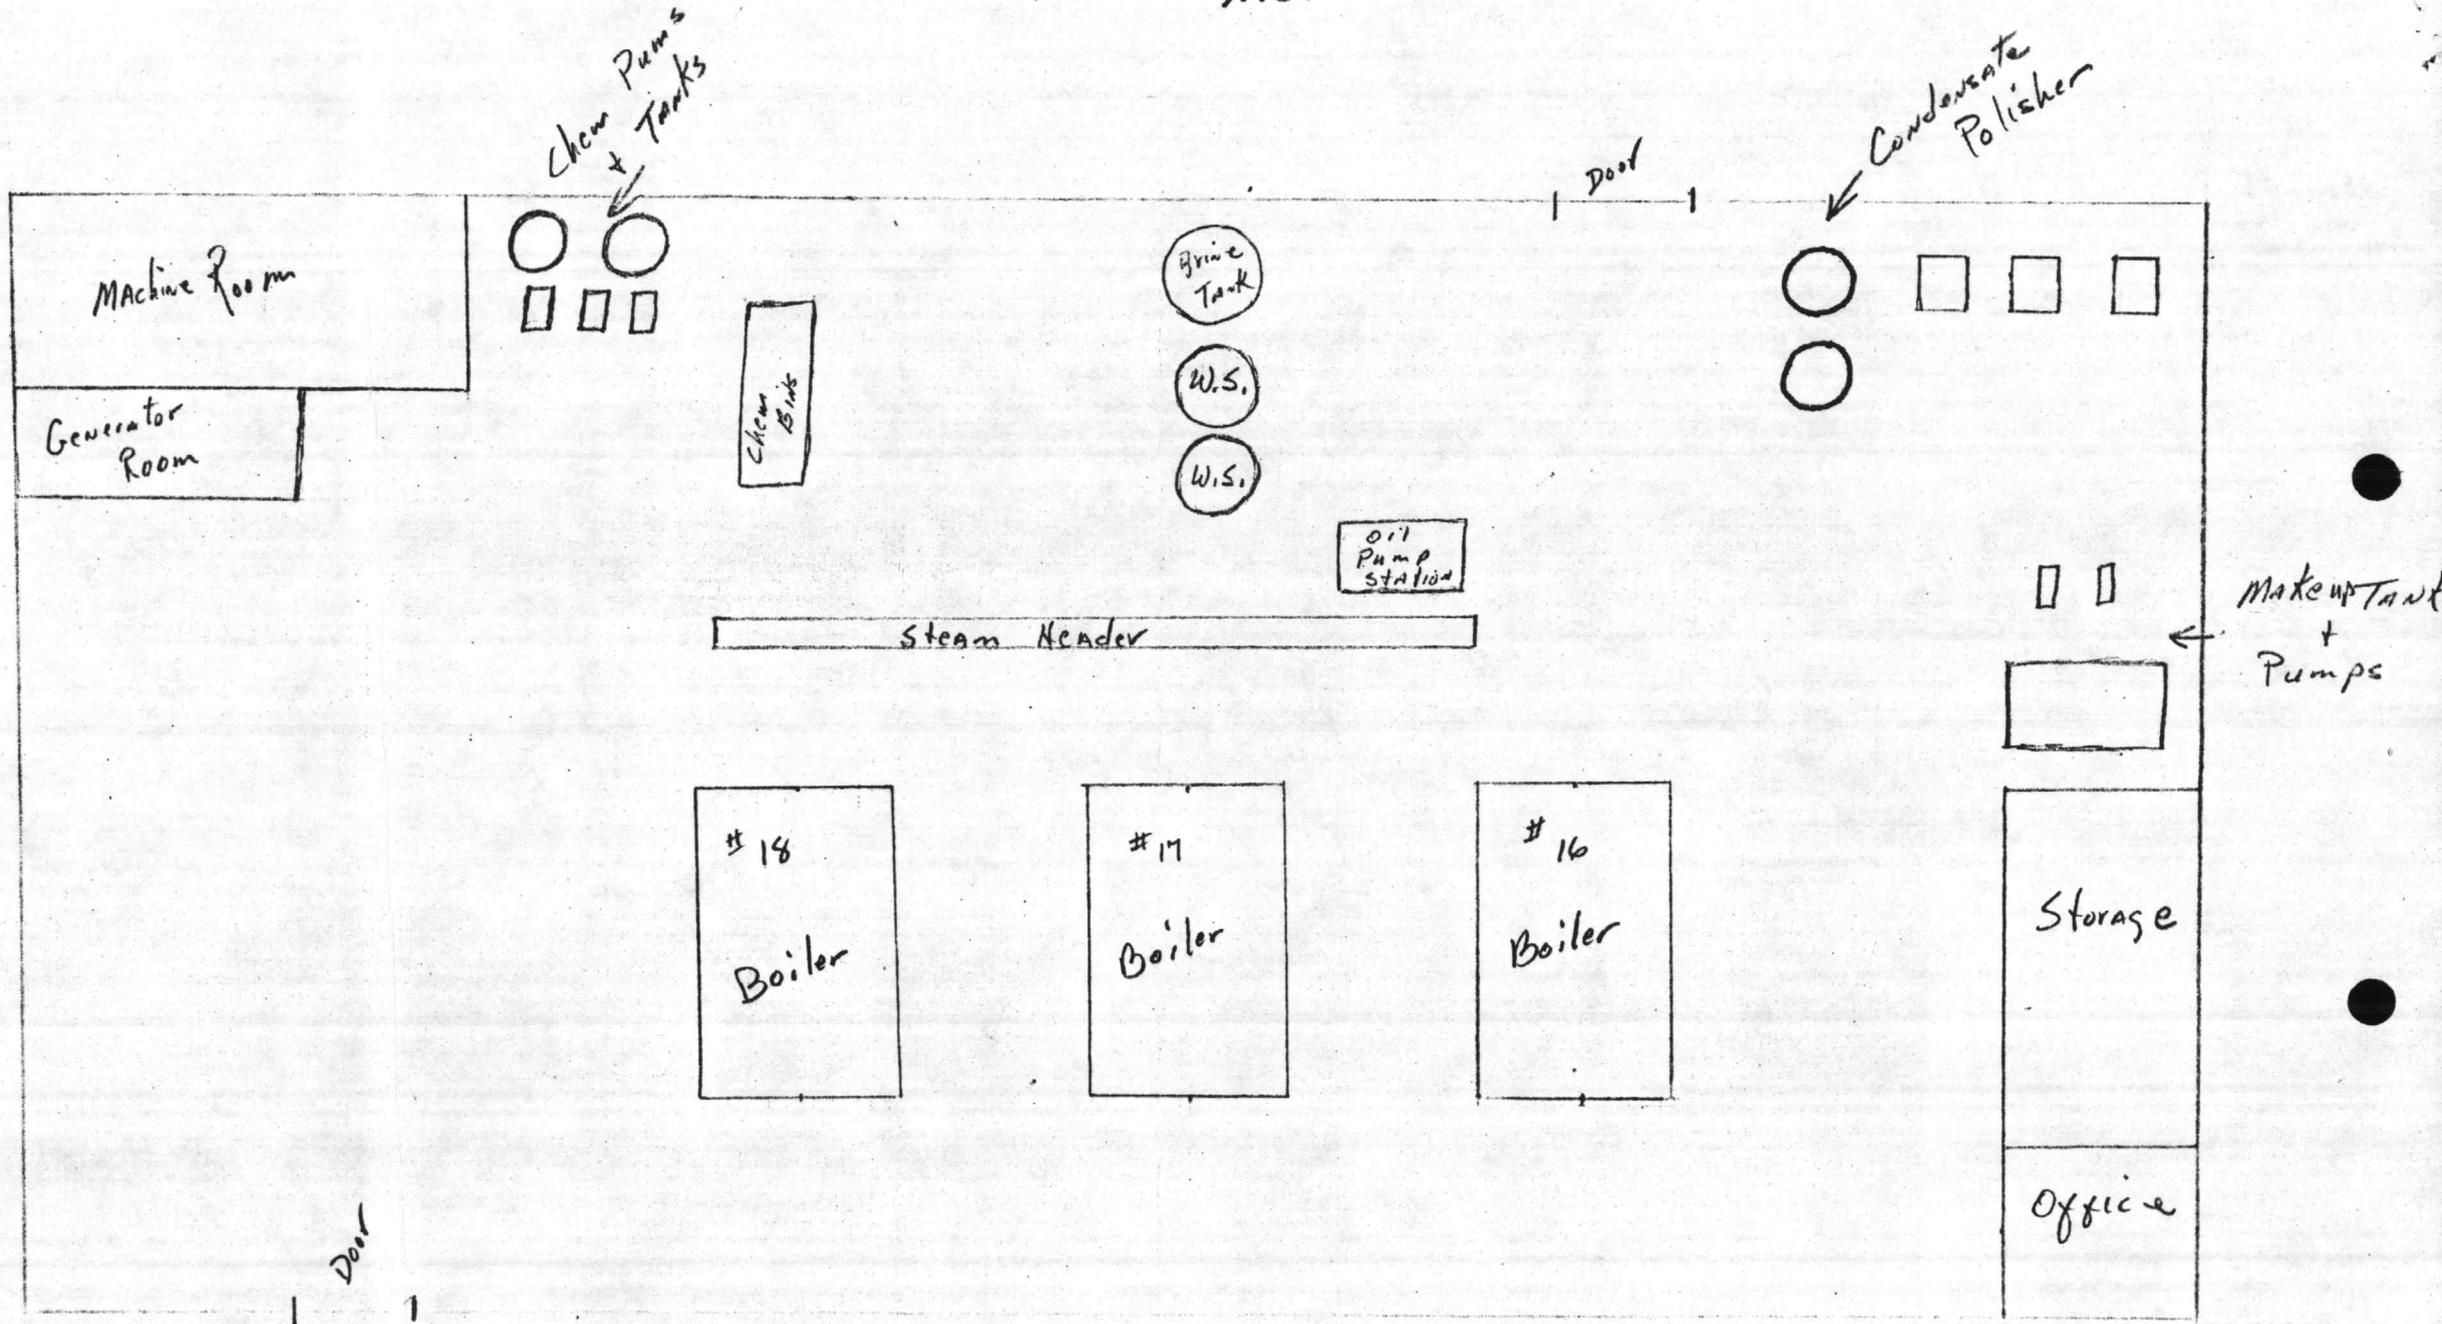
MCAS 4151

Justification: Condensate polishers are needed to filter out iron rust picked up in condensate return line and brought back to boiler plant. This iron is baking out in boiler drums and tubes requiring more use of chemicals to maintain on line treatment and also more maintenance of the water side to get boiler ready for certification. This accumulation of iron rust in the boiler causes heat loss and lower efficiency.

Project is located at MCAS Bldg 4151 Heating Plant. Project is to provide and install two condensate polishers.

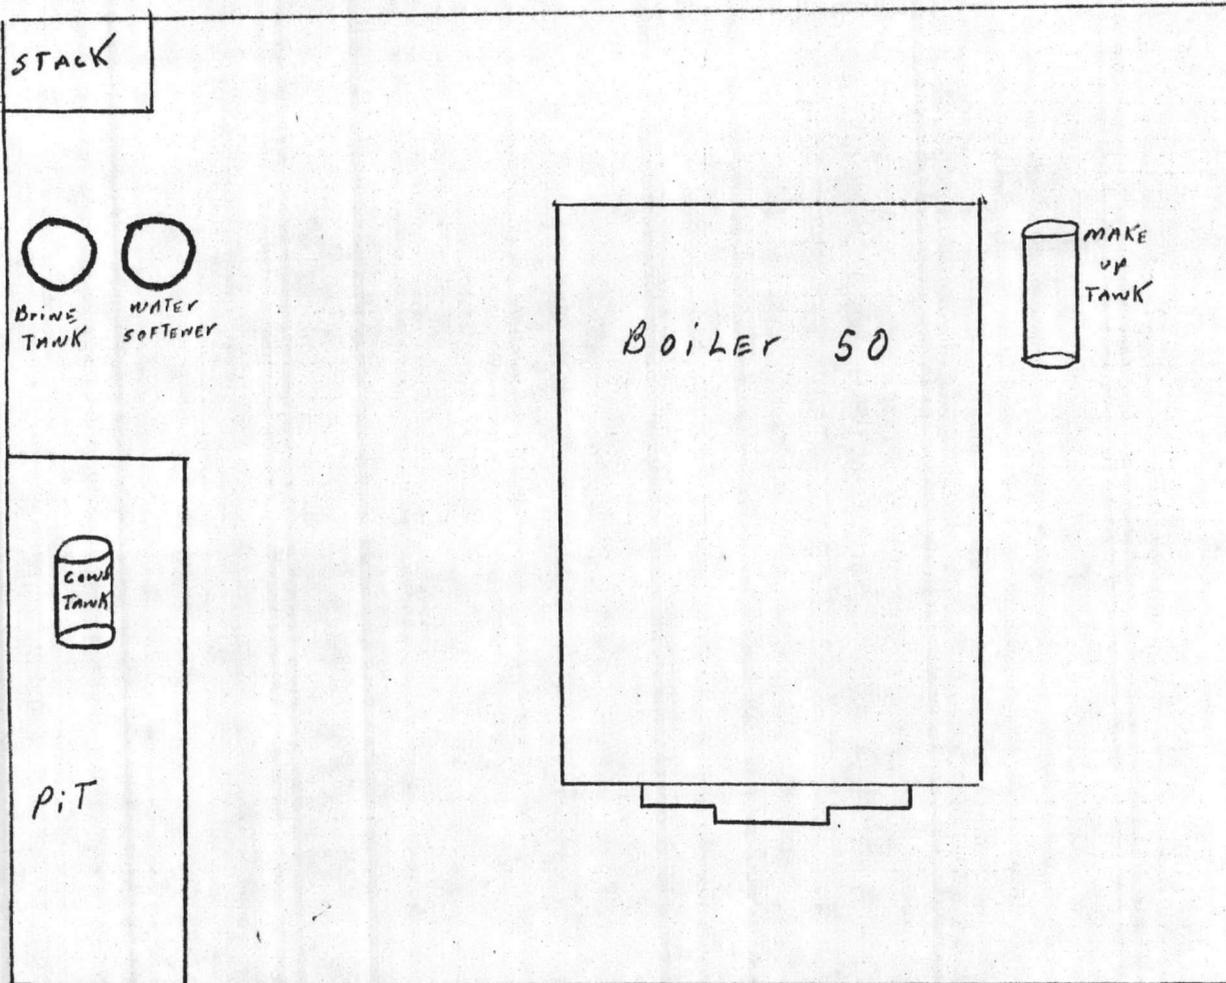
A-1

Justification: To provide soft water for makeup to be used in boiler. Hard water causes scale, pitting, etc. in boiler drums and tubes.

Project is located at A1 Heating Plant. Project is to replace one water softener and one brine tank.

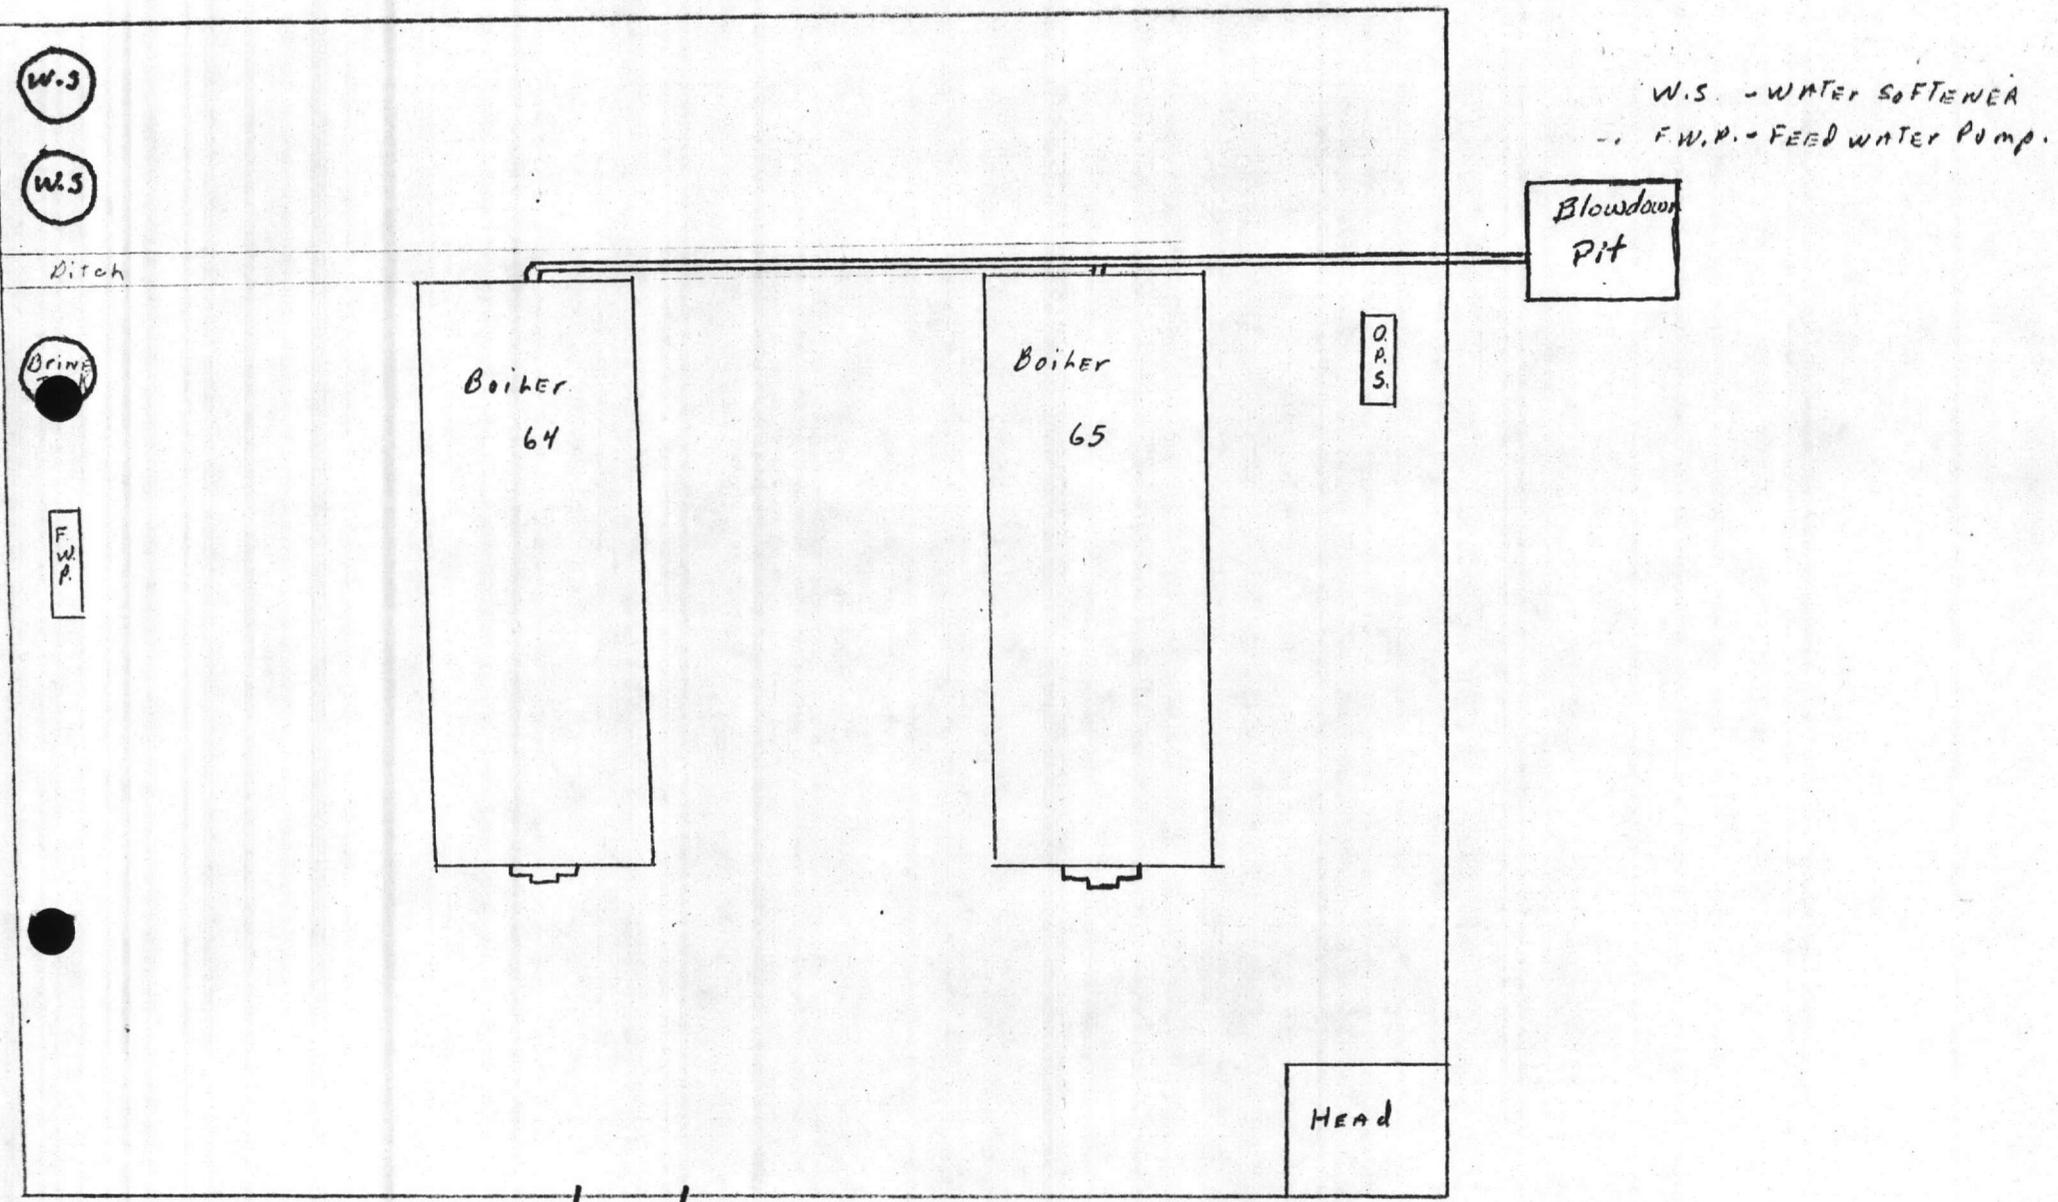
BA-106

Justification: The piping in the ditch has holes in it and the pit has deteriorated to the extent it will not take care of the boiler blowdown water. Water backs up in the ditch in the plant.

Project is located at BA106 Heating Plant. Project is to replace all discharge blowdown lines for two boilers to blowdown tank. Replace blowdown tank and discharge line from blowdown tank.
