PROVIDE AND INSTALL CONDENSATE POLISHERS FOR

BLDG G650 CAMP GEIGER HEATING PLANT

Project is located at bldg G650 Heating Plant. Project is to provide and install two condensate polishers.

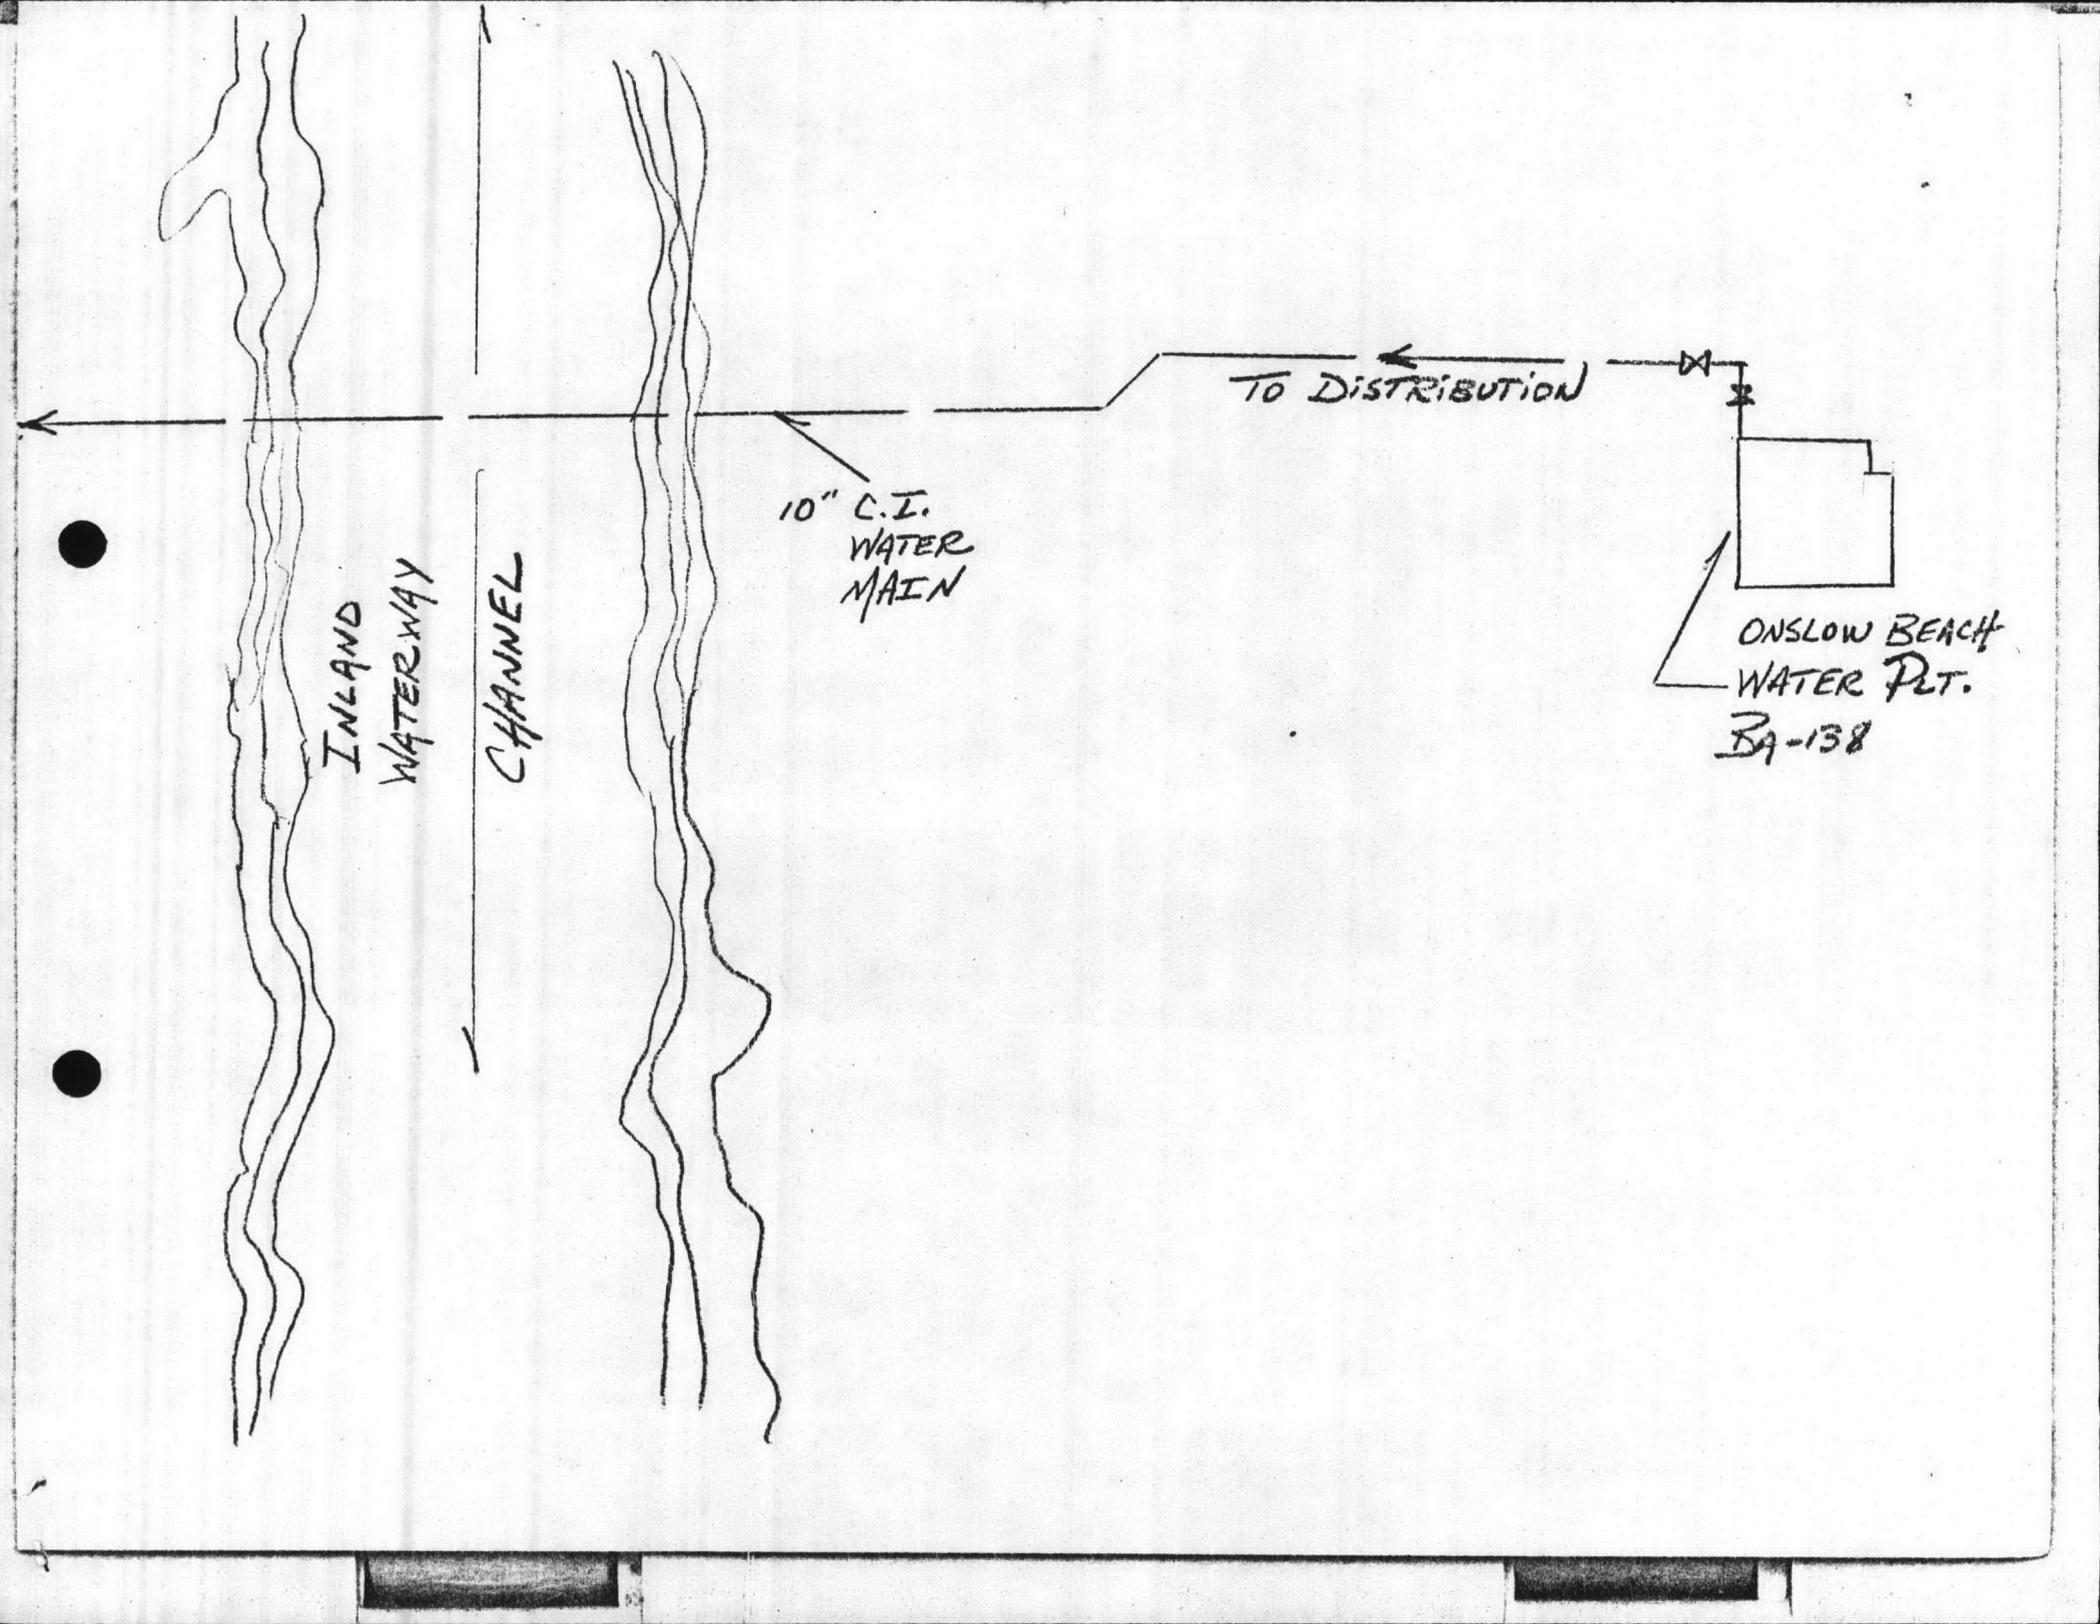
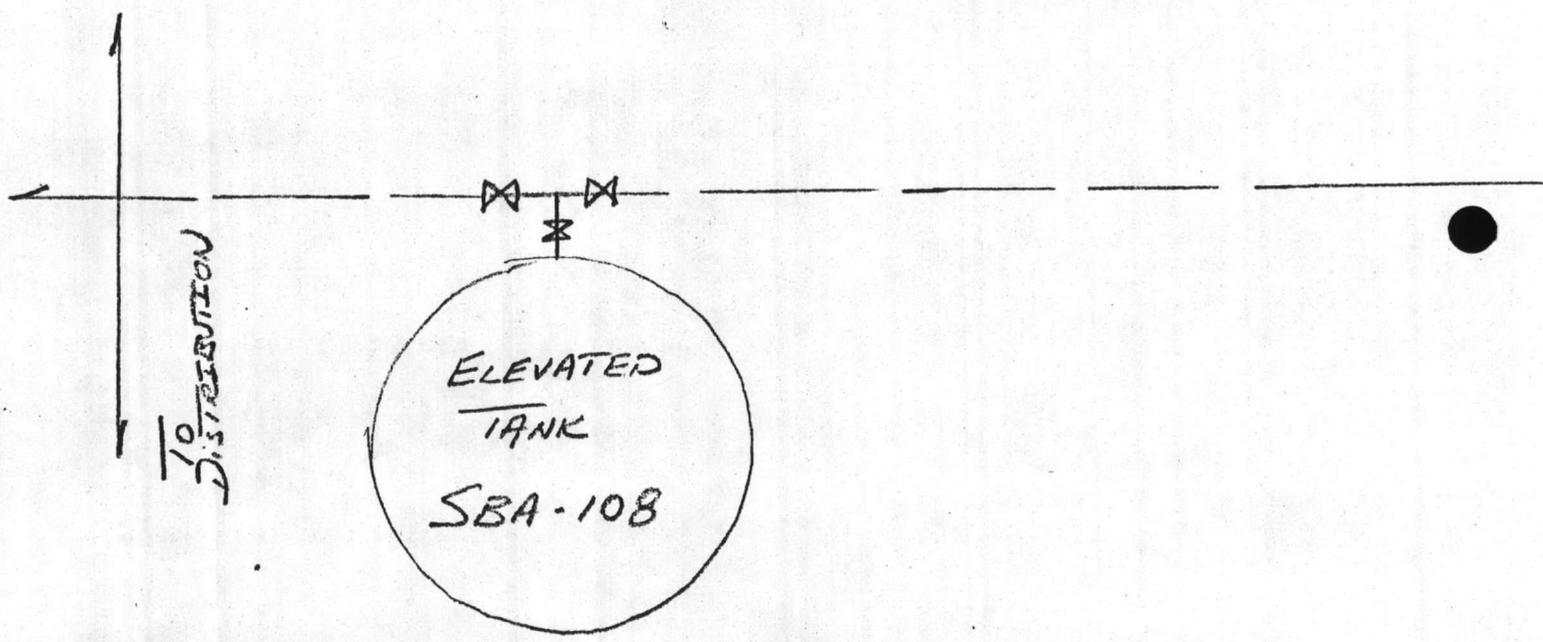
BA-138

Replace approximately 500 feet of 10 inch c.i. waterline crossing the Inter-coastal Waterway. The line presently extends approximately seventy five feet into the water before descending to bottom of waterway. The pipe is over thirty years old and is leaking under water. It has been broken by barges several times. Pipe should be replaced and thoroughly protected from vessels and corrosion. See diagram attached.

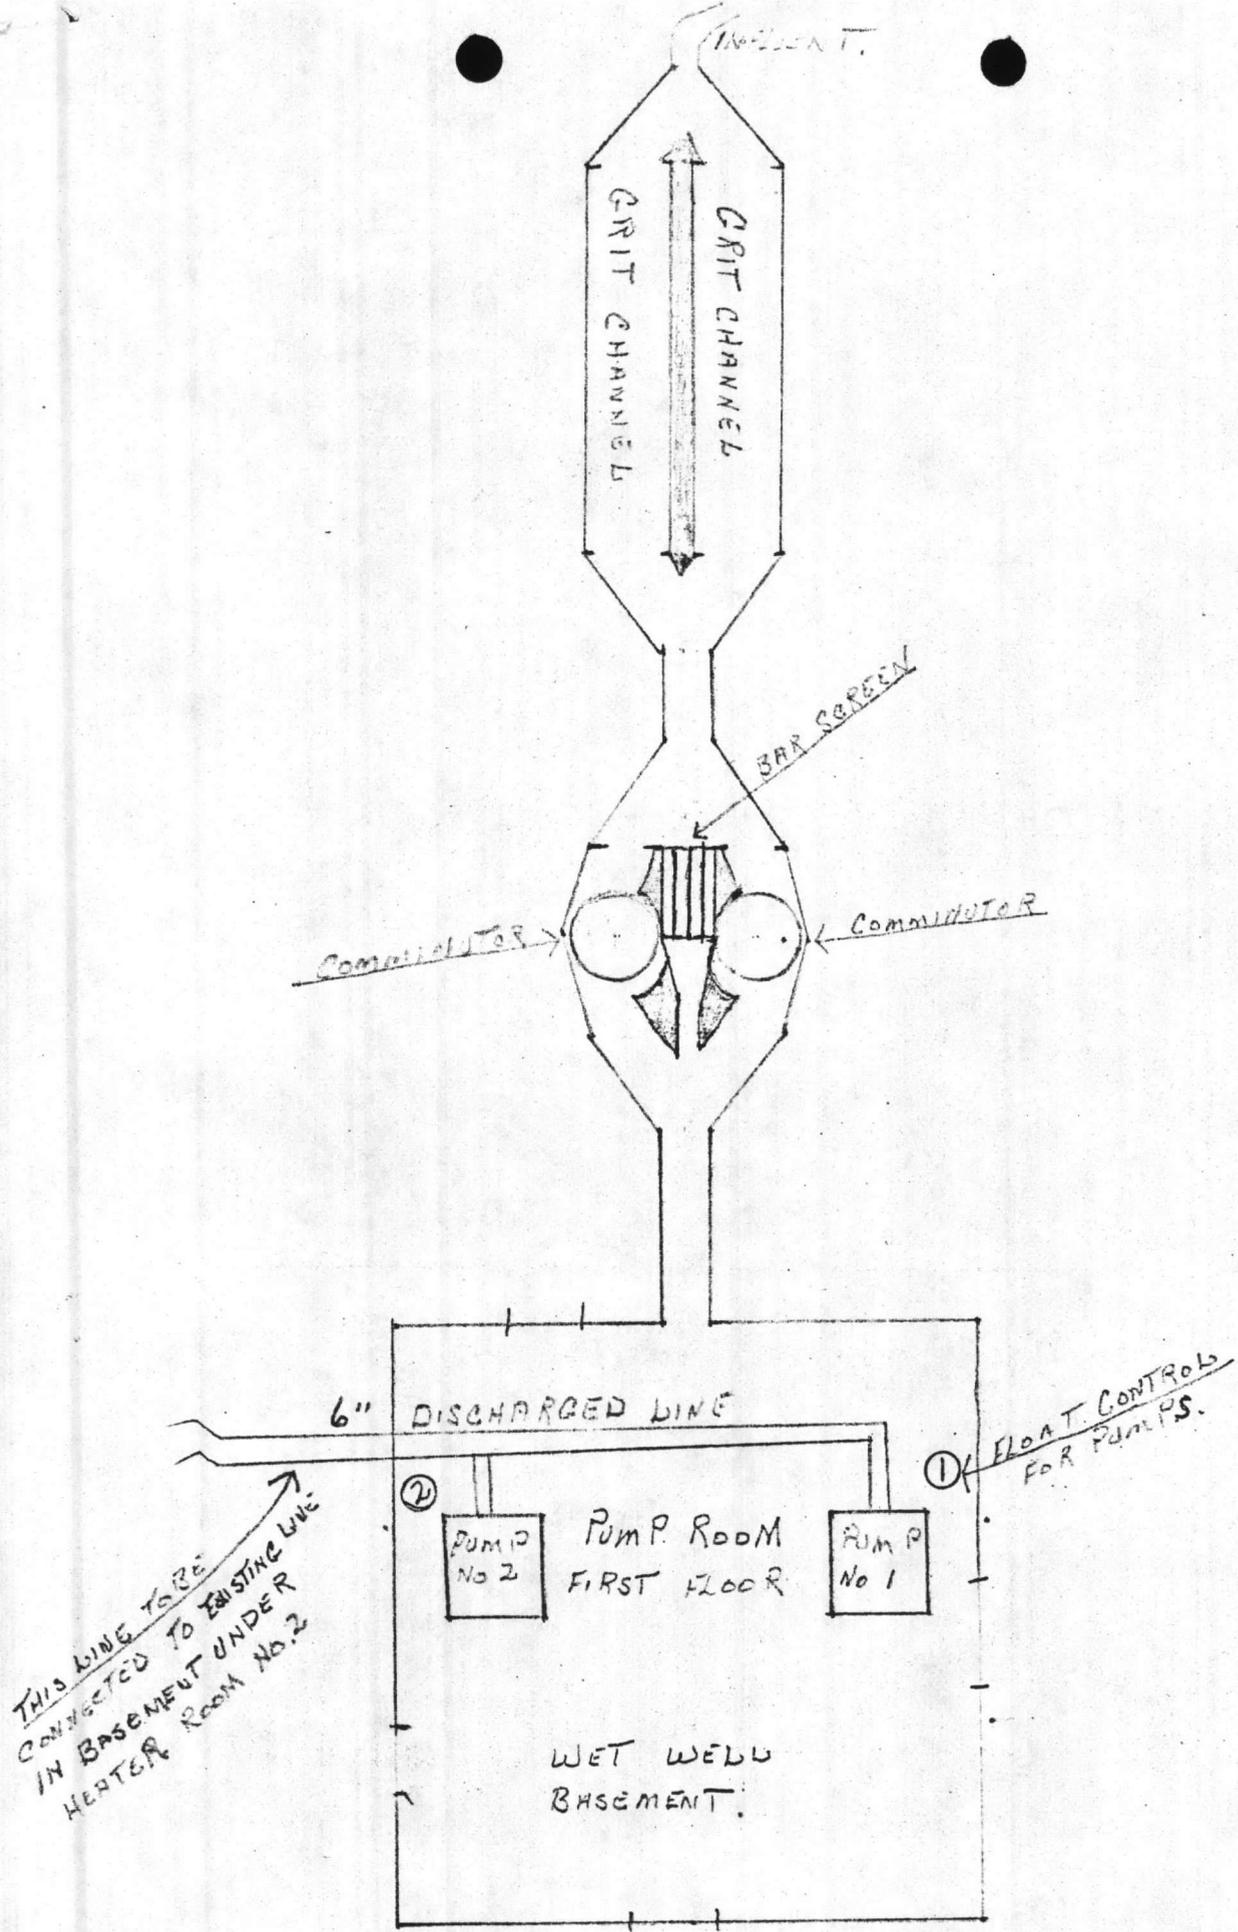
PROPOSED FLOOR PLAN OF LIFT STATION.
 NEW PUMP ROOM AND WET WELL

Corrective action should be taken before the entire wall of the wet well collapses. I do not see any way to patch the existing wall, therefore I recommend a new lift station be built and the discharged line be connected to the existing line under the floor of heater room no. 2 in present floor plans. See attached sketch.
