Ref: JP-5 Fuel Recovery Project
MCAS, New River
Rapid Refueling Area

INTERIM REPORT

CONFIRMATION STUDY TO DETERMINE
EXISTENCE AND POSSIBLE MIGRATION
OF SPECIFIC CHEMICALS IN SITU

SOILS INVESTIGATION
MCAS NEW RIVER
RAPID REFUELING AREA

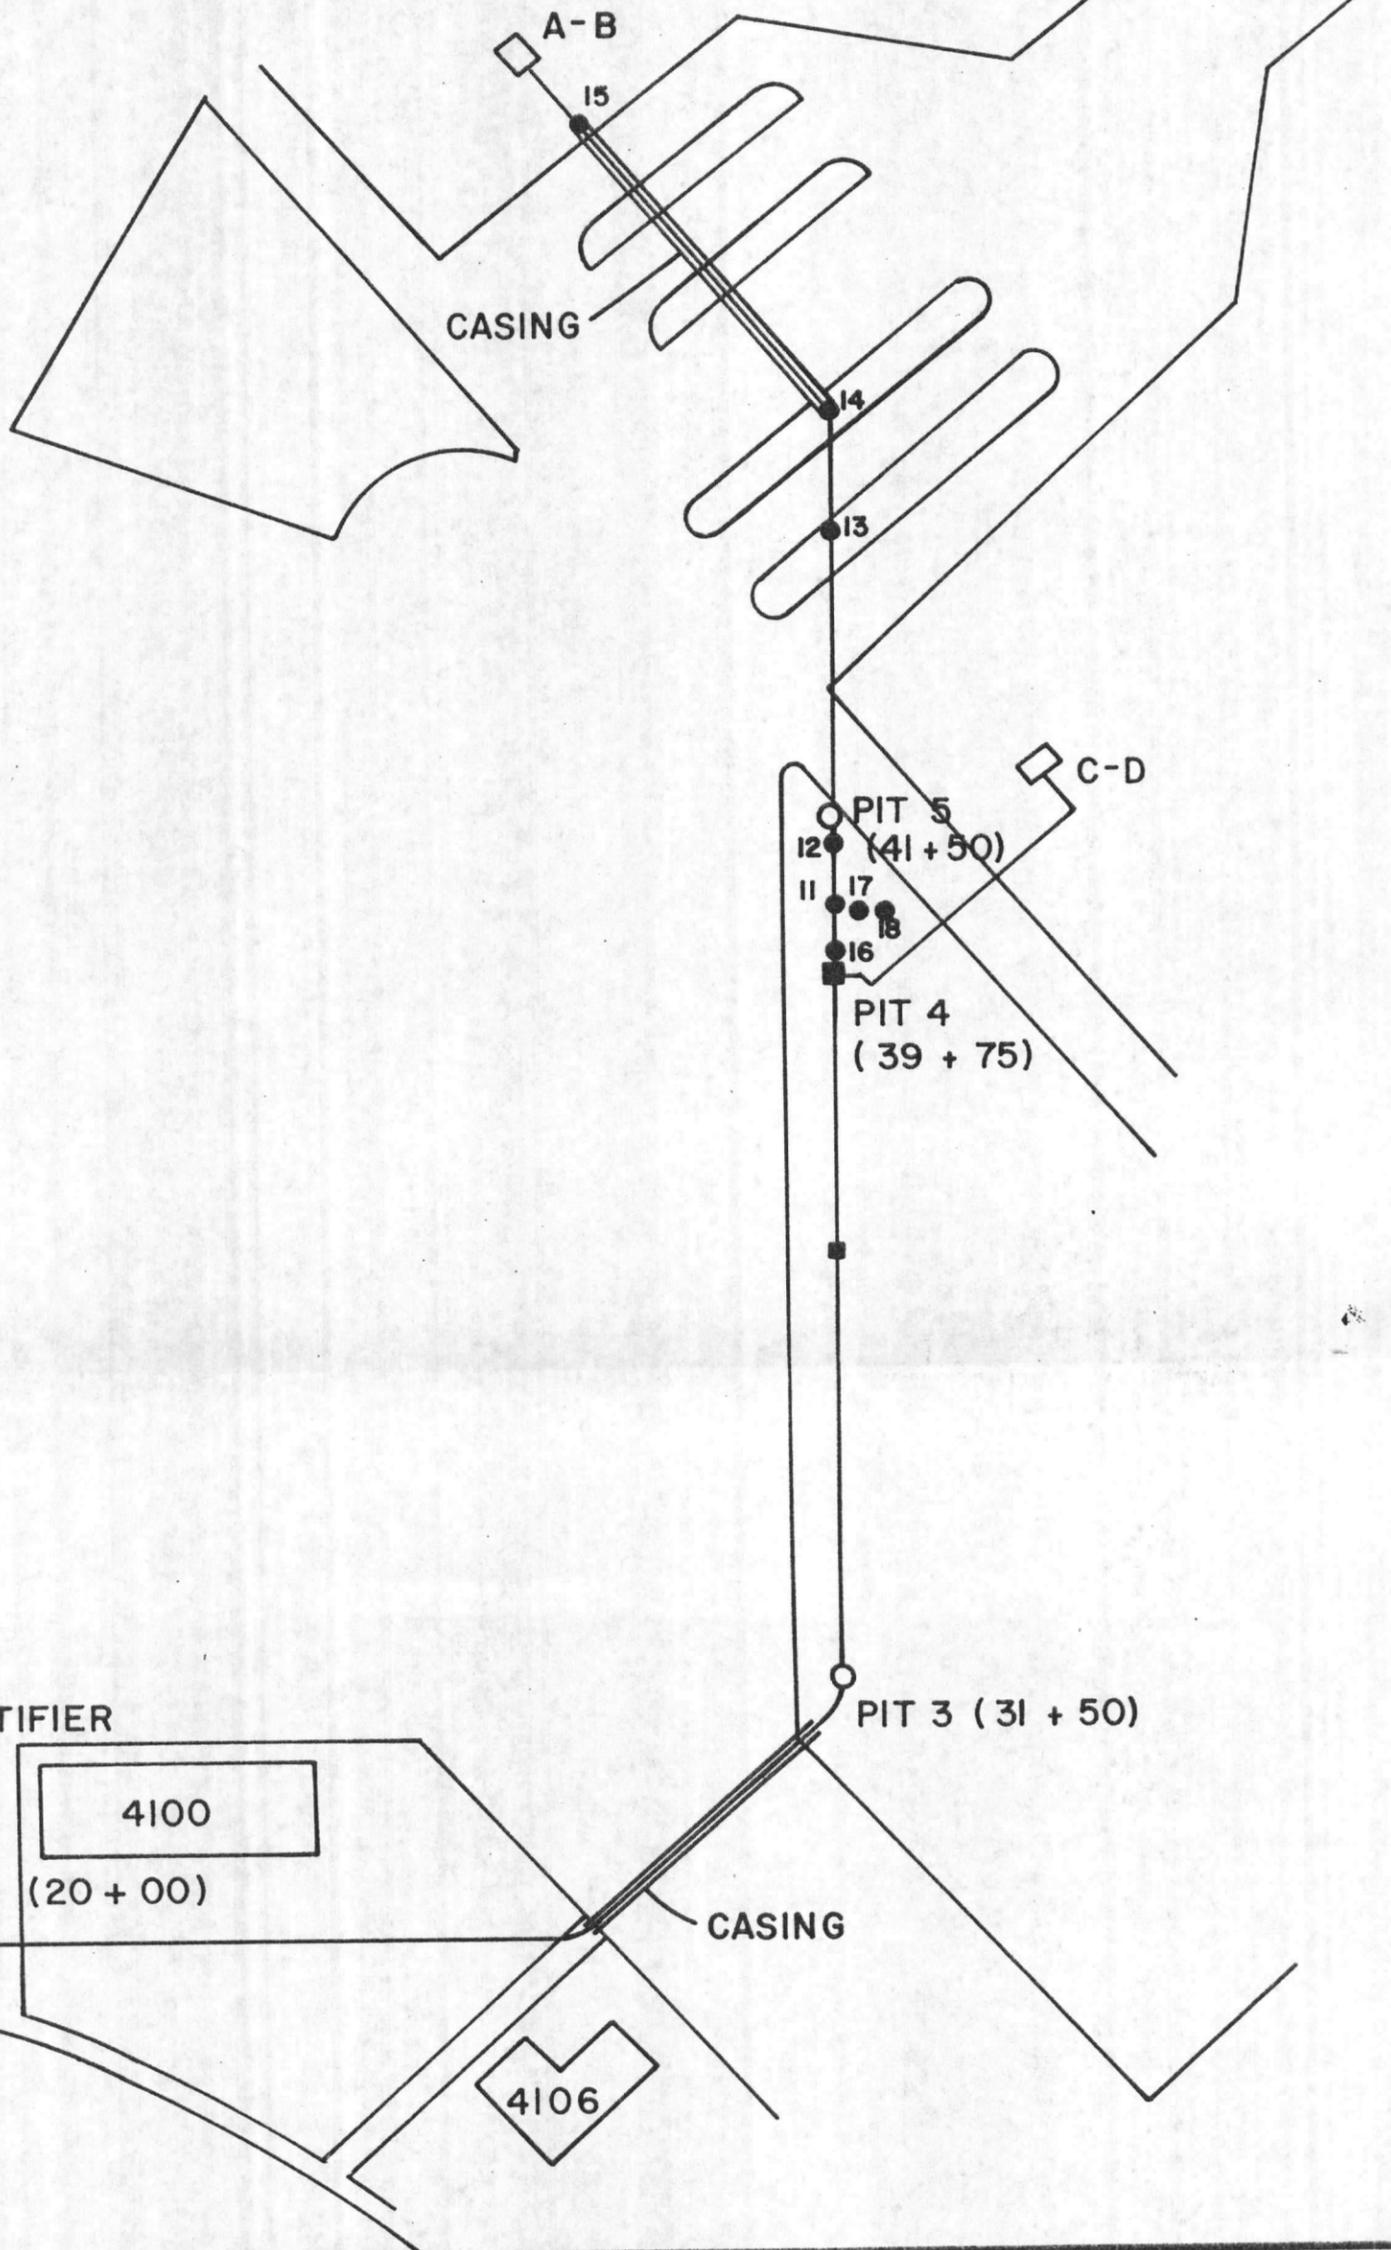
FUEL PIPELINE INVESTIGATION CAMP LEJEUNE, N.C.				DRWN. BY:	CHKD. BY:	JOB NO.:
				J.C.G.	S.C.V.	057-83-128
				DATE:	SCALE:	SHEET OF
				6-29-83	AS SHOWN	
REVISIONS

1. The reference reported serious fuel leaks in the subject area as determined by pressure testing of lines and soil borings adjacent to the lines. However, sufficient soil boring samples were not taken to determine the total area underground which has been contaminated by leaking fuel.

2. It is requested that a change order to the referenced contract be negotiated to perform additional testing by soil boring in order to determine the total area of underground contamination of the soil from fuel leaks.
