MARINE CORPS AIR STATION
LONG RANGE
AIR FIELD MAINTENANCE PLAN

FY 1976 - 1981 *A. KEITZ*

Marine Corps Air Station (Helicopter), New River is located three miles south of the City of Jacksonville at an elevation of twenty-four feet above sea level. There are two major runways, each 5200 feet long by 150 feet wide, emanating from a common hub. The present facilities began with the original construction beginning in 1942 and developed through modification, addition, extension, and strengthening of the pavement to the present. A reduced scale plan of the airfield is provided in Tab A.

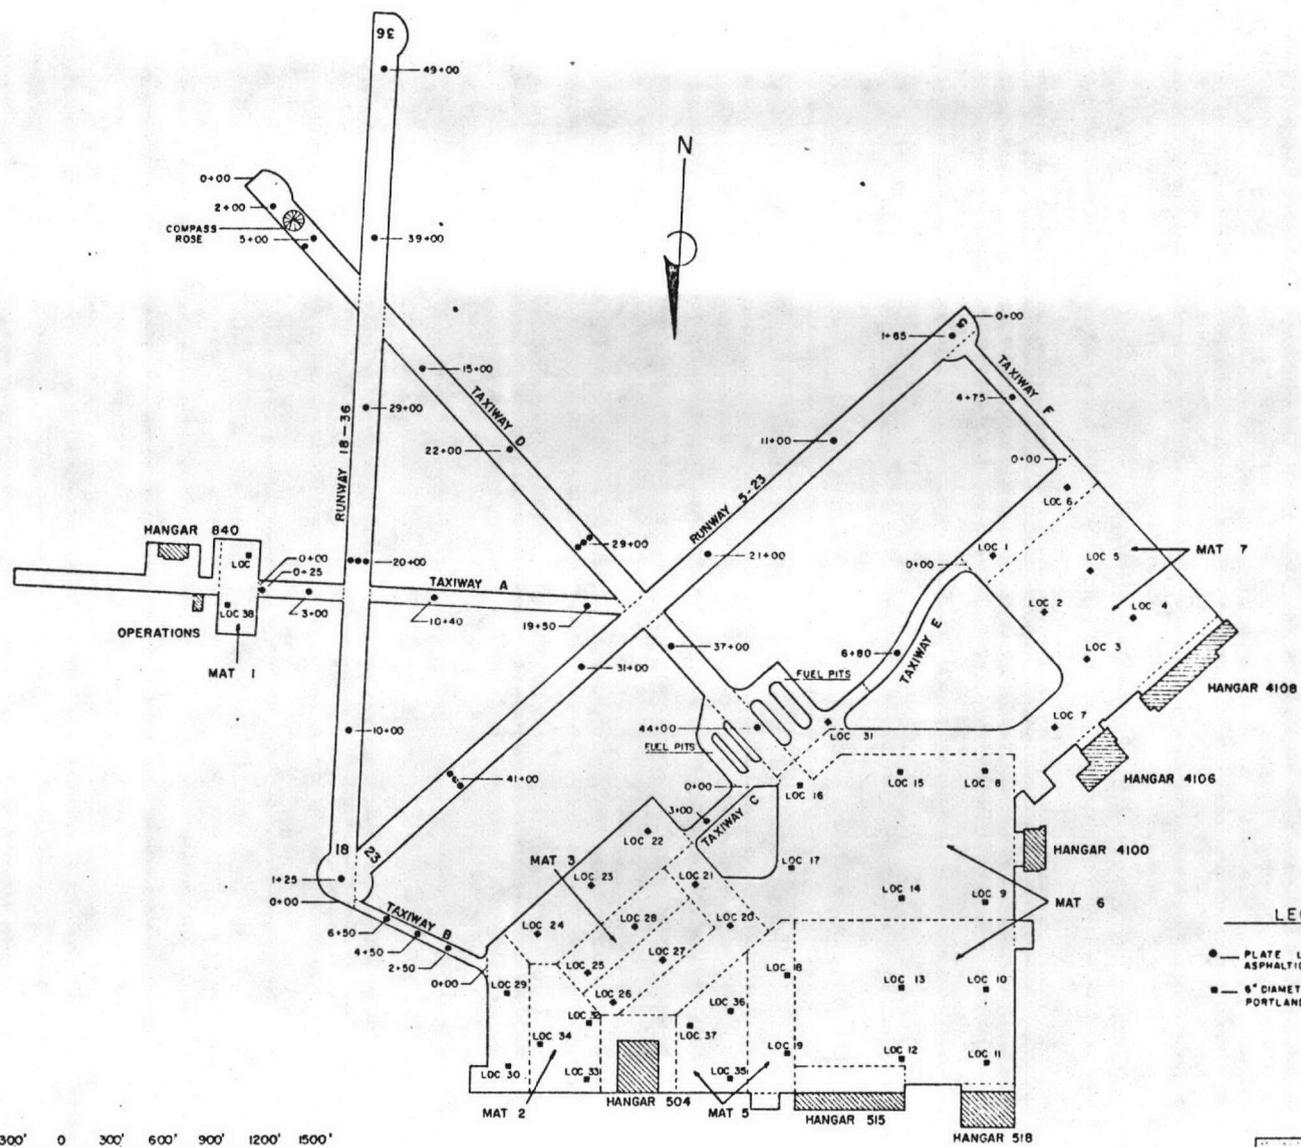
ATLANTIC DIVISION	
NAVAL STATION	
MCAS DJ NEW RIVER JACKSONVILLE, N. C. TEST LOCATION MAP	
NO. 80091	DATE 1954
BY	APP. 10

- LEGEND**
- PLATE LOAD TESTS, ASPHALTIC CONCRETE PAVEMENT.
 - 6" DIAMETER CORE CUT, PORTLAND CEMENT CONCRETE PAVEMENT.

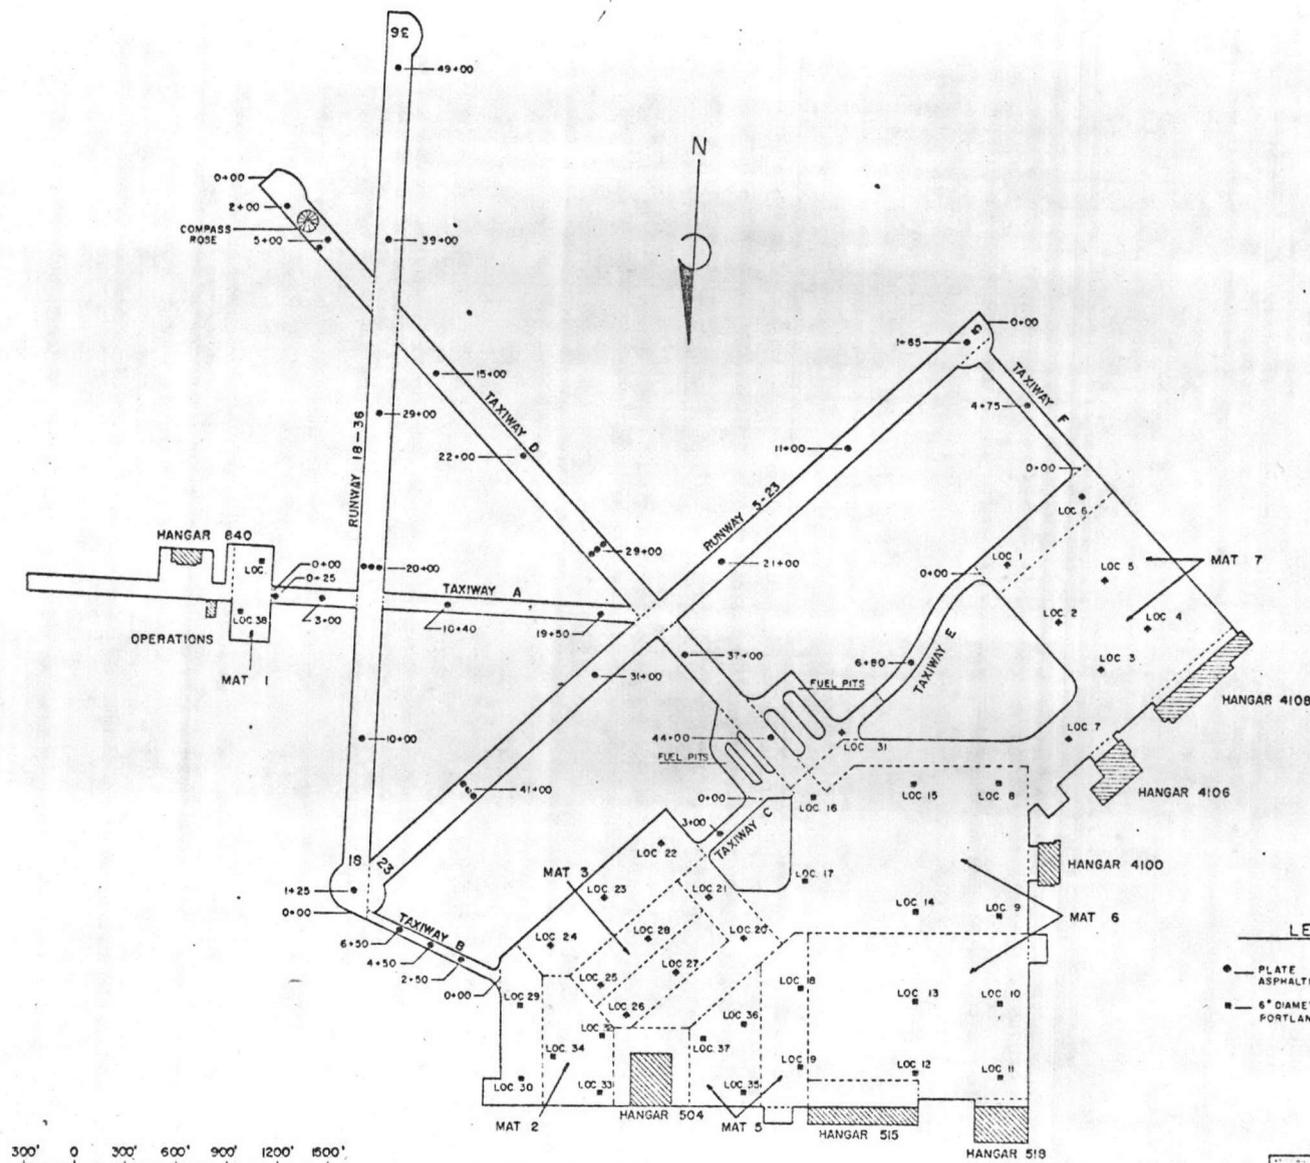
DEPARTMENT OF THE NAVY		NAVAL FACILITIES ENGINEERING COMMAND	
ATLANTIC DIVISION			
NAVAL STATION		PORTFOLK, VA.	
MCAS (H) NEW RIVER JACKSONVILLE, N. C. TEST LOCATION MAP			
NO.	DATE	SCALE	
F	80091	1:10,000	
DATE	BY	APP'D.	BY

LEGEND

- PLATE LOAD TESTS, ASPHALTIC CONCRETE PAVEMENT.
- 6" DIAMETER CORE CUT, PORTLAND CEMENT CONCRETE PAVEMENT.

At the request of the Commanding Officer, Marine Corps Air Station (Helicopter) New River, a pavement evaluation consisting of plate bearing tests and concrete core testing was performed on all airfield pavements during the months of January and February 1976. The purpose of the evaluation was to update the allowable gross aircraft load capability of the runways, taxiways and parking aprons for fixed wing, cargo aircraft type traffic. Although ninety percent of the aircraft utilizing this airfield are helicopters, there are occasions during military exercises when large cargo type aircraft use the field. The majority of these cargo planes are C-130's with a small percent being C-141's.

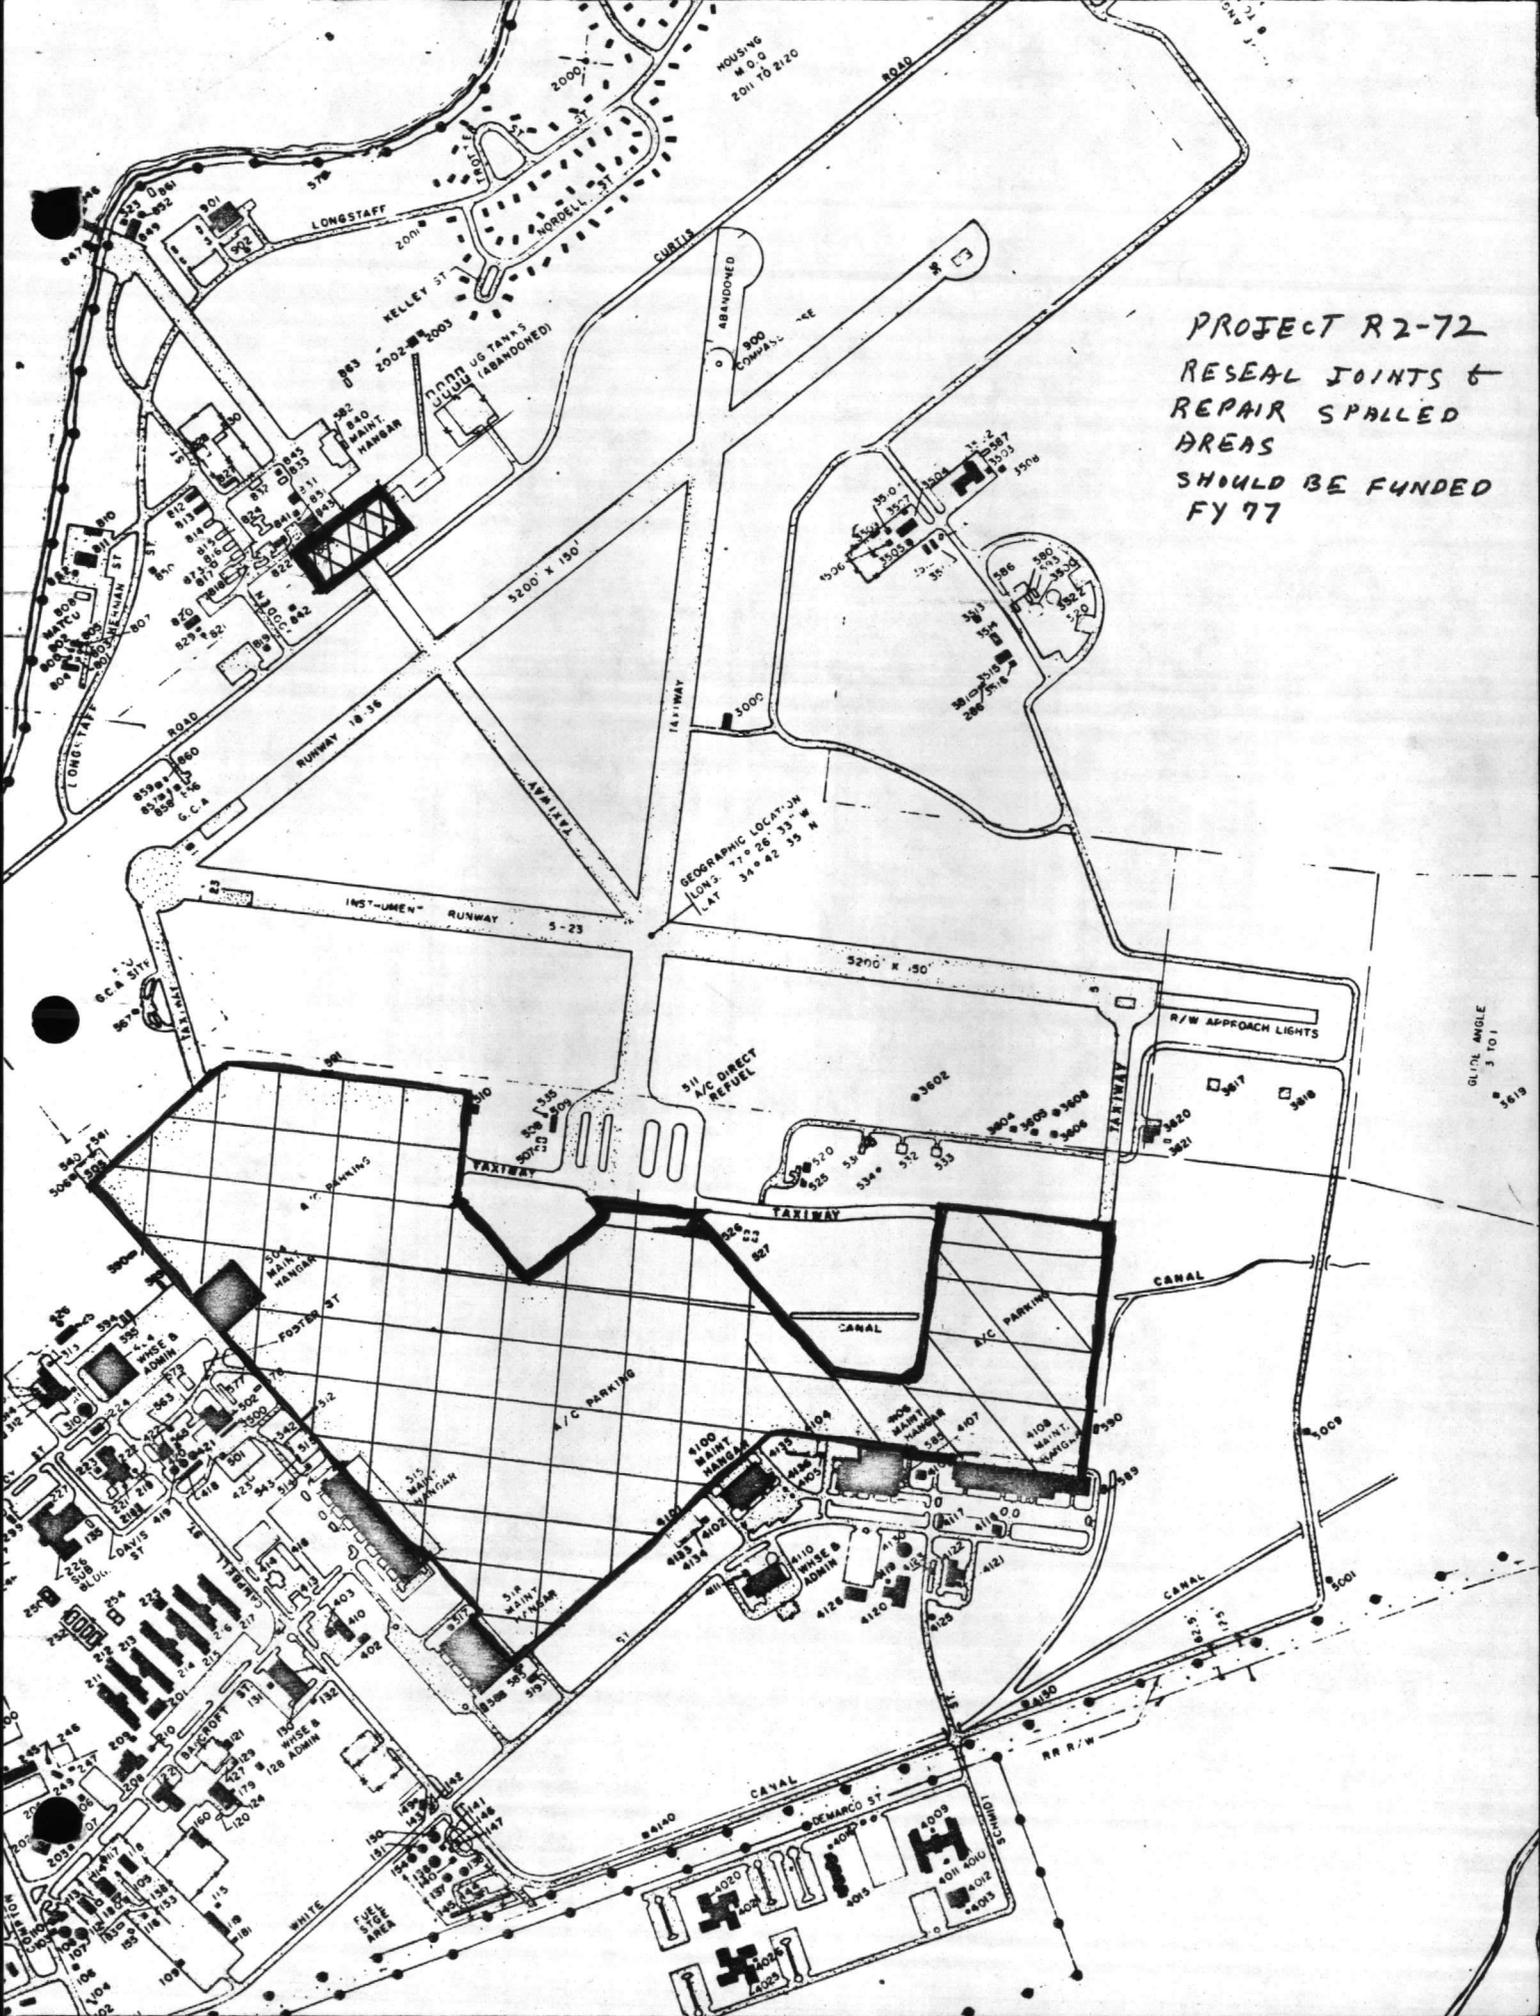
PROJECT R2-72
 RESEAL JOINTS &
 REPAIR SPALLED
 AREAS
 SHOULD BE FUNDED
 FY 77

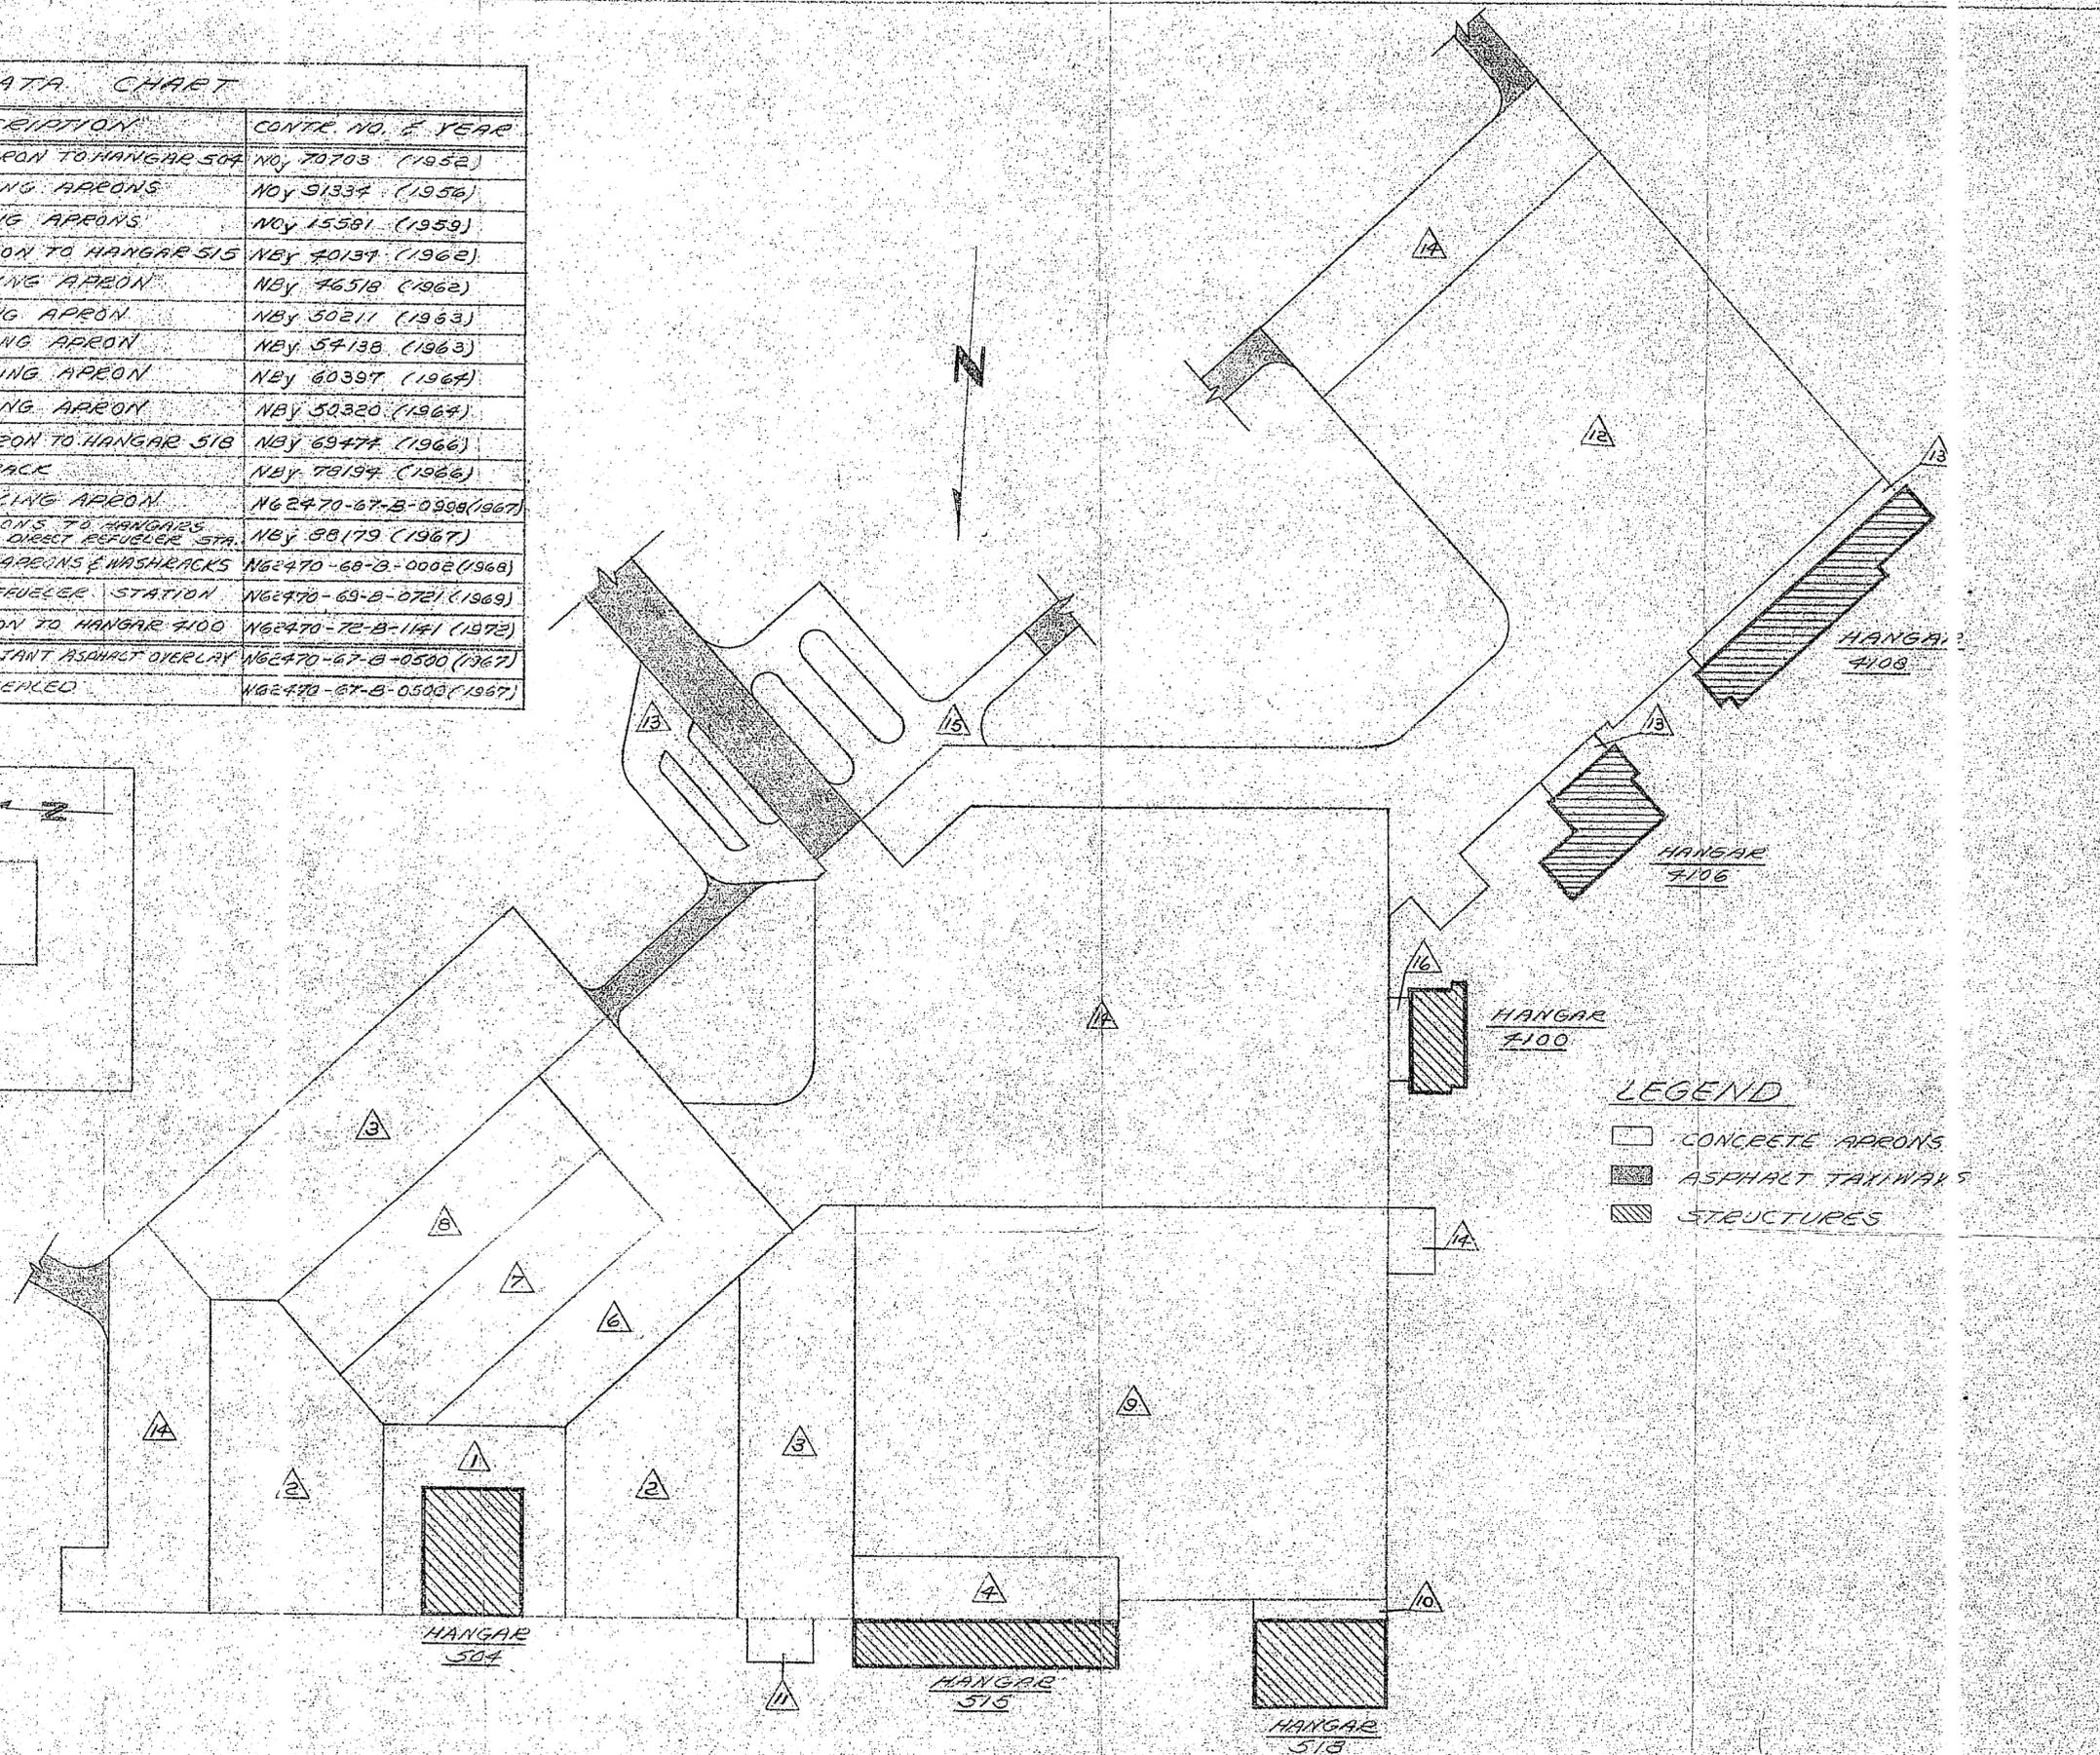
AIRCRAFT PARKING APRONS

DATA CHART		
CODE	DESCRIPTION	CONTR. NO. & YEAR
* 1	ACCESS APRON TO HANGAR 504	NBY 70703 (1952)
** 2	A/C PARKING APRONS	NBY 51334 (1956)
** 3	A/C PARKING APRONS	NBY 15581 (1959)
4	ACCESS APRON TO HANGAR 515	NBY 40134 (1962)
5	A/C PARKING APRON	NBY 46518 (1962)
6	A/C PARKING APRON	NBY 50211 (1963)
7	A/C PARKING APRON	NBY 54138 (1963)
8	A/C PARKING APRON	NBY 60397 (1964)
9	A/C PARKING APRON	NBY 50320 (1964)
10	ACCESS APRON TO HANGAR 518	NBY 69474 (1966)
11	A/C WASHRACK	NBY 79194 (1966)
12	A/C PARKING APRON	N62470-67-B-0998 (1967)
13	ACCESS APRONS TO HANGARS 4106 & 4108 DIRECT REFUELER STA.	NBY 58179 (1967)
14	A/C PARKING APRONS & WASHRACKS	N62470-68-B-0002 (1968)
15	DIRECT REFUELER STATION	N62470-69-B-0721 (1969)
16	ACCESS APRON TO HANGAR 4100	N62470-72-B-1141 (1972)
* 1	JET FUEL RESISTANT ASPHALT OVERLAY	N62470-67-B-0500 (1967)
** 2 3	JOINTS RESEAL	N62470-67-B-0500 (1967)

LEGEND

- CONCRETE APRONS
- ▨ ASPHALT TAXIWAYS
- ▩ STRUCTURES

PLAN
SCALE: 1" = 300'
