Subj: Post Occupancy Evaluation of the Naval Hospital Camp Lejuene, NC

Post Occupancy Evaluation of the
Naval Hospital Camp Lejuene
Listing of Deficiencies

CHECKLIST FOR BARRIER-FREE DESIGN

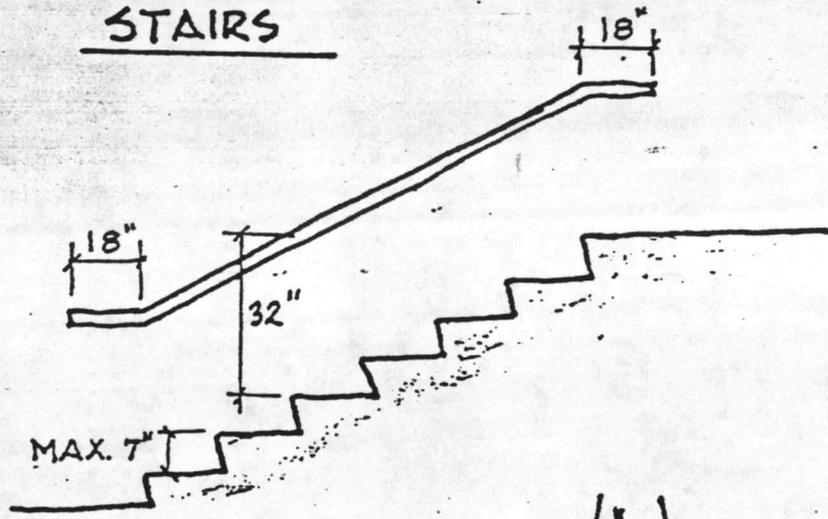
STAIRS

UNACCEPTABLE

ACCEPTABLE

5.4	8. <u>STAIRS</u>			
5.4.1	a. No square or abrupt nosing	✓	_____	NOSINGS EXTEND 3/8" BEYOND RISER FACE
5.4.2	b. Handrails 32" high, when measured from tread at face of riser?	✓	_____	_____

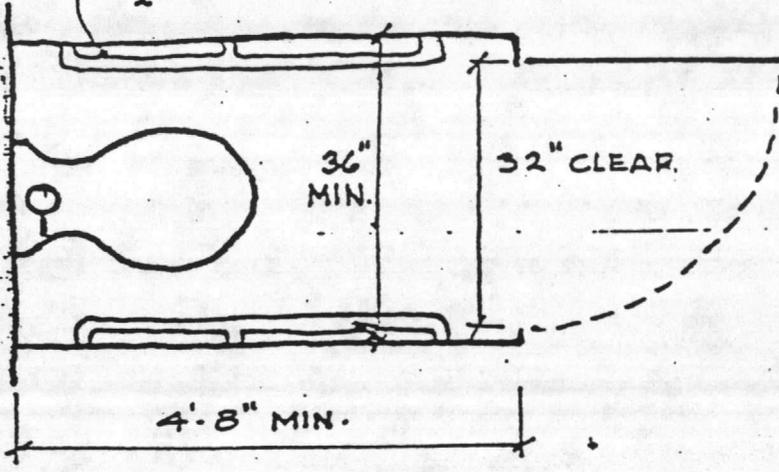
TOILET ROOMS

HANDRAIL 1 1/2" DIA.
1 1/2" FROM WALL

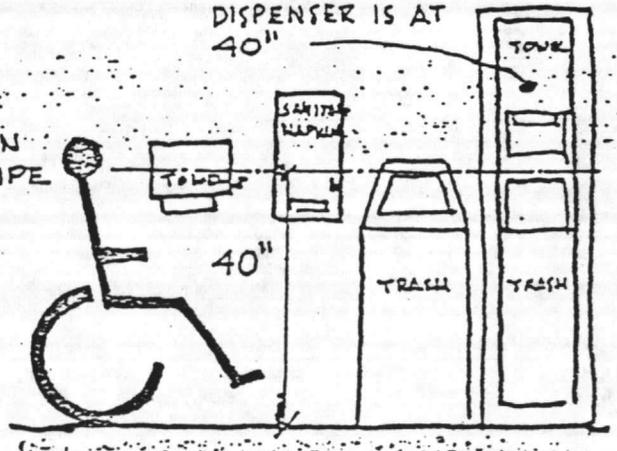
FIXTURE HEIGHTS

THIS TYPE NOT ACCEPTABLE
UNLESS SEPARATE TOWEL
DISPENSER IS AT
40"

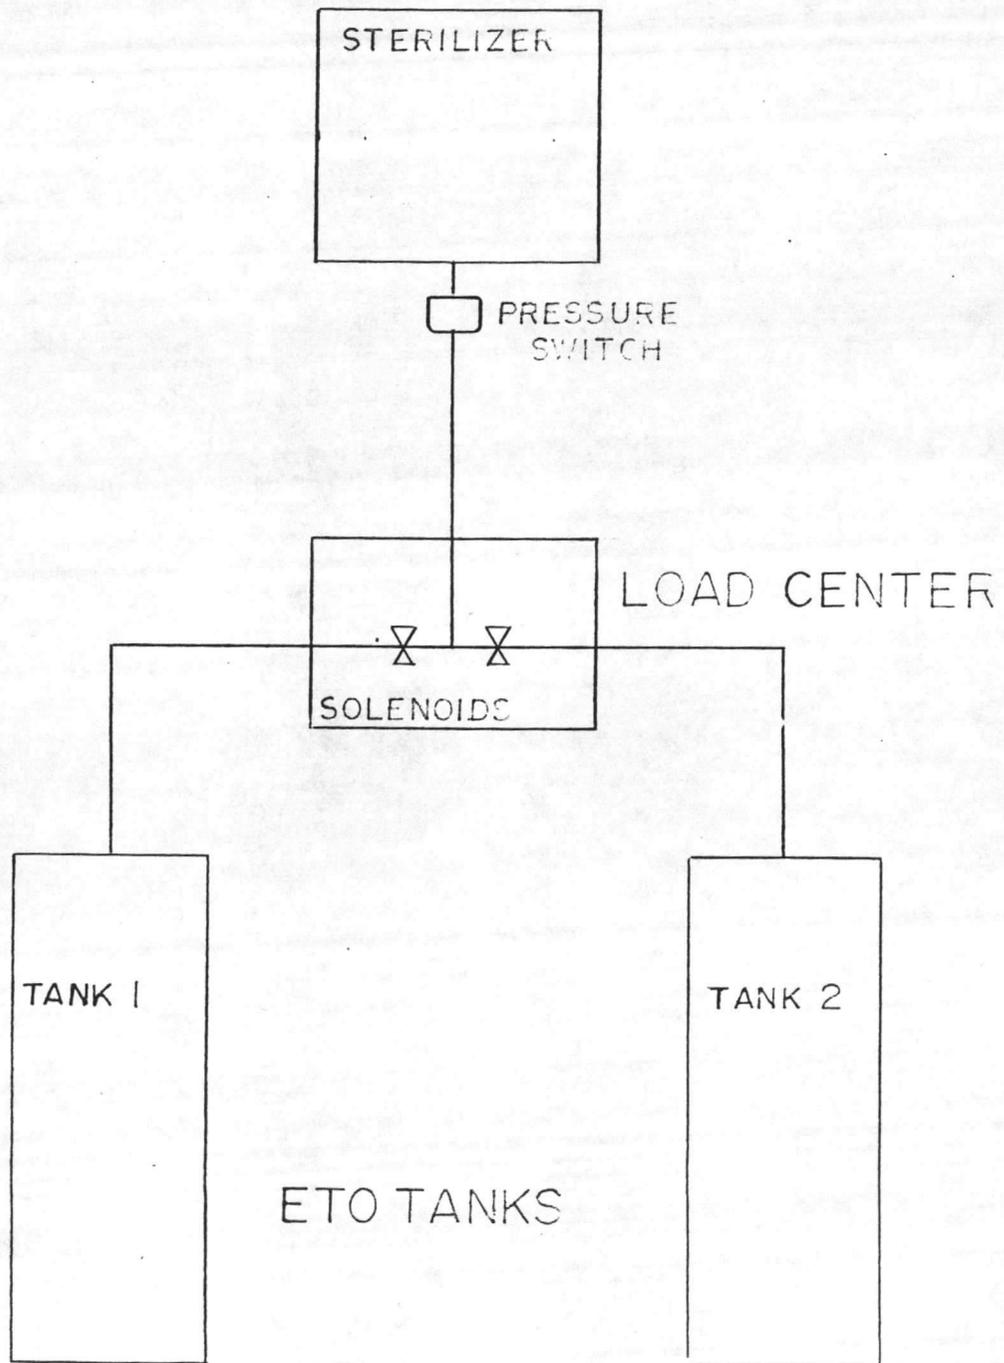
2. Discussion. The ETO system was supplied and installed by Castle. The attached drawing shows the basic components of the ETO system. Each tank contains ETO and freon and contains approximately 80 pounds per square inch (PSI) of pressure when full. Each tank supplies ETO to the load center at a constant pressure. The load center is essentially two on/off solenoids or switches controlled by the pressure switch located at the sterilizer. The switch "calls for" ETO intermittently so that only 8 - 10 PSI is maintained at the sterilizer. The load center uses one tank at a time and triggers an alarm when a tank drops below 10 PSI and starts using the other tank. This alarm prompts maintenance personnel to change the empty tank.

3. Action Taken. When the system was first energized, numerous leaks were found at various fittings throughout the system. The leaks were pinpointed by personnel from Occupational and Preventive Medicine and Facilities Management using leak testing solution and ETO sensing equipment. Those leaks have been corrected. A persistent leak has been identified at the load center. The solenoids are the most likely source of the leak. The Castle representative was contacted and the problem was referred to him for action. Follow-up testing by Occupational and Preventive Medicine indicate that the load center leak has been fixed. Discussion with the contractor also indicated that he would provide a 24 hour maximum response time on any future leaks found under the warranty period. The warranty is administered by Medical Repair.
