**TEST & EVALUATION OF COMMERCIALY  
AVAILABLE HALON 1211 HAND-PORTABLE  
FIRE EXTINGUISHERS FOR USE IN  
HABITABLE & CARGO COMPARTMENTS  
OF USAF AIRCRAFT**

**JOSEPH WALKER  
RICHARD N. VICKERS  
ANTHONY J. KWAN  
ENGINEERING RESEARCH DIVISION  
AIRBASE FACILITIES BRANCH**

**MAY 1981**

**FINAL REPORT**

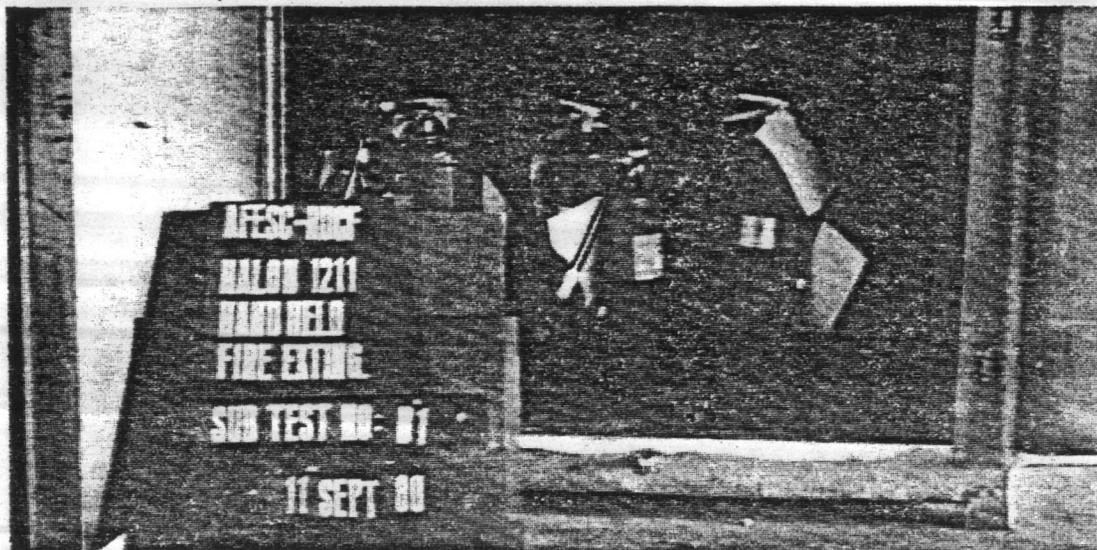
Figure 20. Branson Engineering Co. Model 4510-1N High Temperature Chamber Containing Test Items

Before testing, all test items were operationally tested, recharged to manufacturer's specifications, and checked for leakage around O-rings and valve seals. Extinguishers were then placed inside a Branson Engineering Co. Model 4510-1N high temperature chamber (Figure 20) and placed under high temperature stress. The following temperature sequence was employed in testing.

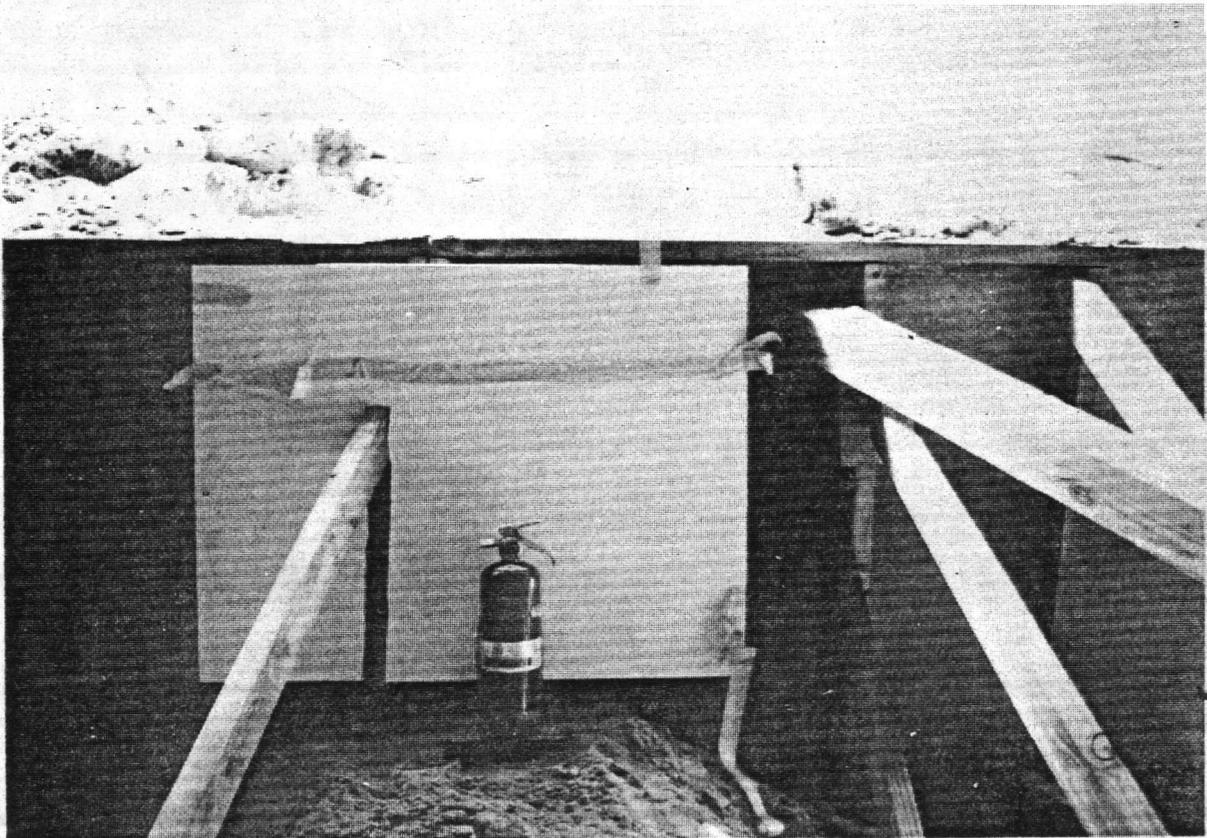
Figure 34. Extinguisher Inside a Concrete Reinforced Bunker

Extinguisher was filled and pressurized to manufacturer's specifications, then placed against a sandfilled backstop inside a concrete reinforced bunker (Figure 34). A ground-mounted caliber .50 machine gun was positioned outside the bunker with the barrel projecting through an aperture in the steel door (Figure 35).

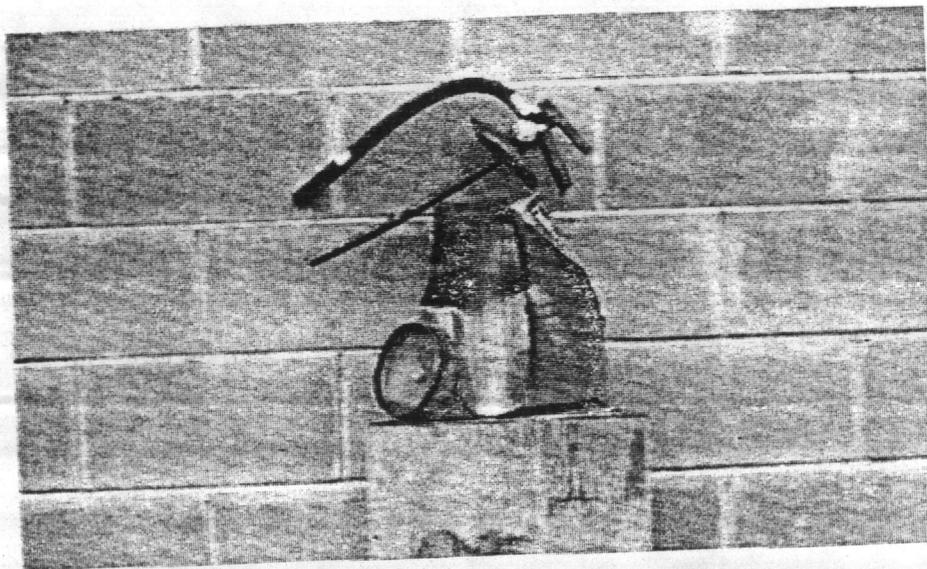
2A:40B:C - Two 2A:40B:C Ansul extinguishers were tested. Both split at the projectile entrance and also split full length at the exit points. Both extinguishers were separated from their bases, which became loose fragments (Figures 43 and 44).

Figure 43. Ansul 2A:40B:C/Projectile Entry and Exit, Extinguisher 1

Figure 44. Ansul 2A:40B:C/Projectile Entry and Exit, Extinguisher 2
