Photos of Aircraft  
Base Facility  
in Operation

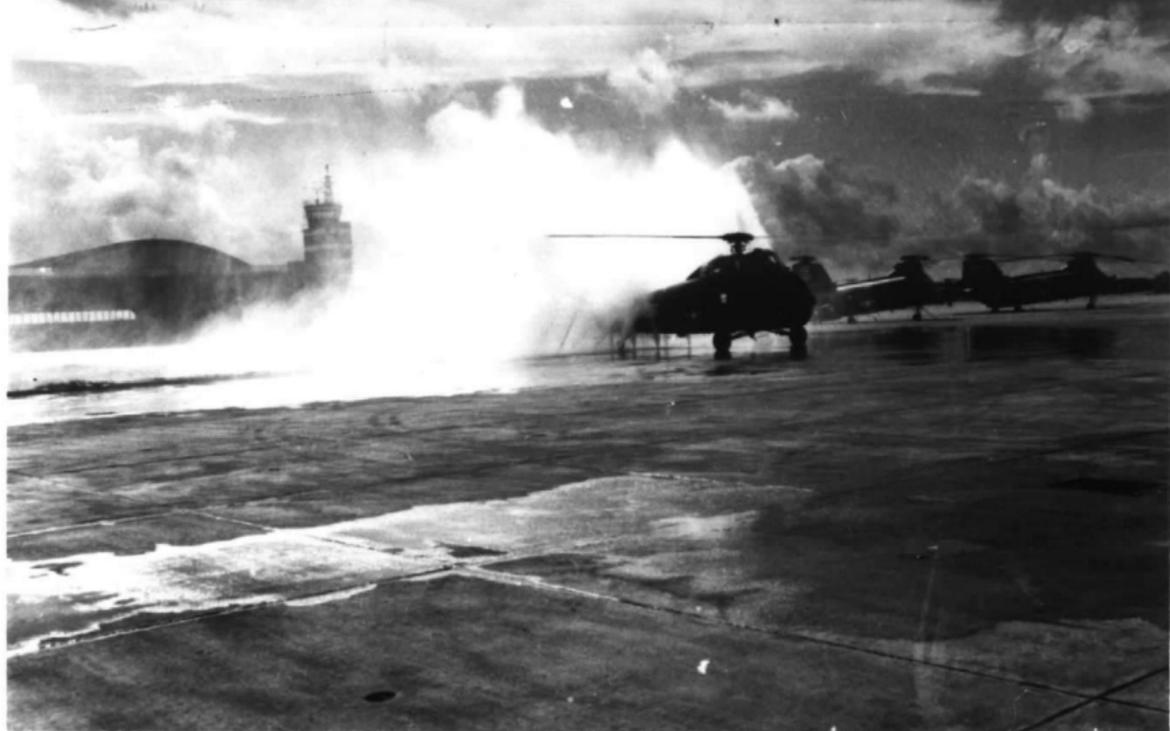
CH34, NOTE THE "BENDBACK" OF THE SPRAY BY THE ROTOR WASH TO COMPLETE THE ENVELOPMENT OF THE HELICOPTER WITH WATER.

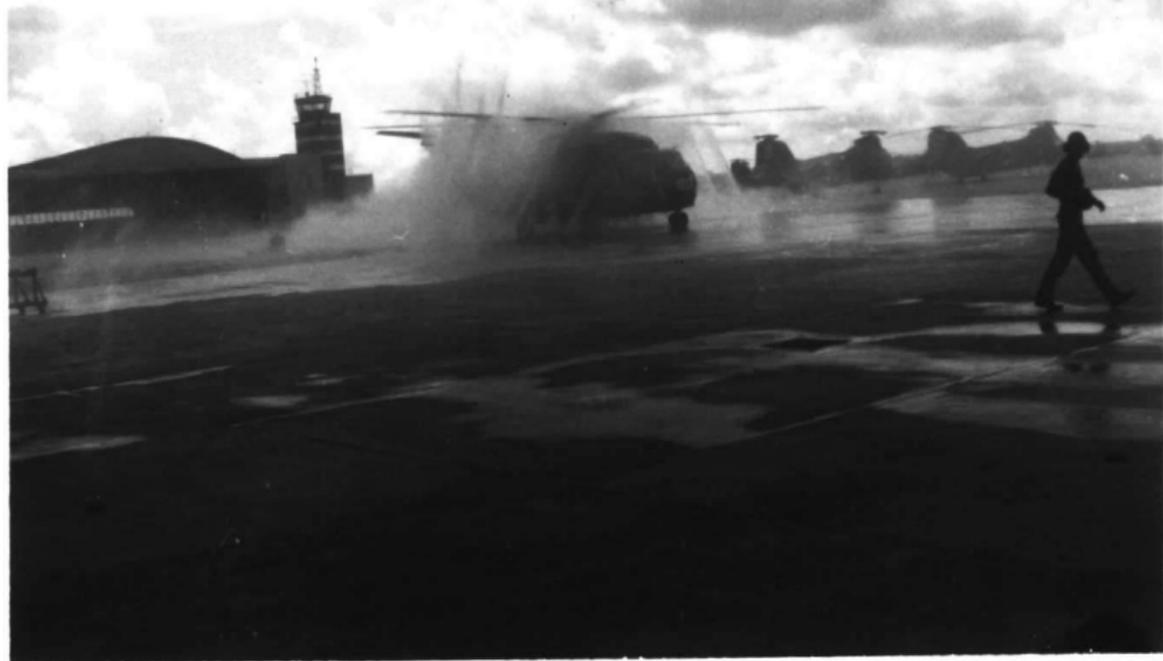
CH 53, NOTE HOW THE ENTIRE HELICOPTER FITS INTO THE  
SPRAY PATTERN.

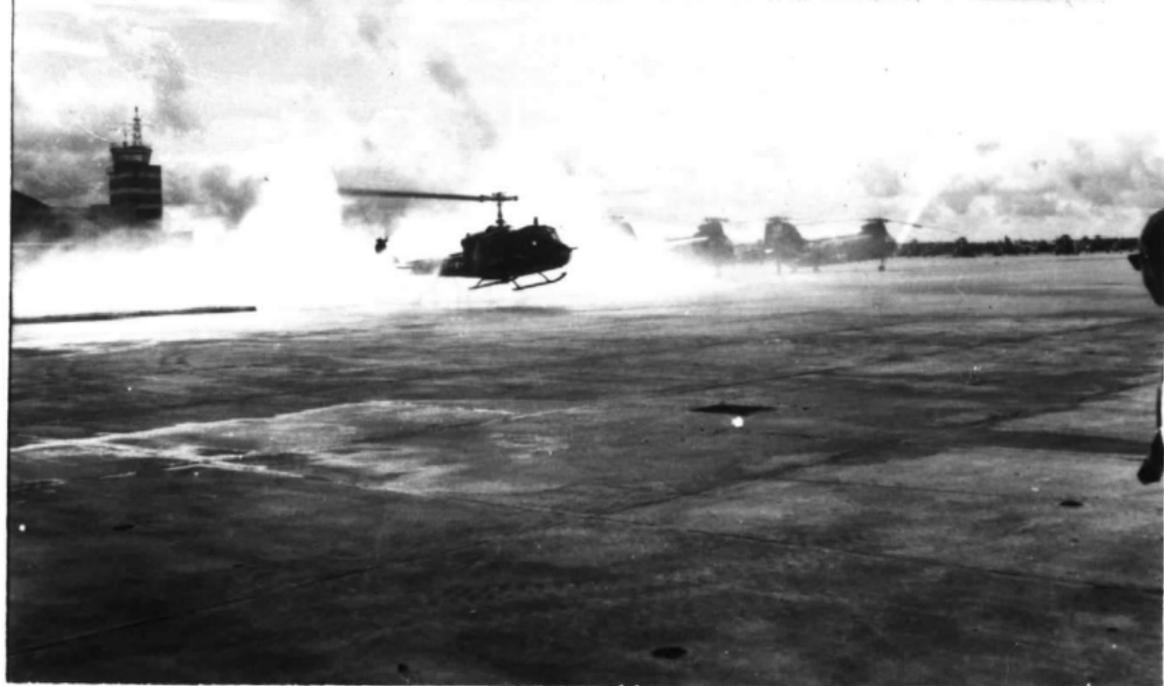
UH1E, IS SKID MOUNTED AND MUST BE FLOWN THROUGH THE  
SPRAY. NOTE THE SURPRESSION OF THE SPRAY AS THE ROTOR  
WASH BENDS IT BACK TOWARD THE HELICOPTER.

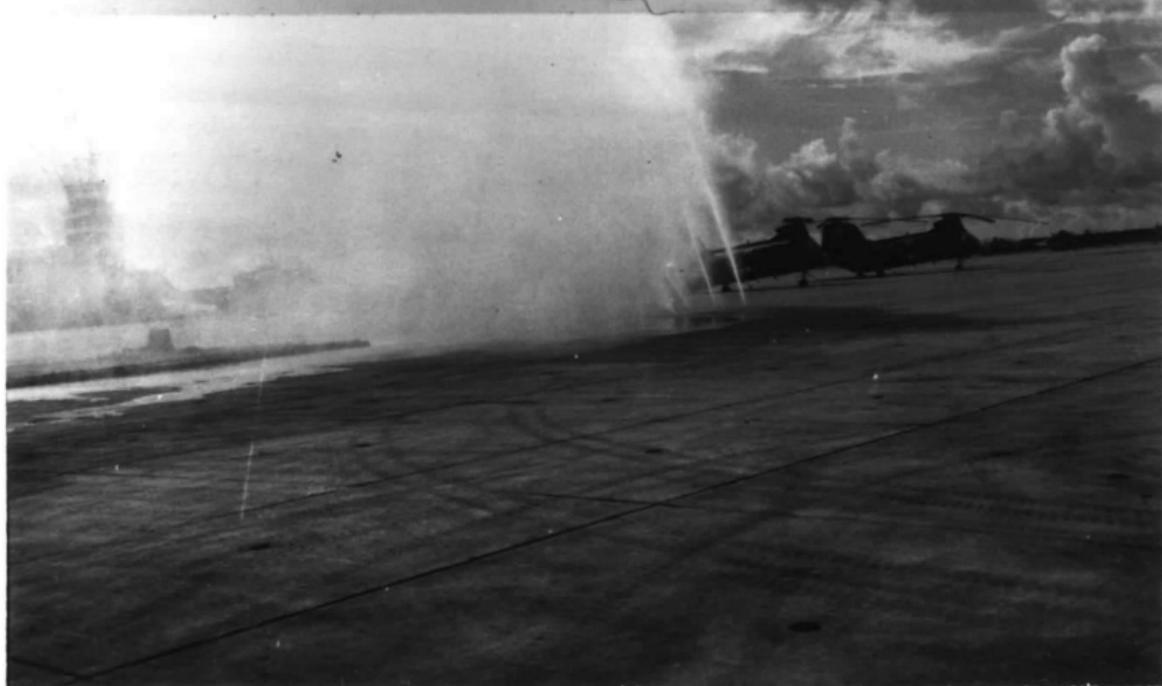
UH1E, NOTE THE REDUCED VISIBILITY AS THE HELICOPTER  
ENTERS THE SPRAY. THIS IS THE SMALLEST OF THE LOCAL  
HELICOPTERS USEING THE FACILITY.

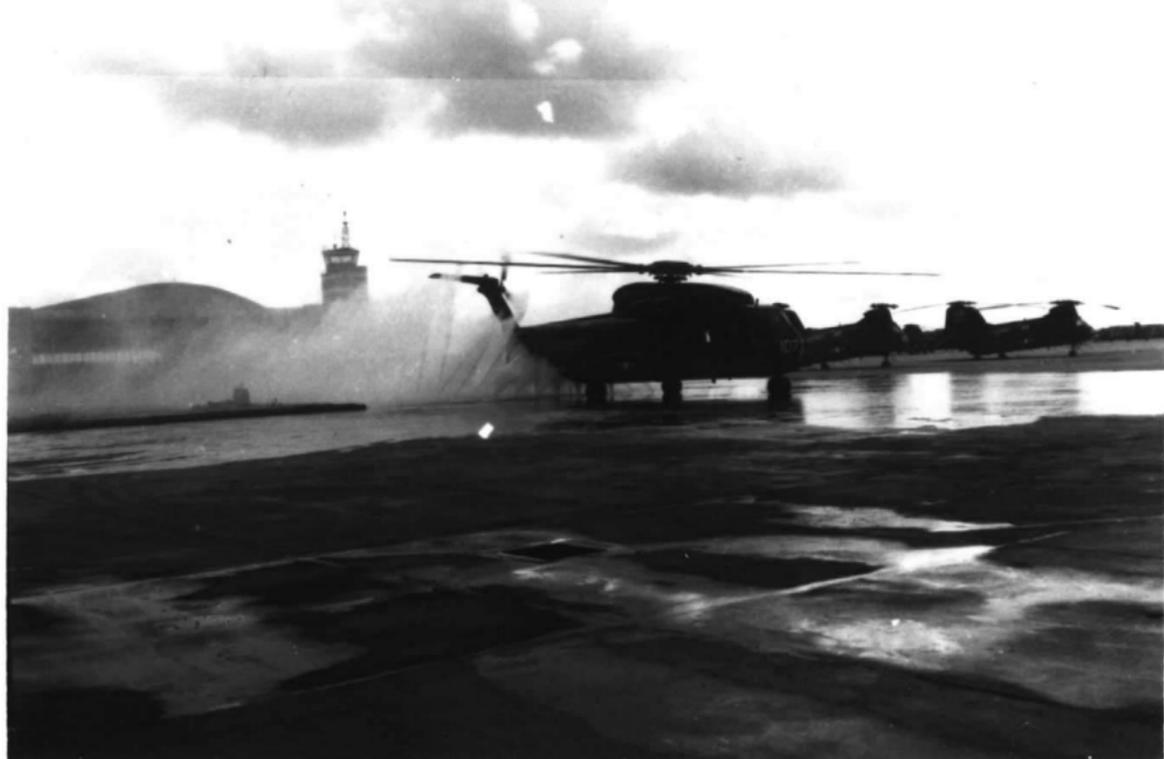
CH 53, THE TAIL ROTOR ALSO AIDS IN DISPERSING THE SPRAY.  
AS THE TAIL PASSES THROUGH THE SPRAY PATTERN.

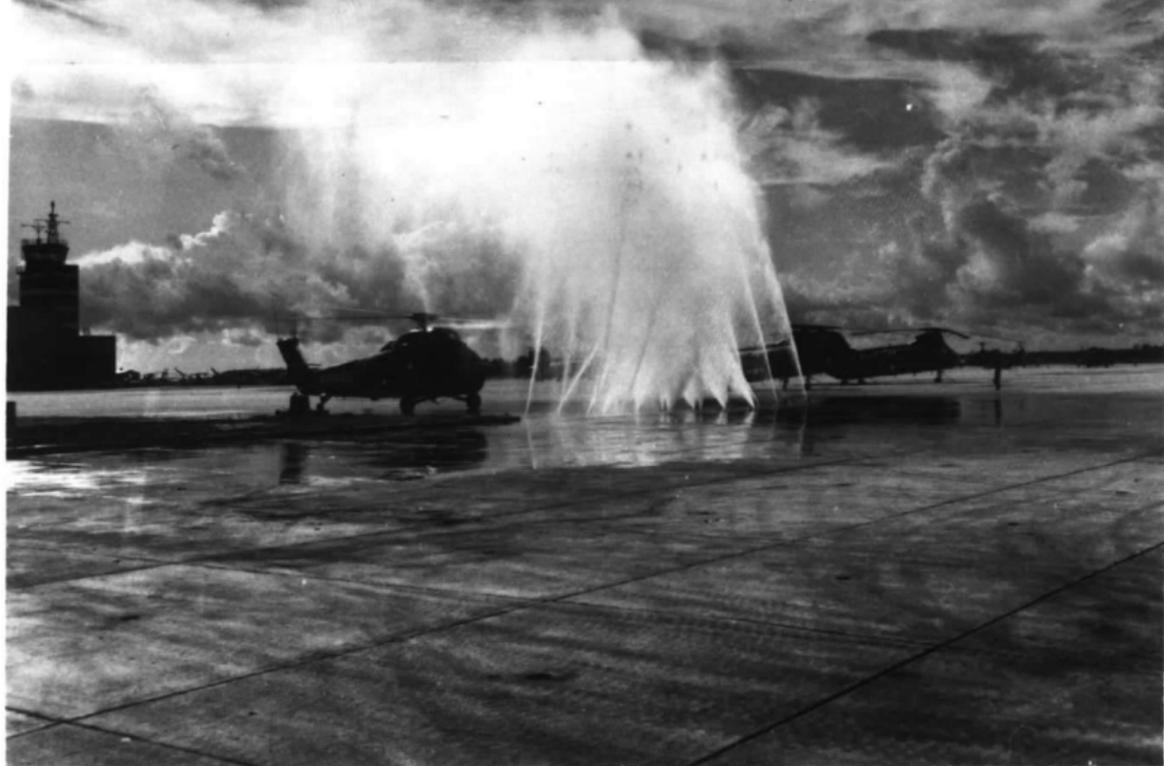
CH34, ROTOR WASH STARTS THE FLOW OF WATER AROUND THE HELICOPTER AS THE SPRAY PATTERN IS APPROACHED.

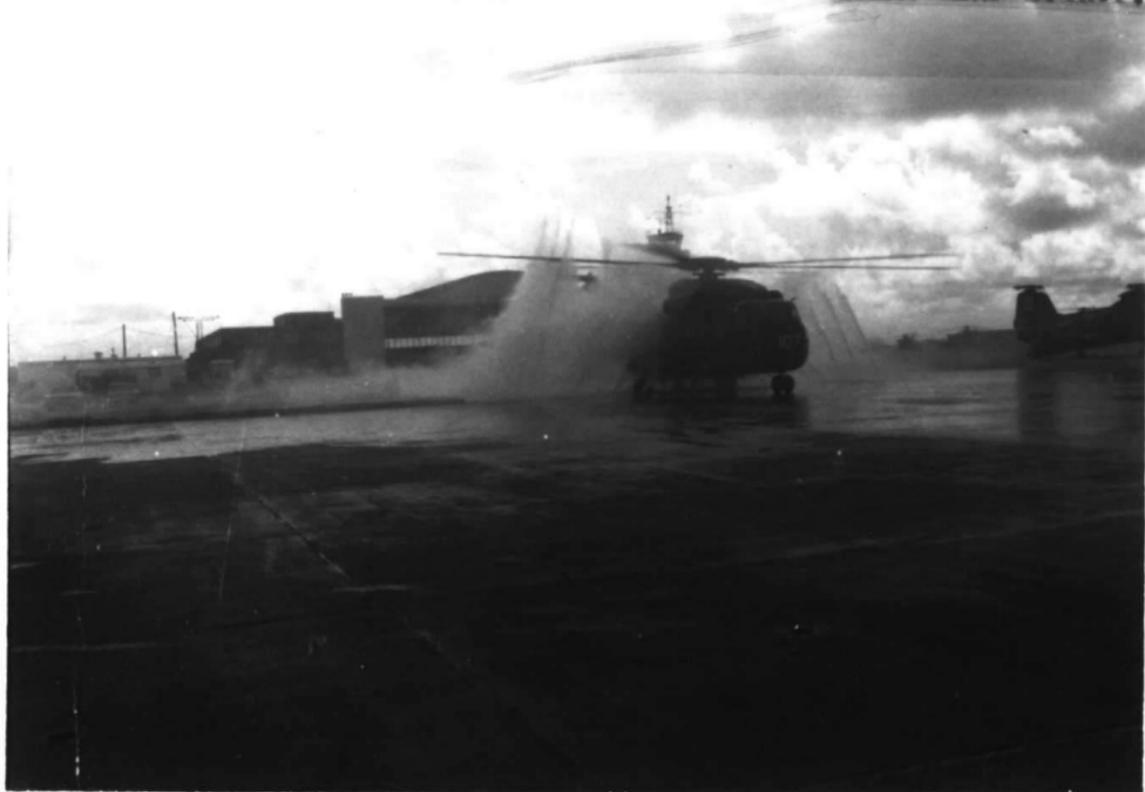
CH 53, NOTE THE TREETMENT OF THE UPPER AND LOWER TAIL SECTION FROM THE COMBINATION OF ROTOR WASH AND SPRAY.

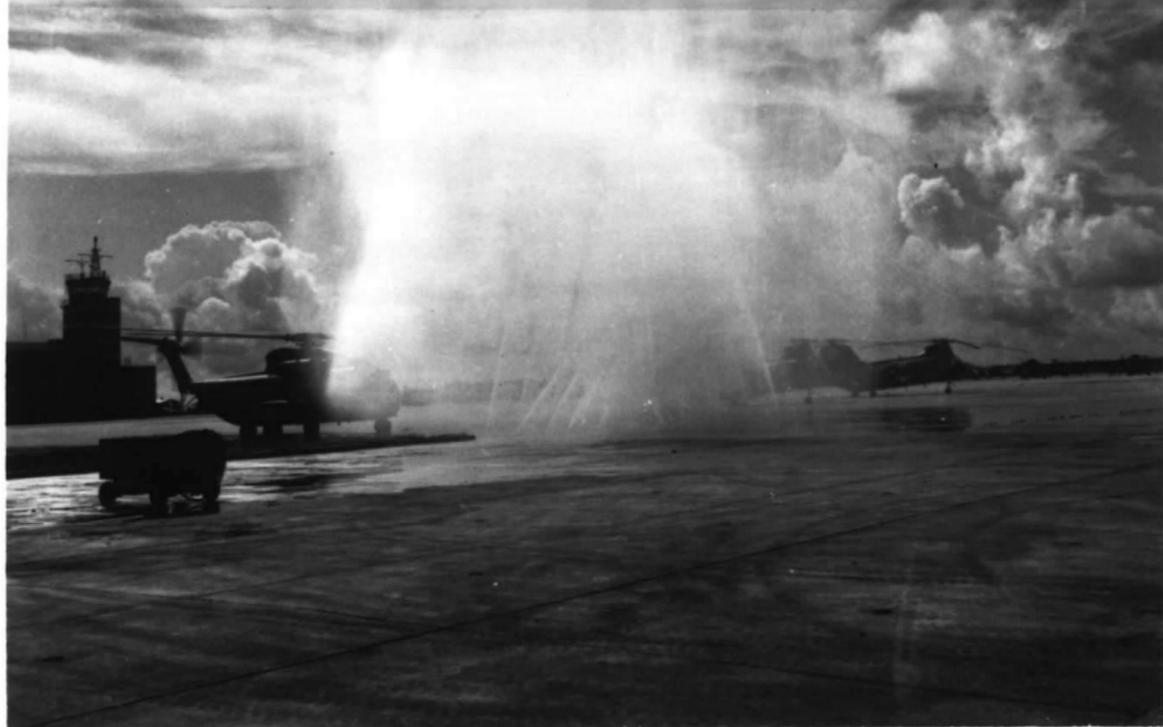
CH 53, NOTE HOW THE VORTAC OF THE MAIN ROTOR WASH  
PULLS THE SPRAY INTO THE ROTORS FROM ABOVE.
